Via Overnight Mail
February 24, 2011

Updated 3/10/2011: Operation code has been added

Subject: Safety Recall BLC (Interim B2C) - Interim Notice
Certain 2004 - Early 2007 Model Year RX 330, RX 350 and RX 400h Vehicles
Driver's Side Floor Carpet Cover and Retention Clip

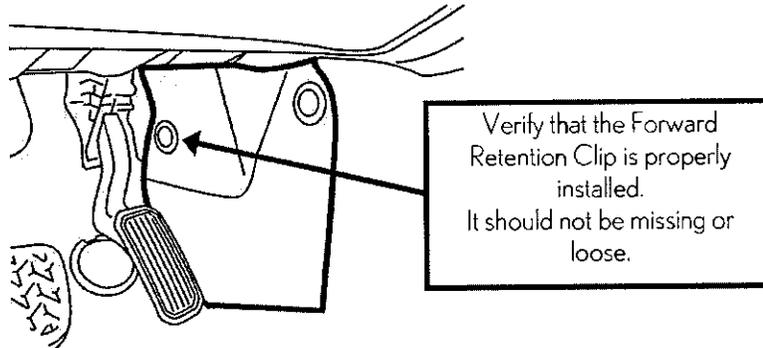
In certain 2004 through early 2007 model year RX 330, RX 350 and RX 400h vehicles, if the forward retention clip used to secure the driver's side floor carpet cover, which is located in front of the center console, is not installed properly, the cover may lean toward the accelerator pedal and interfere with the accelerator pedal arm. If this occurs, the accelerator pedal may temporarily become stuck in a partially depressed position rather than return to the idle position. An accelerator pedal temporarily stuck in a partially depressed position may increase the risk of a crash.

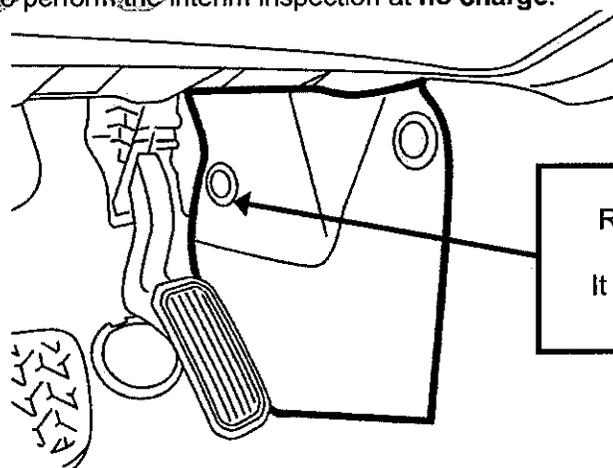
Verify that the Forward Retention Clip is properly installed. It should not be missing or loose.

Once the remedy parts are available, Lexus will replace the Floor Carpet Cover with one of a different shape as well as the forward and rear retention clips. ***Lexus will send a second owner notification letter when the replacement parts are ready and preparations are complete.***

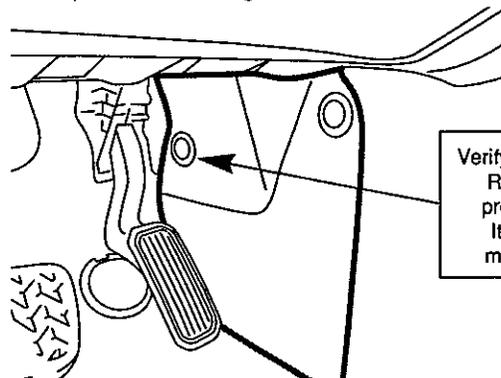
Verify that the Forward Retention Clip is properly installed. It should not be missing or loose.

Once the remedy parts are available, Lexus will replace the Floor Carpet Cover with one of a different shape as well as the forward and rear retention clips. *Lexus will send a second owner notification when the replacement parts are ready and preparations are complete.*

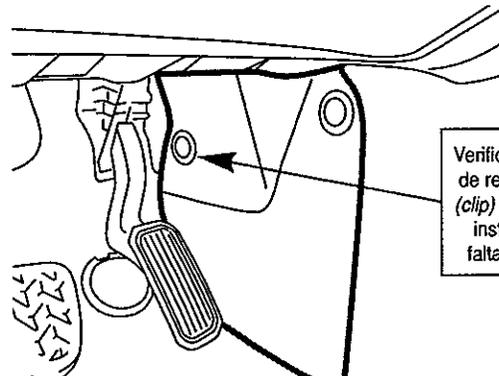
Venifique que el gancho de retención delantero (clip) esté debidamente instalado. No debe faltar ni estar suelto.

Una vez que estén disponibles las partes para implementar la solución, Lexus reemplazará la cubierta de la alfombra del piso por otra que tenga una forma diferente, así como también, los ganchos de retención (clips) delantero y trasero. **Lexus enviará una segunda carta de notificación al propietario cuando estén listas las partes de reemplazo y se hayan completado los preparativos.**
