This Service Information bulletin supersedes SI B63 06 11 dated **January 2012**.

Recall Campaign 11V-438: Repair Ground Cable for Rear Light Lamps (Side Panel)

E46/4 (3 Series Sedan) produced from 9/1/01 to 02/01/05

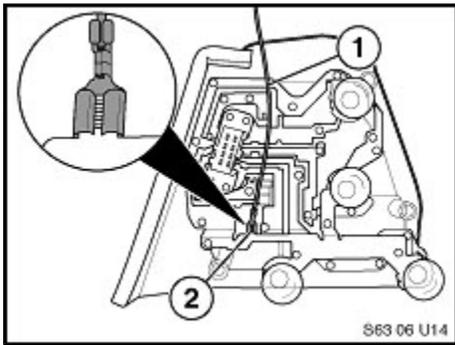
A poor ground connection at the rear lamp assembly (connectors X338 left side – pin # 2 and X339 right side – pin # 3) causes a malfunction of the rear tail lamps.

If both rear lamp assemblies already have an additional ground cable (1) on the bulb holder (2) (see diagram – bulb holder is removed), no further repair is necessary.

1. Check the operation and function of all the lamps (park light, turn signal, and brake light) for both rear lamp assemblies.

If additional ground cables are **not** present on both sides, proceed to the next step.

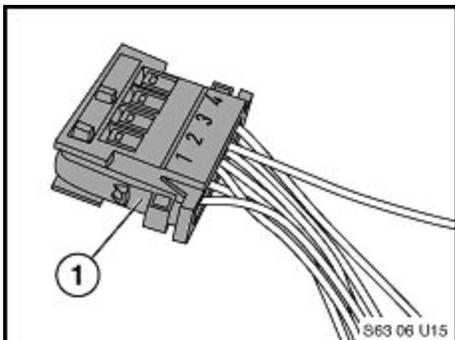
NEW If the lights within either tail lamp assembly **are not** functioning, inspect the wire harness connectors (left side connector X319 and right side connector X318). If thermal damage is found, then:

NEW Replace **the 8-pin connector socket housing and all 7-pin connectors** for the

malfunctioning side(s) only.

NEW Remove the socket housing (1) (X338 and/or X339): Refer to ISTA (Integrated Service Technical Application) Repair Instructions **REP 63 21 055** "Replace the socket housing for the left-hand or right-hand rear light (side panel)".

NEW Make note of the pin assignments and wire colors. Remove the harness tape about 150 mm from the 8-pin socket housing. Cut the cables off directly flush with the 8-pin socket (connector) housing X319 and/or X318 as needed. Replace the socket housing and all the (7) connector terminals, only for the defective side. Clean the connectors on the light carrier to improve a good contact to the other circuits. Proceed to the next step, # 3.
