**Subject: Navistar Safety Recall No. 99501
DOT No. 99V-033.001**

INTERNATIONAL VEHICLE RECALL

G-99501
April, 1999

**SUBJECT: VEHICLE RECALL (U.S., EXPORT)
Tie Rod Separation on 6000 & 8000 #
Capacity Dana Spicer Steer Axle**

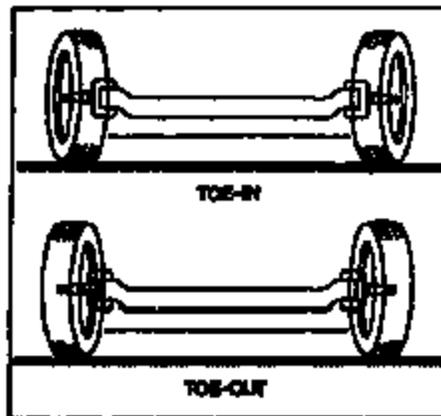
Figure 1

The following procedure may be used to set toe-in when electronic alignment equipment is not available. To obtain an accurate reading, two mechanics are required to insure that the pointers are always placed or adjusted to be exactly in front of the line scribed on both tires. Toe-in is the amount in fractions of an inch that the front wheels are closer together at the front than at the back (Figure 1).

- 1. Block rear wheel.**
- 2. Jack up front axle.**
- 3. Wipe off excess dirt and moisture from the center of both front tire treads complete 360°. Use a piece of caulk or white spray paint to mark the center area of both tires around the complete circumference.**
- 4. Put a scribe or pointed instrument against the center of the whitened area of each tire and rotate the tires 360°. The scribe must be held in place so that a single thin straight line is marked all the way around the tires.**

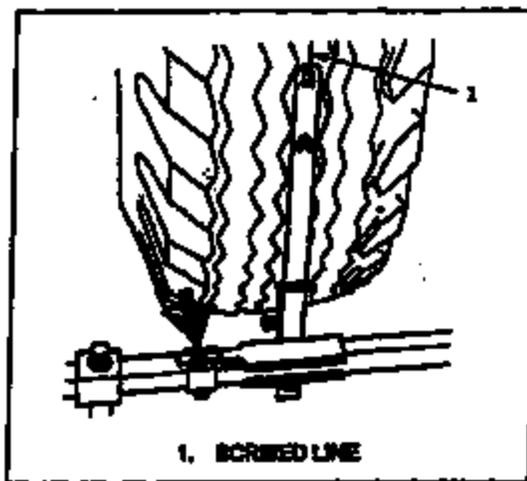
Figure 2

5. Put a floating radius gauge plate under each wheel. Lower the vehicle and remove the lock pins from the radius gauge plates to allow the front wheels to return to the normal operating position. If full floating radius gauges plates are not available, lower the vehicle to the floor and roll it forward 12 to 15 feet (3.65 to 4.57 m) to neutralize the front suspension. Neutralizing the front suspension is extremely important especially if the vehicle has been jacked up to scribe the tires; otherwise, the front wheels will not return to the normal operation position due to the tires gripping the floor surface when the vehicle is lowered.
6. Set the sliding scale end of the trammel bar to zero (0) (Figure 2) and lock the scale in place.

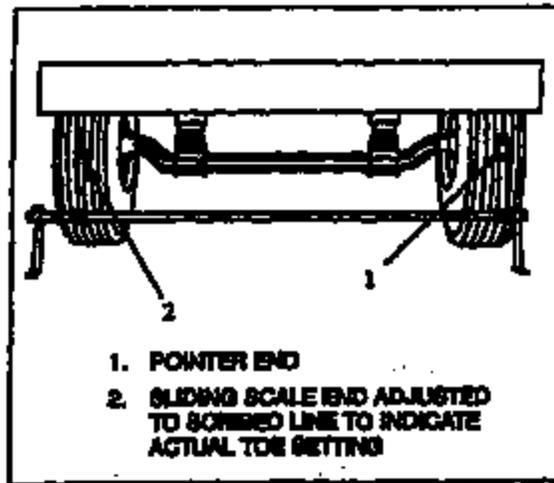
Figure 3

7. Put the trammel bar at the rear of the front tires so that the sliding scale that was set to zero in step 6 is centered against the scribed line on one of the tires (Figure 2).
8. Adjust the pointer on the end of the trammel bar opposite the sliding scale so it lines up with the scribed line on the rear of the opposite front tire. Lock the pointer in place on the trammel bar. Remove the trammel bar being careful not to contact either of the pointers.
9. Put the trammel bar against the front of the tires so the pointer end is aligned against the scribed line on the front tire. Loosen and remove the sliding scale pointer on the opposite end of the trammel bar so it is also aligned against the scribed line on the opposite tire. Lock the scale in place (Figure 3).

10. Read the toe-in or toe-out on the sliding scale. If toe-in is correct, it will read $1/16 \pm 1/16$ inch (0 – 1/8 inch toe-in).
11. If toe-in is within the specification, position and tighten tie-rod clamps to 70-85 ft lbs.

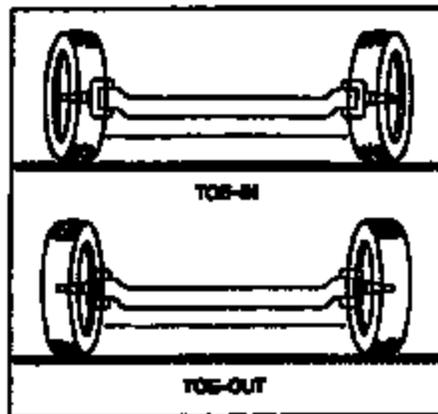
Figure 1

The following procedure may be used to set toe-in when electronic alignment equipment is not available. To obtain an accurate reading, two mechanics are required to insure that the pointers are always placed or adjusted to be exactly in front of the line scribed on both tires. Toe-in is the amount in fractions of an inch that the front wheels are closer together at the front than at the back (Figure 1).

1. Block rear wheel.
2. Jack up front axle.
3. Wipe off excess dirt and moisture from the center of both front tire treads complete 360° . Use a piece of caulk or white spray paint to mark the center area of both tires around the complete circumference.
4. Put a scribe or pointed instrument against the center of the whitened area of each tire and rotate the tires 360° . The scribe must be held in place so that a single thin straight line is marked all the way around the tires.

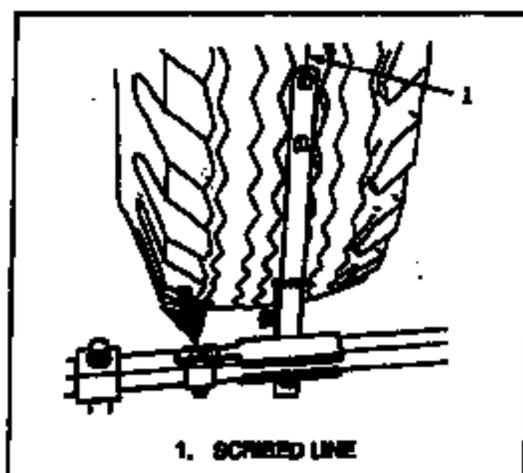
Figure 2

5. Put a floating radius gauge plate under each wheel. Lower the vehicle and remove the lock pins from the radius gauge plates to allow the front wheels to return to the normal operating position. If full floating radius gauges plates are not available, lower the vehicle to the floor and roll it forward 12 to 15 feet (3.65 to 4.57 m) to neutralize the front suspension. Neutralizing the front suspension is extremely important especially if the vehicle has been jacked up to scribe the tires; otherwise, the front wheels will not return to the normal operation position due to the tires gripping the floor surface when the vehicle is lowered.
6. Set the sliding scale end of the trammel bar to zero (0) (Figure 2) and lock the scale in place.

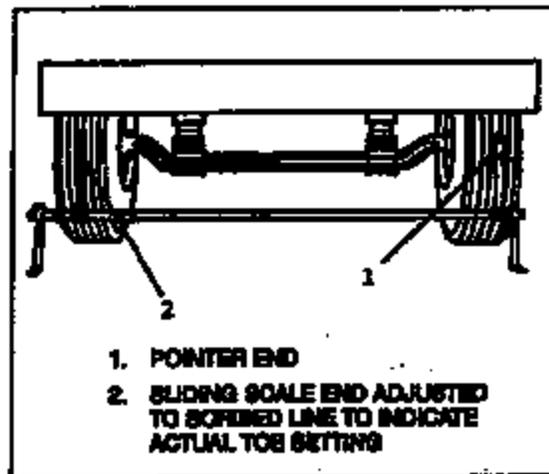
Figure 3

7. Put the trammel bar at the rear of the front tires so that the sliding scale that was set to zero in step 6 is centered against the scribed line on one of the tires (Figure 2).
8. Adjust the pointer on the end of the trammel bar opposite the sliding scale so it lines up with the scribed line on the rear of the opposite front tire. Lock the pointer in place on the trammel bar. Remove the trammel bar being careful not to contact either of the pointers.
9. Put the trammel bar against the front of the tires so the pointer end is aligned against the scribed line on the front tire. Loosen and remove the sliding scale pointer on the opposite end of the trammel bar so it is also aligned against the scribed line on the opposite tire. Lock the scale in place (Figure 3).

10. Read the toe-in or toe-out on the sliding scale. If toe-in is correct, it will read $1/16 \pm 1/16$ inch (0 – $1/8$ inch toe-in).
