September 2011

Dealer Service Instructions for:

Safety Recall L16 - Left Tie Rod

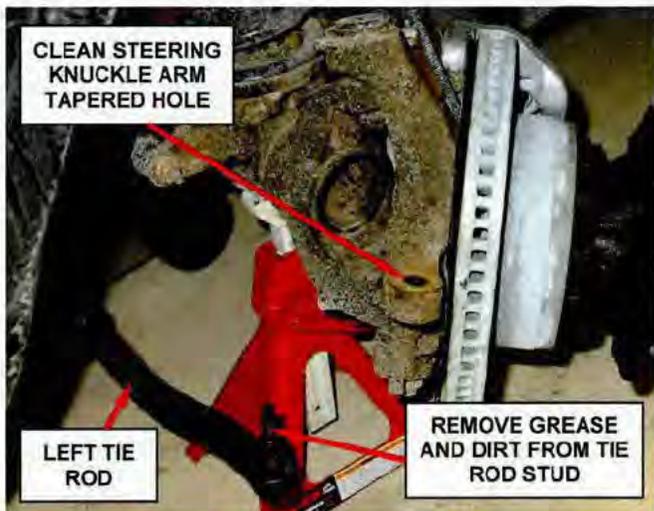
Figure 6 – Clean Steering Knuckle Arm Tapered Hole and Tie Rod Stud

CAUTION: Failure to clean the steering knuckle arm tapered hole may cause the tie rod connection to the steering knuckle to not seat properly. The steering knuckle arm tapered hole must be clean and dry.

11. Clean the tapered bore in the steering knuckle with Mopar Brake Cleaner (P/N 04897150AB) or equivalent (Figure 6).

12. Remove any grease or dirt from the tie rod stud before installing the stud into the steering knuckle arm tapered hole (Figure 6).

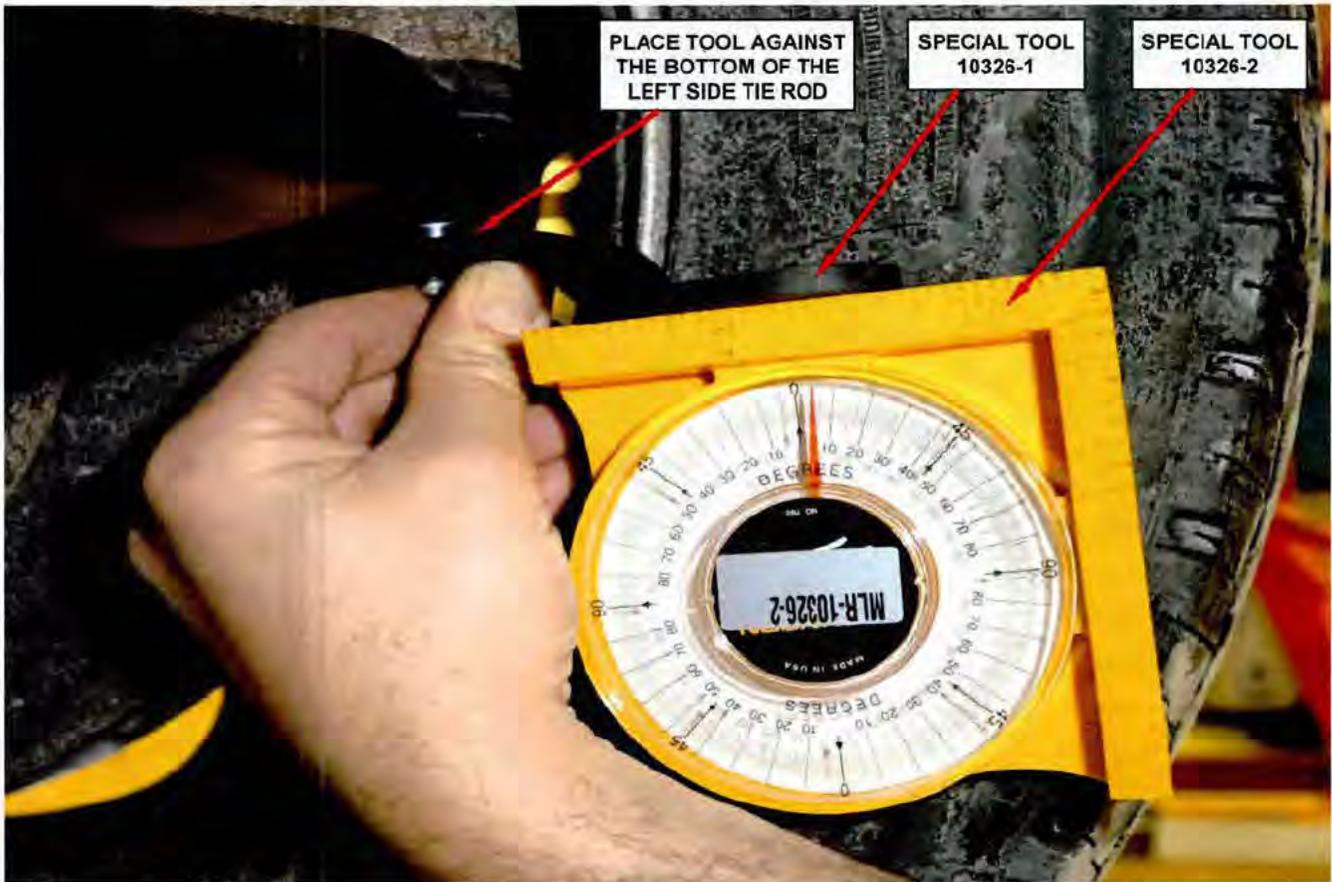
Figure 8 – Adjust the Left Tie Rod Angle to Match Right Tie Rod Angle

WARNING: Failure to have the same right and left tie rod angles will cause the condition this recall is addressing to still be present.

21. Install Special Tool 10326-1 and 10326-2 onto the bottom surface of the left side tie rod as shown in Figure 8.
22. Adjust the left tie rod so that the same angle appears on the inclinometer gauge as was measured on the right tie rod.

23. Tighten tie rod adjuster clamps to 40 ft. lbs. (54 N·m).
24. Recheck both right and left tie rod angles. The right and left tie rod angles must be the same. If the tie rod angles are different, loosen the left tie rod adjuster clamp and adjust left tie rod as required.

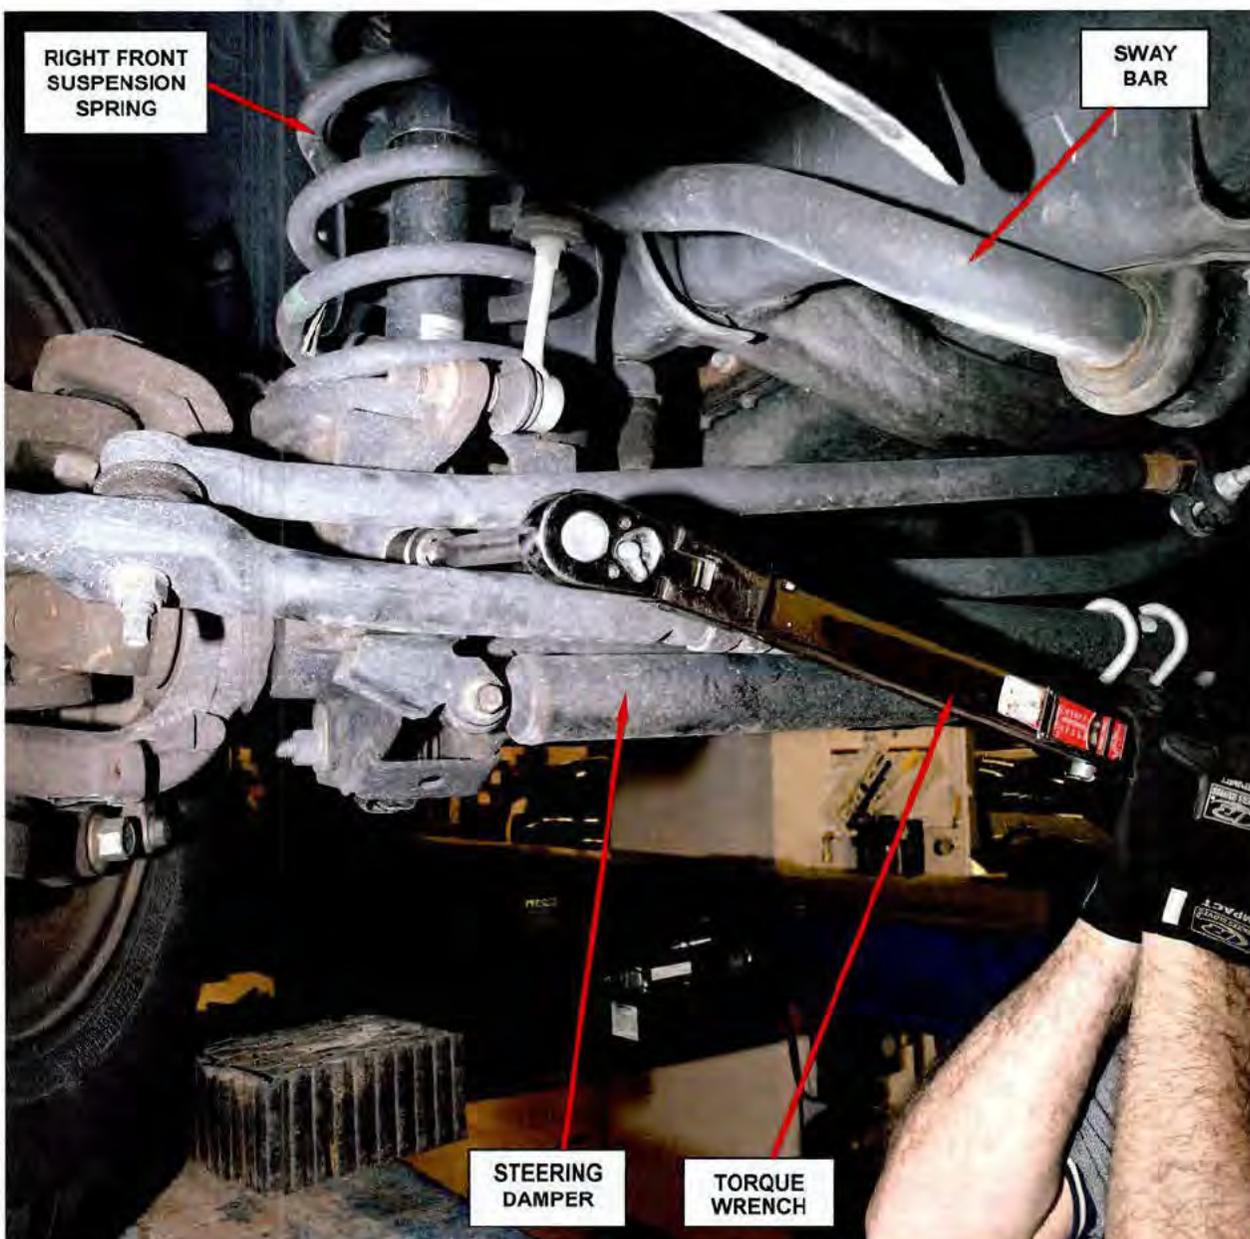
Figure 9 – Tighten Track Bar Bolt at Axle

The same vehicles may also have a loose front track bar bolt. This could cause a rattle or banging noise under certain driving conditions.

1. Turn the steering wheel to the full right position.
2. Tighten the track bar bolt at the axle to 250 ft. lbs. (300 N·m) (Figure 9).
