December 1, 2011

**11V-567**  
**(5 Pages)**

**Re: Recall Notification**  
**2001-10 and 2012 Model Year GL1800**  
**Secondary Master Cylinder**

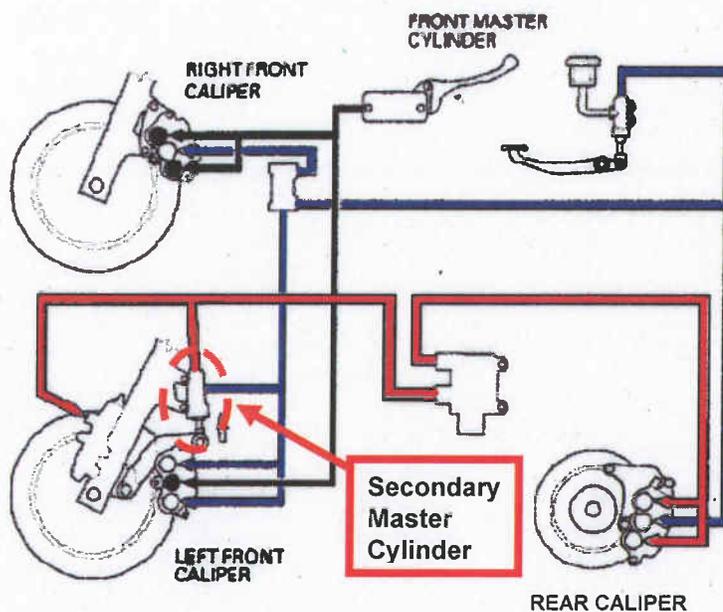
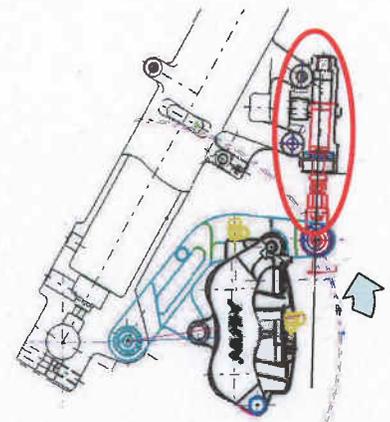
**Location of the secondary master cylinder in the combined braking system.**

Some vehicles may experience rear brake drag after the rider releases the rear brakes. The combined brake system utilizes a secondary master cylinder (illustrated below) mounted on the left front fork that is actuated by a torque-reaction of the left front brake caliper. As with a typical master cylinder, the secondary master cylinder includes a compensating port to facilitate expansion of brake fluid as the brake temperature increases. Due to production tolerance stack-up, the secondary master cylinder may be mounted at an increased angle compared to the design specification. Swelling of the secondary master cylinder pressure cup may also occur after prolonged exposure to brake fluid and high temperatures. These factors in combination may result in the compensating port becoming blocked. If the compensating port becomes blocked, the rear brake will drag and the brake fluid temperature will increase, causing the fluid to expand and the braking force/drag to increase. Unexpected braking/dragging increases the risk of a crash and continued riding with the rear brake engaged/dragging may generate enough heat to cause the rear brake to catch fire.

The secondary master cylinder is actuated by a torque reaction of the left front brake caliper whenever the front brake is applied

Honda motorcycle dealers will inspect the secondary master cylinder of all affected motorcycles in dealership stock or sold to customers (consumers and commercial entities) using a specially developed tool. If an inspection indicates that the compensating port can be blocked, the dealer will replace the secondary master cylinder with one that has additional free-play. Registered owners of affected motorcycles will be contacted by mail and asked to take their motorcycle to a Honda dealer. The dealer will inspect the motorcycle, and if necessary, replace the secondary master cylinder, free of charge.

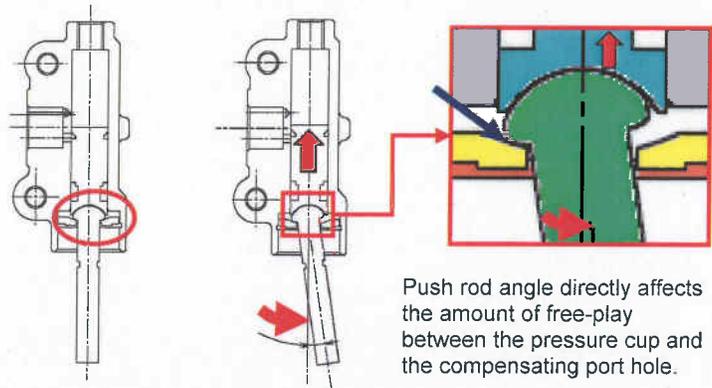
Stacking of manufacturing tolerances in the mounting of the secondary master cylinder causes the operating angle of the push rod to increase, which reduces free-play between the pressure cup and the compensating port.

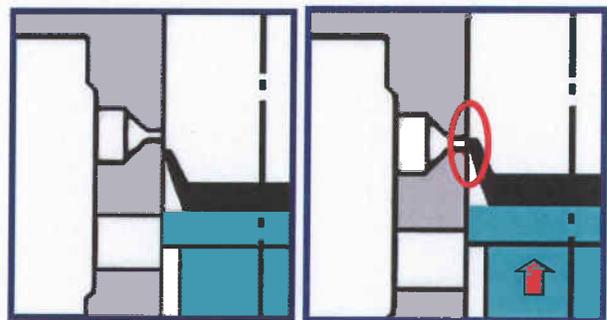
If the free-play is completely expended due to an increased pushrod angle and the pressure cup swells due to prolonged exposure to brake fluid and high temperature, the compensating port hole can become blocked and fluid cannot freely return after the rider releases the brake lever or pedal.
