RECALL CAMPAIGN

REF. NO. 27
ABS / ASR ELECTRONIC
CONTROL UNIT
360 MODENA / 360 MODENA F1

RECALL CAMPAIGN NO. 27

INTRODUCTION: Ferrari 360 Modena / 360 Modena F1 ABS / ASR Electronic Control Unit

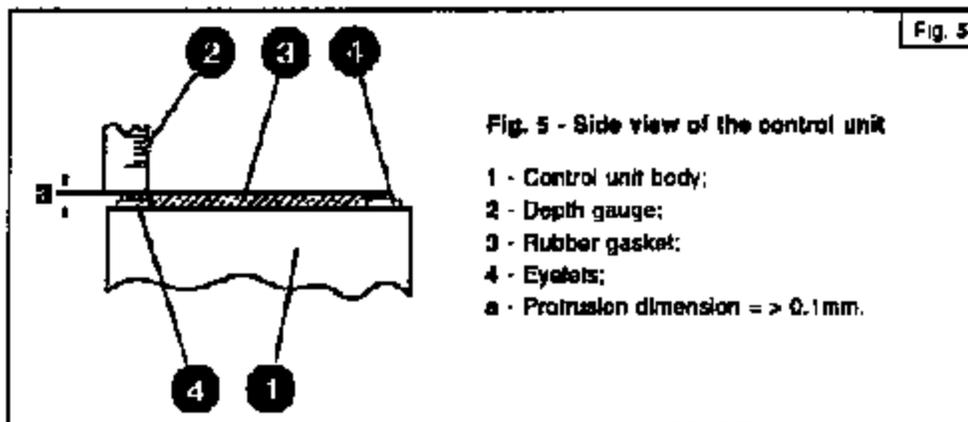
The protrusion of dimension "a" is an indication of the remaining thickness of the rubber gasket which will be compressed during the tightening and which is vital for sealing.

Warning: The gasket is an integral part of the electronic control unit and **CANNOT** be replaced. If the gasket is damaged the electronic control unit must **NOT** be fitted!

Using a calibrated depth gauge, carefully measure the protrusion "a" (Fig. 5).

Measure the dimension of the protrusion using the calibrated depth gauge, taking care to apply it without pressure on the rubber gasket and make the measurement from the eyelets for the fixing screws.

Notice: the eyelets are the highest points.

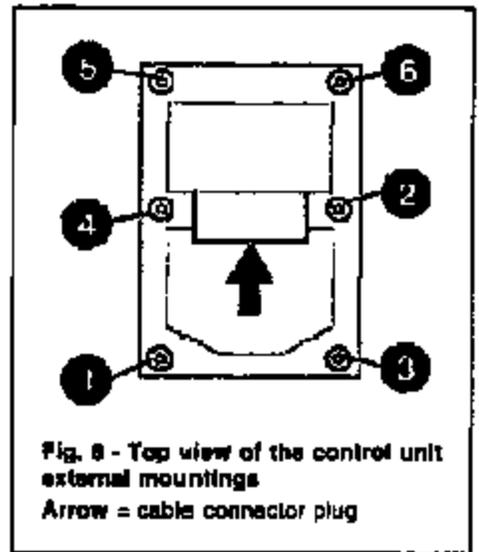
ATTENTION: IF THE SCREWS REQUIRE AN EXCESSIVE TORQUE, AND THE THREADS ARE BINDING, THE ENTIRE HYDRAULIC UNIT MUST BE REPLACED. IF ON THE OTHER HAND THE TORQUE REQUIRED IS TOO LOW, THE PRESSURE EXERTED ON THE GASKET WILL BE INSUFFICIENT, OR THE SCREWS MAY WORK LOOSE DURING OPERATION OF THE CAR AND PROVOKE FAILURE DUE TO A DANGEROUS SEALING DEFECT.

Fig. 6 - Top view of the control unit external mountings
Arrow = cable connector plug

There are 6 screws, first, gradually tighten screws 1,2,3,4 (Fig. 6) in a cross sequence until the corners of the electronic control unit are seated on the body of the pump. Next, tighten the screws 1,2,3,4 only gently at first, then successively tighten the other two screws 5,6 (Fig. 6).
