ODI RESUME

Investigation: EA 02-018
Prompted By: RQ02-002
Date Opened: 08/19/2002 Date Closed: 08/22/2003
Principal Investigator: TERRI DRONEBURG
Subject: RAPID TIRE DEFLATION

Manufacturer: FORD MOTOR COMPANY
Products: 1999-2001 FORD F-350,450,550 &E350,450
Population: 879103

Subject: Tire Valve Stem Ejects While Vehicle Is In Motion
EA Number: EA02-018
Subject Vehicles: 1999-2001 Ford F-350, F450, F550 trucks and
1999-2001 Ford E-350 and E-450 vans

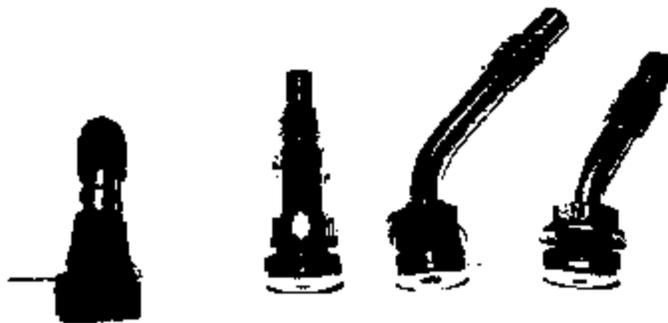
Figure A

Some subject vehicles have rubber valve stems and other subject vehicles have all-metal valve stems. The rubber valve stems have a bulb at the base of the stem that is inserted into the rim and is made of rubber. In addition, the shaft of the stem that protrudes from the rim is coated in rubber. The all-metal valve stems are made of metal, such as chrome-plated steel or brass. NHTSA's interest in this investigation was with the rubber valve stem that Ford installed on the subject vehicles. In response to the Recall Query, Ford submitted information to the agency that identified the rubber valve stem as the Dill TR600HP (High Pressure). The Dill TR600HP valve stems were the only rubber valves experiencing failures. If the rubber valve stem fails, a tire may experience sudden air loss causing the tire to rapidly deflate in less than 10 seconds, which may result in a loss of vehicle control. Ford equipped the majority of the 2002 models of the subject vehicles with the all-metal two-piece valve stems. These metal valve stems do not appear to be failing.

Figure A. The Dill TR600HP is shown at far left. The three other valve stems shown to the left are examples of all-metal valves stems referred to in the text.
