SI B12 07 03  
Engine Electrical

Recall 03V-240: E65/66 with N62 DME Reprogramming

#### MODEL

E65/66 with N62 engine produced up to 04/04/2003

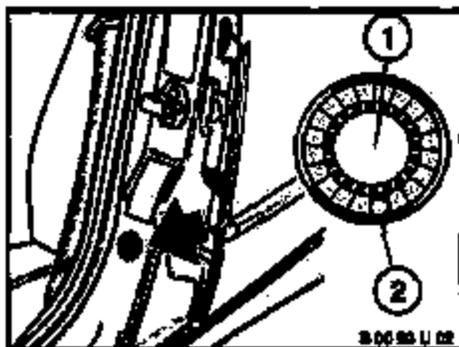
This Recall Campaign has been assigned code number 366. After the vehicle has been checked, and corrected if necessary, obtain a label (SD92-215) and:

- a. emboss your BMW dealer warranty number in the middle of the label (1);
- b. punch out code number 366 printed on the label and,
- c. affix the label to the B pillar as shown.

If the vehicle already has a label from a previous Service Action/Recall Campaign, affix the new label next to the old one. Do not affix one label on top of another one because a number from an underlying label could appear in the punched-out hole of the new label.
