SI B 11 05 03
Engine

Recall Campaign 03V - ■ 324: Retorque of Oil Drain Plug Located on Oil Filter Cover

745i, 745Li, and 760Li produced from 5/20/2003 through 7/18/2003

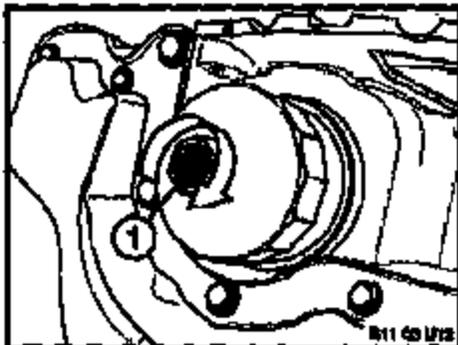
Some E65/E66 vehicles produced between 5/20/2003 and 7/18/2003 may have an insufficiently torqued oil drain plug. This Allen Head plug is located within the hex nut of the oil filter cover. A loosening of the plug could initially lead to an oil leak. If left unattended, a subsequent loss of oil would cause the illumination of the oil pressure light and a warning message in the instrument cluster. If a large amount of oil loss occurs, engine damage may result.

Tighten the Allen Head screw, located within the oil filter cover hex nut, to the correct torque.

Raise vehicle on hoist. Utilizing an appropriate torque wrench, retorque the 6 mm Allen Head screw (shown as "1" in illustration below) to 10 Nm. Clean any residual oil from the surface of the oil pan and ensure that there is no further leakage.
