Section 573.6 Defect Information Report
FL-411, NHTSA no. 03V-227
Supplement No.: 1

(c) (1) Manufacturer: FREIGHTLINER LLC
P.O. BOX 3849
Portland, Oregon 97208
(503) 745-5219

Subject: Fifth Wheel Bracket Pivot Pin

October 2003
FL411A
NHTSA 03V-227

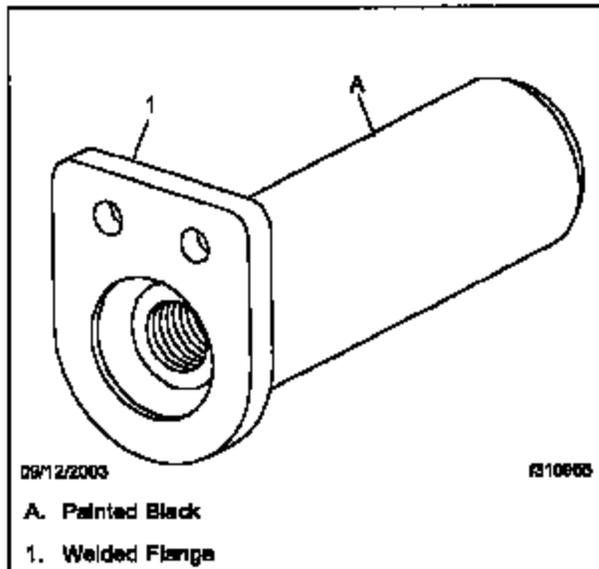
Fig. 1, Old Style Pivot Pin

The fifth wheel bracket pivot pin that connects the fifth wheel top plate to its mounting structure could develop fatigue cracks in the weld under certain loading conditions. This could lead to the separation of the fifth wheel top plate from its mounting structure without warning, possibly resulting in a crash.

If the vehicle has an old style pin installed, proceed with the replacement procedure.

4. To remove the old pin assembly, bend back the tabs on the tab washer if they were bent up against the bolts.
5. Remove the bolts that attach the pivot pin.

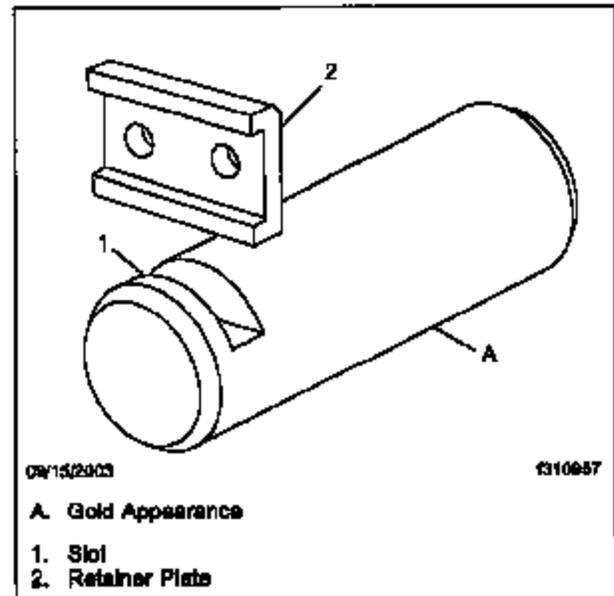
Fig. 2, New Style Pivot Pin

If the vehicle has a new style pin, no further work is required.
