RE: Recall Number 03V-030 (reference previous recall 01V-388) Defect Information Report (additional information) (Hyundai Campaign 049)

**REFERENCE: Campaign 049, Santa Fe V6 Crankshaft Position (CKP) Sensor  
Inspection/Replacement - Expanded Vehicle Production Range**

Group	CAMPAIGN
Number	03-01-001
Date	MARCH, 2003
Model	2001 SANTA FE V6

**Subject**  
**2001 SANTA FE V6 CRANKSHAFT POSITION (CKP) SENSOR INSPECTION/REPLACEMENT CAMPAIGN 049**

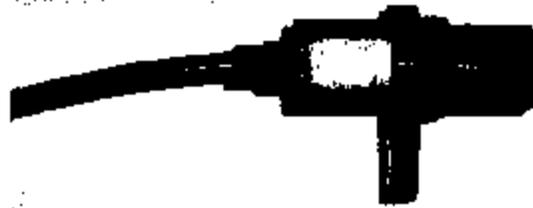
39180-37200

IF: The wiring of the CKP sensor comes out straight from the top of the sensor (as shown in the picture to the right) AND DOES NOT have a 90 degree plastic "knob" at the top of the sensor, then **REPLACE** the sensor, following the instructions below.

REPLACE
