December 2003

Safety Recall No. C43 Instrument Cluster Capacitor

2004 (HB) Dodge Durango

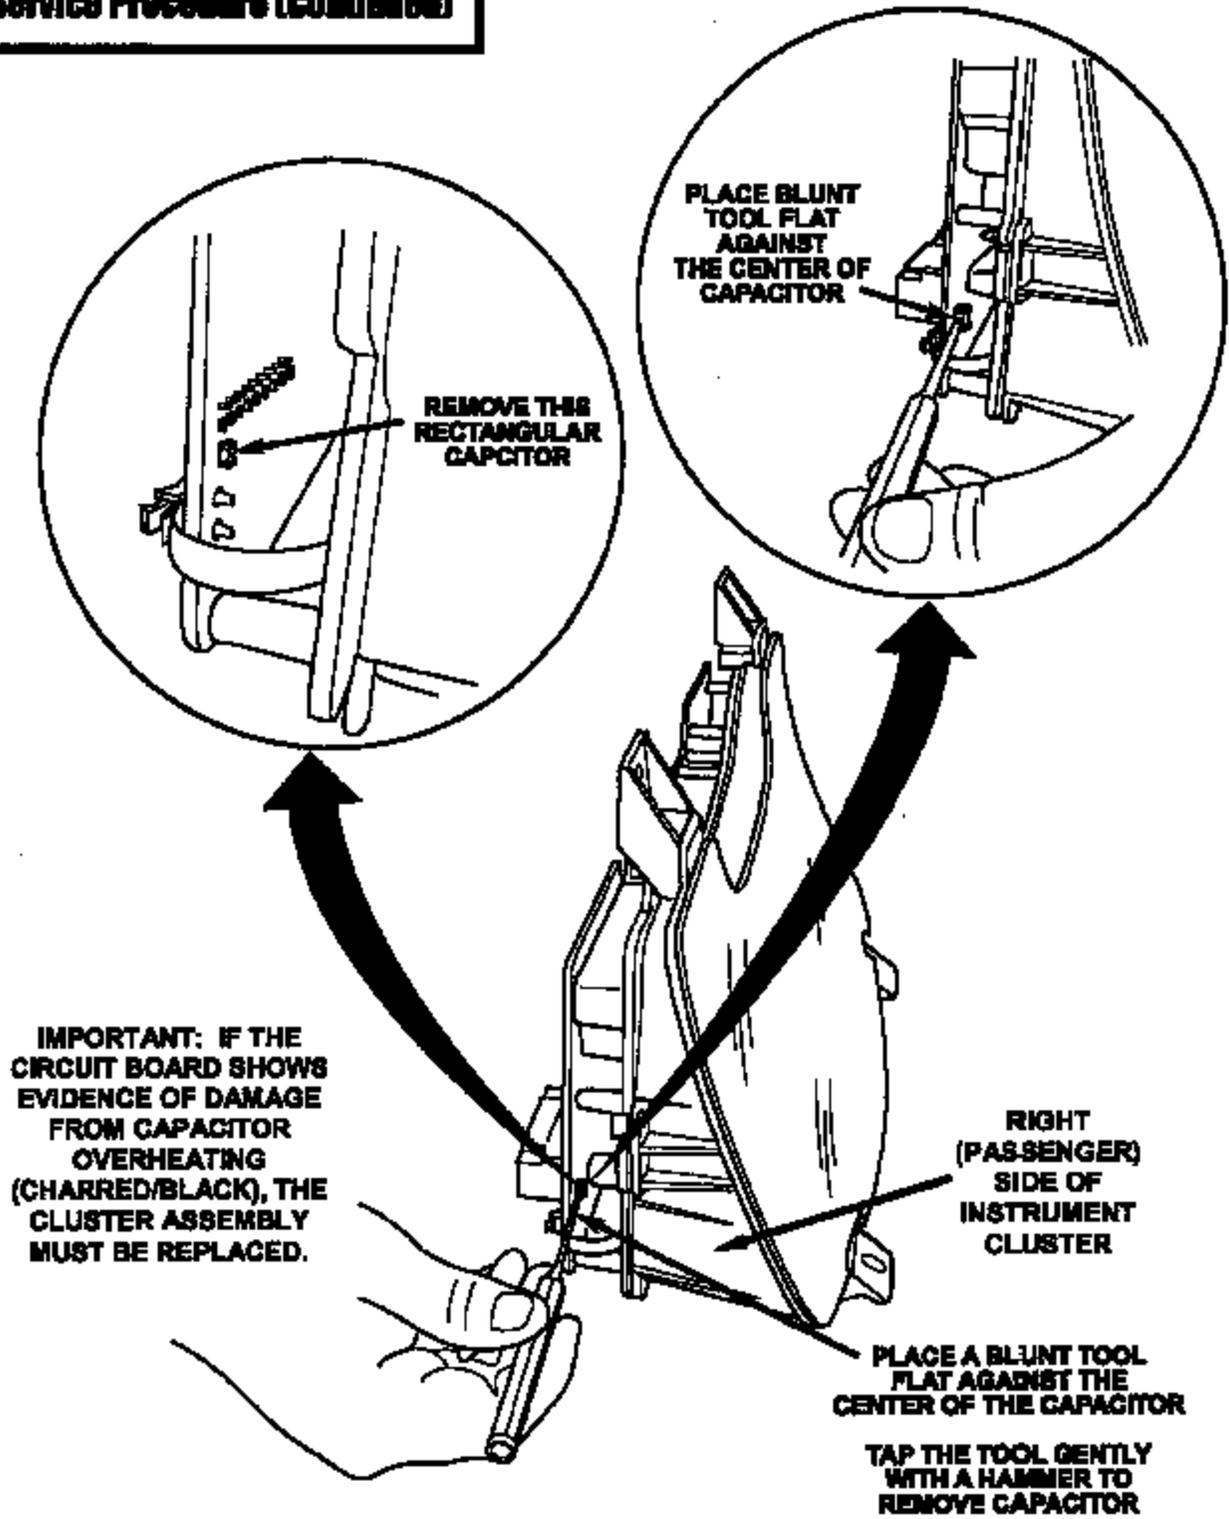
Figure 8

17. Place a **blunt tool** such as a 5/32" pin punch against the circuit board capacitor on the right (passenger) end of the circuit board (Figure 8). Do NOT use a tool that is wider than the overall width of the capacitor.

IMPORTANT: If the circuit board shows evidence of damage from capacitor overheating (charred/black), the cluster assembly must be replaced. Use normal service procedures to obtain a replacement cluster assembly.

18. **Gently** tap the tool with a small hammer to separate and remove the capacitor from the circuit board. Keep the circuit board in the vertical position so that the removed capacitor falls away from the cluster assembly.
19. Inspect the capacitor location and ensure that all of the capacitor material has been removed from between the two terminals and make sure that the capacitor has fallen away and is not trapped within the circuit board assembly.
20. Remove the two temporary screws from the circuit board assembly (Figure 7).
21. Carefully install the rear cluster cover onto the instrument cluster.
22. Install the twenty-two (22) screws into the rear cluster cover (Figure 6). Tighten the screws securely.
23. Position the instrument cluster so you can access and connect the electrical connectors on the back of the cluster housing (Figure 5).
