## ODI RESUME

INVESTIGATION: RQ98-018  
DATE OPENED: 10-JUL-1998 DATE CLOSED: 8 -JUL-02  
SUBJECT: Post-Recall Fuel Injection Assembly Leakage  
PROMPTED BY: Recall 98V-184  
PRINCIPAL INVESTIGATOR: Jeffrey Quandt

MANUFACTURER: DaimlerChrysler Corporation  
MODEL(S): Chrysler Concorde, New Yorker, and LHS; Dodge Intrepid; Eagle Vision; and Plymouth Prowler vehicles equipped with 3.5L V6 engines  
MODEL YEAR(S): 1993-1997  
VEHICLE POPULATION: 722,765

## DaimlerChrysler 3.5L Fuel Rail Recall

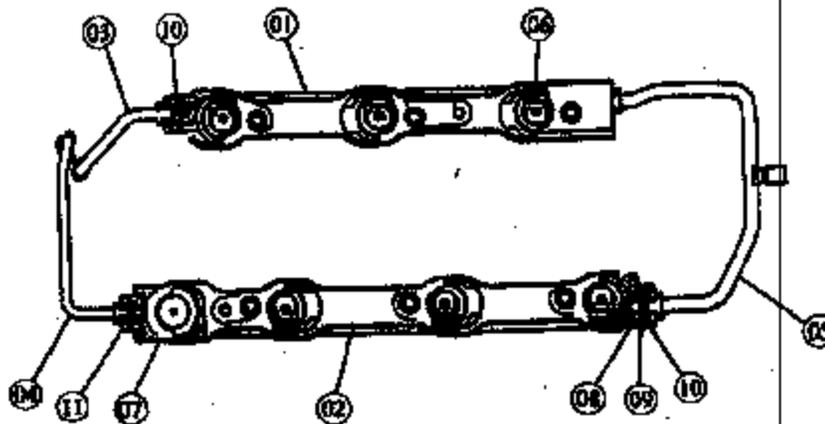
FIGURE 1. 3.5L FUEL RAIL ASSEMBLY

<sup>1</sup> Outlet rail replaced if cracked/leaking (Labor Op. 14790183 or 14790185).

<sup>2</sup> Upper injector o-rings (6), replaced if one or more leak during initial or final pressure test (Labor Op. 14790184 or 14790185).

<sup>3</sup> Fuel rail (6) and pressure regulator (2) nitrile o-rings, replaced for all 98V-184 procedures.

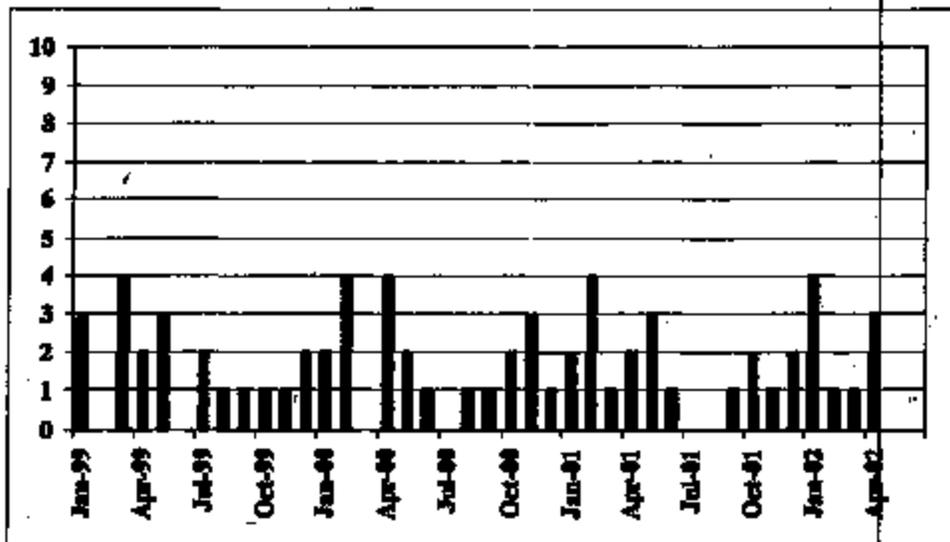
Figure 2. ODI Complaint Trend,  
Fuel Rail Assembly Leakage Following Recall 98V-184 Repairs.

Post-repair leakage complaints to ODI have continued at a constant level of about 20 per year since the recall was initiated (Figure 2). Problems with leakage occurring immediately following recall service have been largely corrected by DaimlerChrysler's revisions to the recall procedure and increased dealer proficiency in performing the appropriate repairs. There is some concern that some fuel leakage incidents are continuing to recur, in some instances more than two years after recall repairs were completed. However, the data indicate that such events are relatively rare and that follow-up dealer repairs are providing appropriate resolution when they do occur. DaimlerChrysler has advised ODI that there are no time restrictions on the availability of free repairs for the fuel injector assembly leakage remedy procedures provided by Recall 98V-184.
