YAMAHA MOTOR CORPORATION, U.S.A.

Re: Recall No.: 00V-076

Technical BULLETIN

YZF-R1K, KC, L, LC; YZF-R6L, LC, M, MC FACTORY MODIFICATION CAMPAIGN

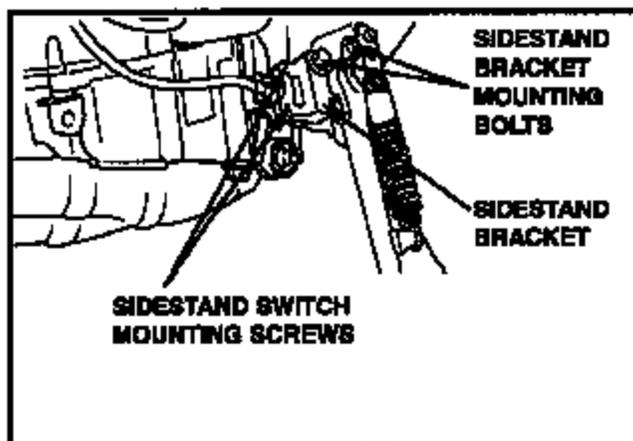
Yamaha Motor Corporation, U.S.A. has determined that a defect which relates to motor vehicle safety exists in 1998 and 1999 YZF-R1 motorcycles, and also in 1999 and certain 2000 YZF-R6 motorcycles. The screws holding the sidestand switch may loosen and fall out due to engine heat and vibration. If this happens, the sidestand switch would not function correctly, so it would be possible to ride the motorcycle with the sidestand in the down position. This condition would increase the risk that the sidestand could hit the ground during a turn, which could cause loss of control and an accident/crash with resulting personal injury or death.

1. Support the motorcycle securely on a stand which positions it vertically, such as on a race stand.
2. Remove the 2 mounting bolts holding the sidestand bracket to the frame.
3. Remove the 2 screws holding the sidestand switch to the sidestand bracket.
