00V-076 (01)

Technical BULLETIN

RECALL

YZF-R1K, KC, L, LC; YZF-R6L, LC, M, MC FACTORY MODIFICATION CAMPAIGN

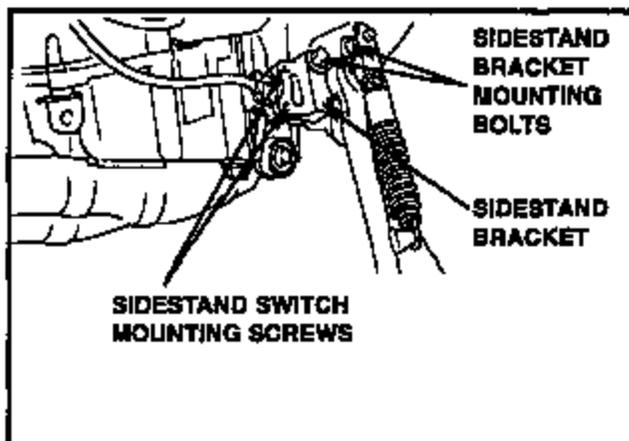
Yamaha Motor Corporation, U.S.A. has determined that a defect which relates to motor vehicle safety exists in 1998 and 1999 YZF-R1 motorcycles, and also in 1999 and certain 2000 YZF-R6 motorcycles. The screws holding the sidestand switch may loosen and fall out due to engine heat and vibration. If this happens, the sidestand switch would not function correctly, so it would be possible to ride the motorcycle with the sidestand in the down position. This condition would increase the risk that the sidestand could hit the ground during a turn, which could cause loss of control and an accident/crash with resulting personal injury or death.

1. Support the motorcycle securely on a stand which positions it vertically, such as on a race stand.
2. Remove the 2 mounting bolts holding the sidestand bracket to the frame.
3. Remove the 2 screws holding the sidestand switch to the sidestand bracket.
