Re: Recall No.: 00V-076

Technical BULLETIN

YZF-R1K, KC, L, LC; YZF-R6L, LC, M, MC FACTORY MODIFICATION CAMPAIGN

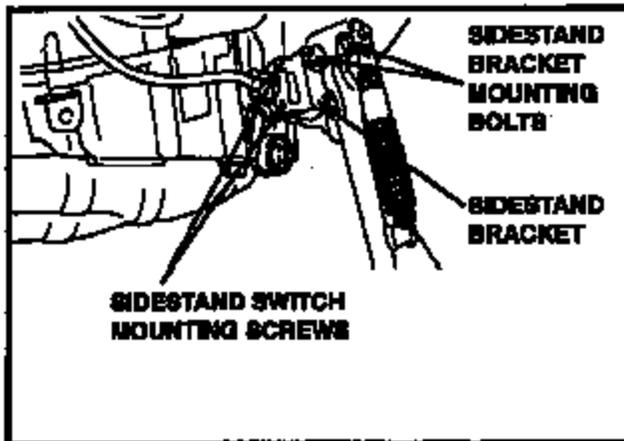
Yamaha Motor Corporation, U.S.A. has determined that a defect which relates to motor vehicle safety exists in 1998 and 1999 YZF-R1 motorcycles, and also in 1999 and certain 2000 YZF-R6 motorcycles. The screws holding the sidestand switch may loosen and fall out due to engine heat and vibration. If this happens, the sidestand switch would not function correctly, so it would be possible to ride the motorcycle with the sidestand in the down position. This condition would increase the risk that the sidestand could hit the ground during a turn, which could cause loss of control and an accident/crash with resulting personal injury or death.

1. Support the motorcycle securely on a stand which positions it vertically, such as on a race stand.
2. Remove the 2 mounting bolts holding the sidestand bracket to the frame.
3. Remove the 2 screws holding the sidestand switch to the sidestand bracket.
