Reference: NHTSA Identification Number 01V-040

## **Interim Customer Notice Safety Recall No. 973W Lubricate Secondary Hood Latch**

#### **1994-1999 (BR/BE) Dodge Ram Pick-Up Truck**

**Safety Recall No. 973 - Secondary Hood Latch**

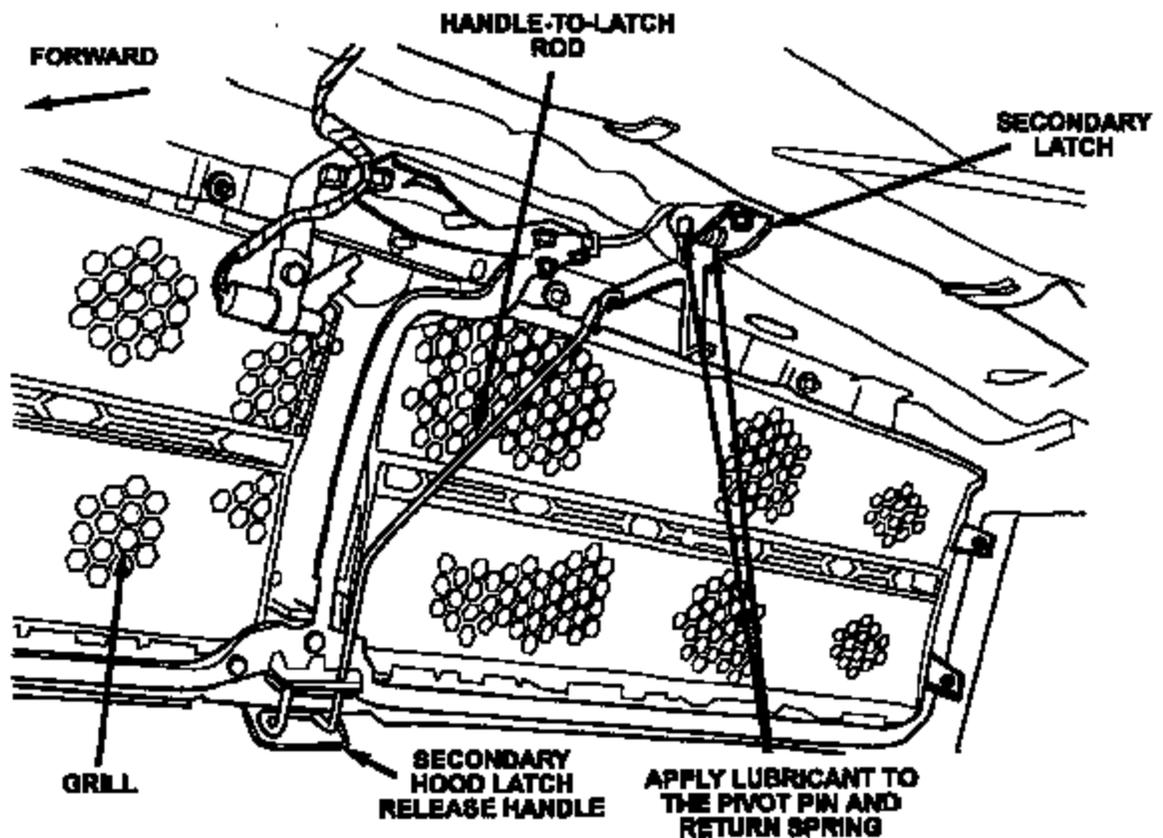
**Figure 1 – Underhood View Shown**

The secondary hood latch on about 793,000 of the above trucks may stick in the open position. This could allow the hood to open unexpectedly while driving if the primary (main) latch mechanism is not engaged.

1. With the engine OFF, open the hood.
2. Using Mopar Spray White Lube (Lithium Grease) or equivalent, spray the secondary hood latch pivot pin and return spring (Figure 1).
3. Activate the secondary latch several times to ensure that the latch fully returns to the closed position and does not bind or stick.
4. Close the hood, making sure that the primary latch is engaged.

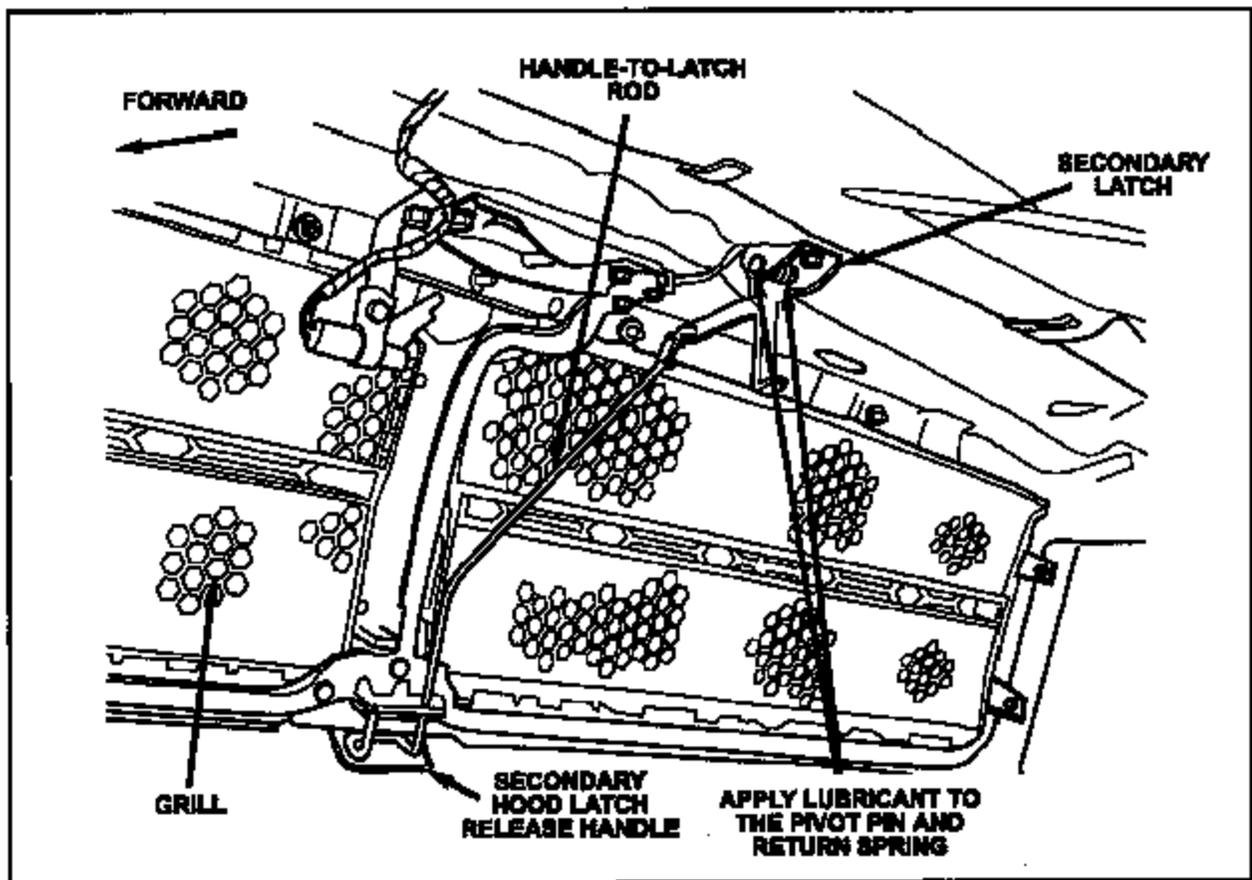
**Figure 1 – Underhood View Shown**

We are writing to inform you of a future safety recall on some 1994 through 1999 model year Ram pick-up trucks. These trucks have been operated for extended periods in geographic areas using large amounts of road salt for ice and snow removal. This safety action relates to a secondary latch that helps secure your vehicle's hood. There is also a primary latch, which is the principle mechanism holding the hood in place. Corrosion of the return spring on the secondary latch may cause the mechanism to bind in the "release position." If the primary latch is not engaged, and if the secondary latch binds, the hood could open unexpectedly.

1. With the engine OFF, release the primary hood latch by pulling the hood release lever located below the steering wheel, at the bottom of the instrument panel.
2. Reach into the opening under the center of the grille and push up on the secondary hood latch release handle and open the hood (Figure 1).
3. Using Mopar Spray White Lube (Lithium Grease) or equivalent, spray the secondary hood latch pivot pin and return spring (Figure 1).
4. Push up on the secondary latch release handle several times to ensure that the latch fully returns to the closed position and does not bind or stick. Apply additional lubricant as required until the secondary latch operates freely.
5. Close the hood. Pull up on the hood to make sure that the primary latch is engaged.

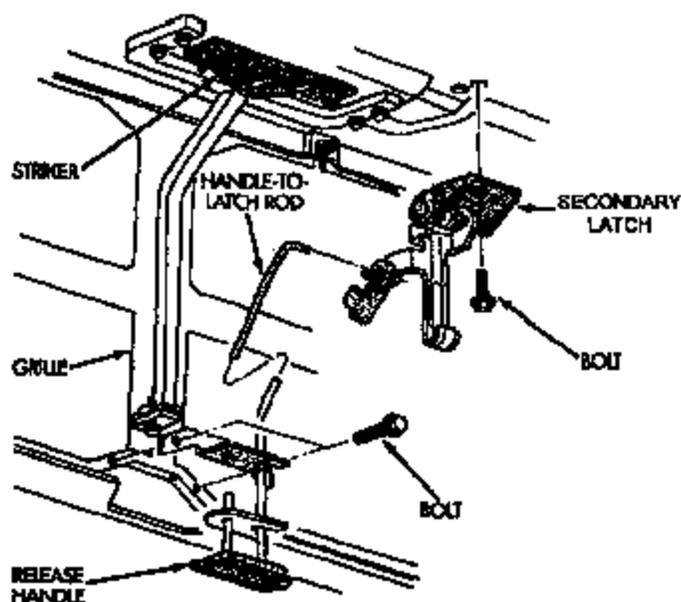
**Figure 1**

The secondary hood latch on about 793,000 of the above trucks may corrode and bind in the "released position." If the primary hood latch is not engaged, and if the secondary latch binds, the hood could open unexpectedly and cause an accident without warning.

1. Release the hood latch and open the hood.
2. Disconnect the handle-to-latch rod at the secondary latch.
3. Remove the secondary latch mounting bolt (Figure 1).
4. Remove and discard the latch from the hood.
5. Install the new secondary latch and tighten mounting bolt to 95 in. lbs. (11 N·m)
6. Connect the handle-to-latch rod onto the new secondary latch.
7. Cycle the secondary latch several times to ensure that it operates freely.
8. Close the hood and unlatch the primary hood latch. Without touching the secondary latch, pull up on the hood vigorously several times to ensure that the secondary latch engages properly.
