March 26, 2004

RE: 04V-086

In accordance with our campaign to correct a safety defect related to the headlamp in certain 2001-2002 model year Honda Civic automobiles, we are submitting a copy of the dealer bulletin, which also includes the text of the customer letter.

Safety Recall: Combination Light Switch

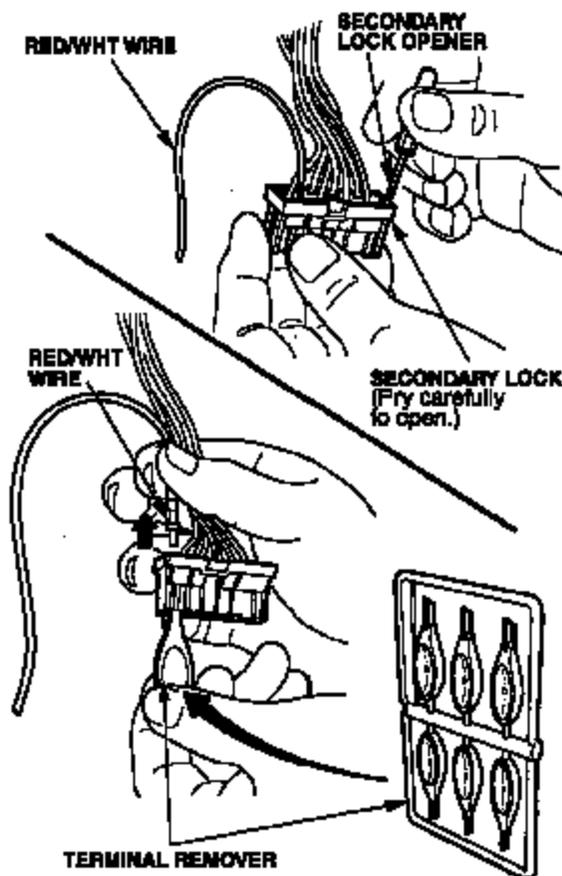
11. Inspect the 16P connector for heat damage or discoloration.
 - If the connector is OK, go to step 12.
 - If the connector is damaged or discolored, go to step 14.
12. Using the Secondary Lock Opener from the Terminal Maintenance Set (T/N 070AZ-S5A0100), carefully pry open the secondary lock on the RED/WHT wire side of the 16P connector.

13. Twist off a terminal remover from the Terminal Remover Set (T/N 070AZ-S5A-011). Insert the terminal remover into the center row cavity of the 16P connector, above the RED/WHT wire cavity, then remove and discard the RED/WHT wire.
