SUBJECT: Vehicle Recall Campaign - SC0261 (NHTSA ID# 00V-230.003)
Felsed Throttle Pedal

**SUBJECT: Vehicle Recall Campaign - SC0261
Felsted Throttle Pedal**

SUBJECT: ELECTRONIC THROTTLE PEDAL RETURN SPRING BREAKAGE

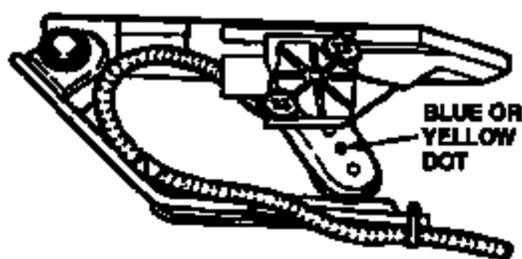
Figure 3 — Checking for Blue or Yellow Mark on Pedal Roller Arm

If the throttle pedal is a Felsted assembly, check for a blue or yellow mark on the left-hand side of the roller assembly arm. If a blue or yellow mark is present, the springs have already been replaced and installation of a spring pack is not necessary. If a blue or yellow mark is NOT present, a spring pack must be installed as outlined in the following instructions.
