//ALL HMA-BST3D 04/23/04 04/26/04 04/27/04
TO: All Hyundai Dealership Service and Parts Managers
FROM: Service
SUBJECT: Campaign 067 - Vapor Tube Hose Clamp Position on certain
2004 Model Year Elantras.

Subject VAPOR TUBE HOSE CLAMP POSITION CAMPAIGN 067	Group CAMPAIGN
	Number 04-01-004
	Date APRIL, 2004
	Model 2004 ELANTRA

Group	CAMPAIGN
Number	04-01-004-1
Date	APRIL, 2004
Model	2004 ELANTRA

Subject	VAPOR TUBE HOSE CLAMP POSITION CAMPAIGN 067
---------	--

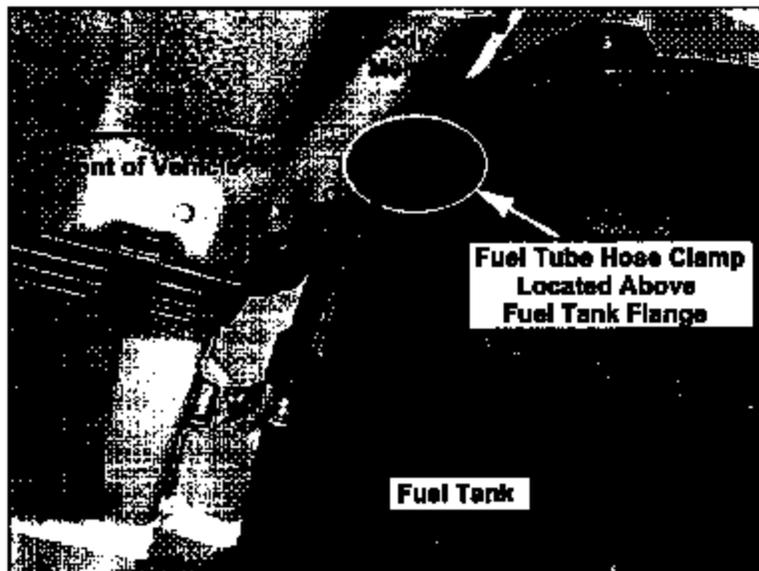
CORRECT POSITION

If both clamp ears are facing away from the fuel tank.

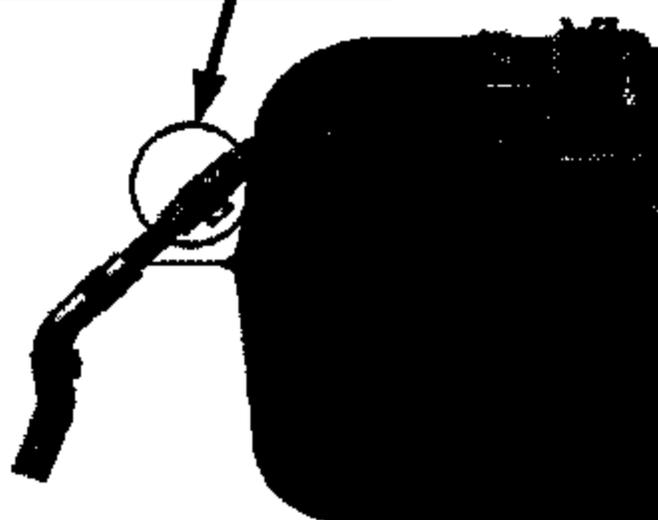
INCORRECT POSITION

If either of the clamp ears face towards the fuel tank.

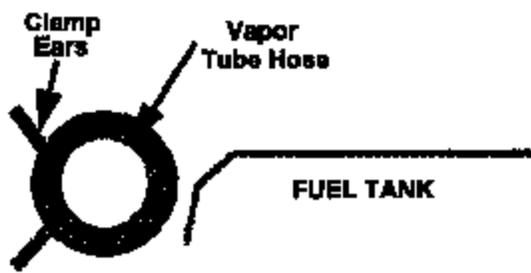
CORRECT POSITION

If both clamp ears are facing away from the fuel tank.

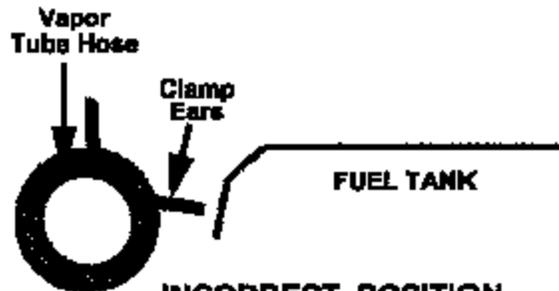
INCORRECT POSITION

If either of the clamp ears face towards the fuel tank.
