Mazda North American Operations

00E-069 (01)

Re.: Submission of Part 573 report for the MAZDA SPEED resinous hood
(Accessories) for Mazda RX-7

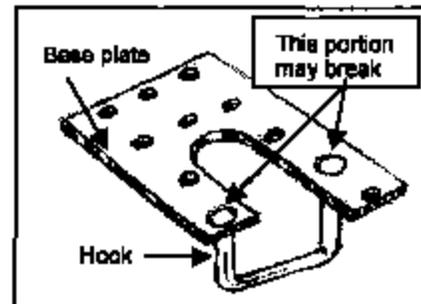
A hook on a hood striker for the resinous hood may separate from a base plate at the welded portion due to insufficient welding strength. In the worst case, the hood may suddenly open while driving and this may result in a loss of front visibility.

All RX-7 owners who purchased resinous hoods will be notified of the defect by first class mail in December 2000 and be instructed to bring their vehicle to a Mazda dealer. Dealers will replace the hood striker with a modified one. Repairs will be performed at no cost to the vehicle owner.
