RE: Recall Number 04V-208 Defect Information Report (additional information)  
(Hyundai Campaign 067)

**REFERENCE: Recall Campaign 067 – Vapor Tube Hose Clamp Position on certain 2004 Model Year Elantras – Customer Notification**

Subject <b>VAPOR TUBE HOSE CLAMP POSITION CAMPAIGN 067</b>	Group <b>CAMPAIGN</b>
	Number <b>04-01-004-1</b>
	Date <b>APRIL, 2004</b>
	Model <b>2004 ELANTRA</b>

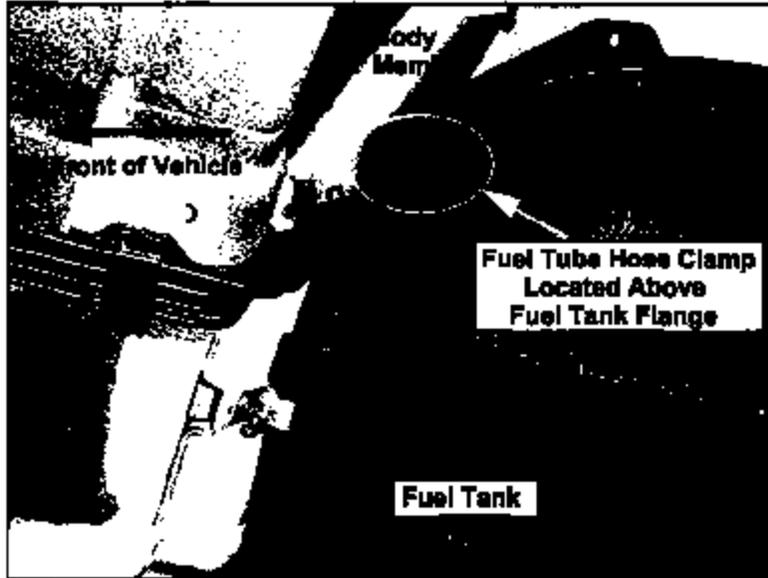
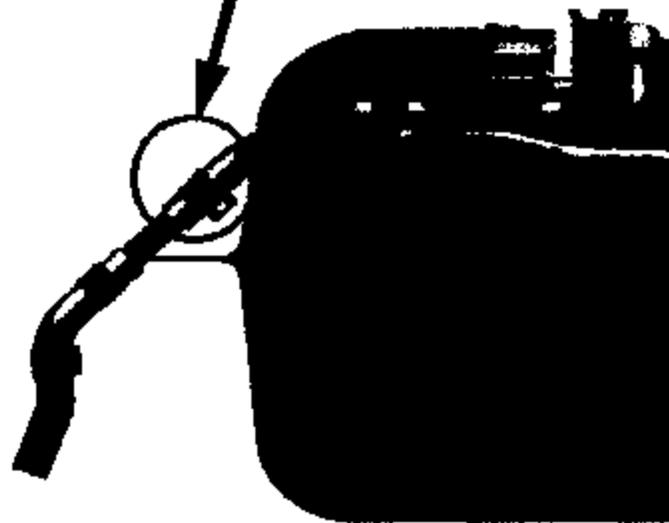
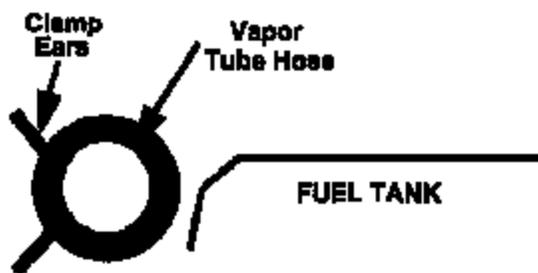
**CORRECT POSITION**

This bulletin describes how to inspect the position of a vapor tube hose clamp, and if necessary, how to reposition it to prevent contact with the fuel tank. The vapor tube hose clamp is located in the opening between the front upper side of the fuel tank and underbody cross member as shown.

If both clamp ears are facing away from the fuel tank.

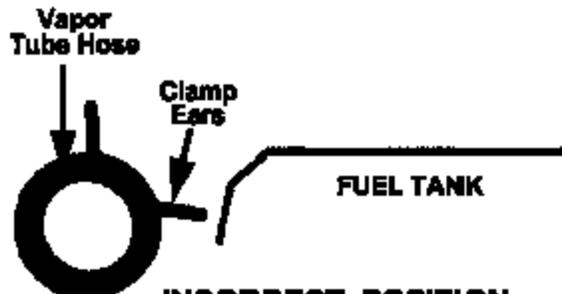
**INCORRECT POSITION**

A vapor tube clamp that is located near the fuel tank may not be positioned properly. The spring-type hose clamp contains ears that are used to open the clamp during its installation. The vapor tube hose clamp ears should be directed outboard, not toward the fuel tank. If a vehicle contains a vapor tube hose clamp that is mispositioned so one of its ears is facing toward the fuel tank and that vehicle is involved in a severe high speed crash, the damage to the vehicle may cause the mispositioned clamp to damage the fuel tank.

If either of the clamp ears face towards the fuel tank.
