**Subject: Recall Campaign VN (04V-233)
2004 Model Year Volkswagen Touareg Vehicles
Check/Replace Rear Seat Belt Buckles**

Safety Recall Circular

**Subject: 2004 Model Year Volkswagen Touareg Vehicles
Check/Replace Rear Seat Belt Buckles**

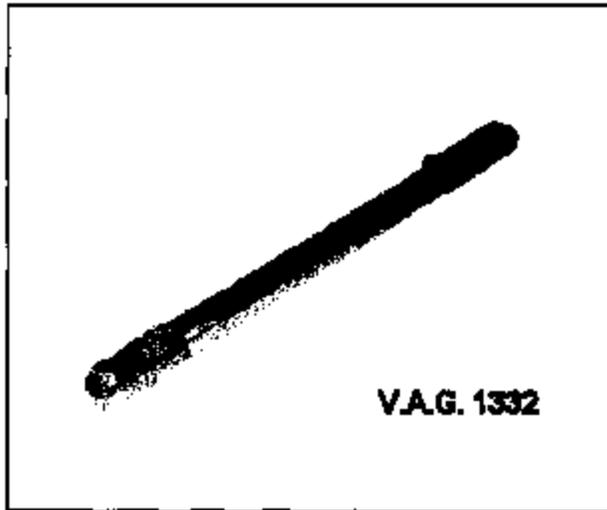
← Torque wrench V.A.G. 1332 or equivalent

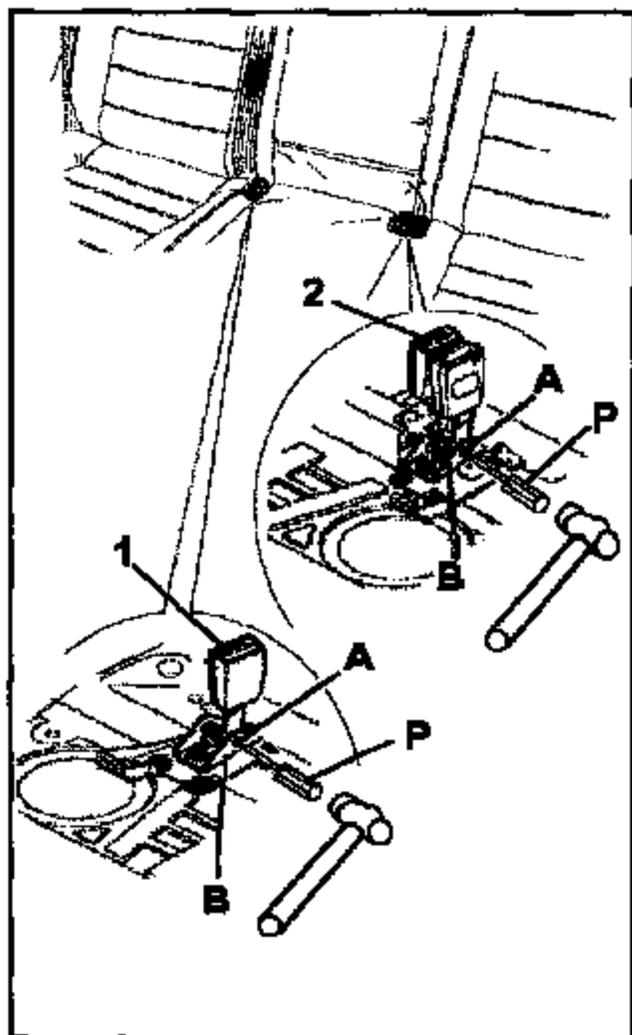
Section A – Check Mounting Pin on Left and Right Rear Seat Belt Press Button Buckles

- Open both rear doors
 - Raise the front of the left and right rear seat bottoms by lifting straps then fold seat bottoms forward
- ⇐ The end of the mounting pin -A- on the left seat belt double press button buckle -2- and right seat belt press button buckle -1- is flared to prevent it from coming out of the anchoring bracket -B-
- ⇐ Use a flat punch -P- with a hammer and lightly hit each mounting pin 2 or 3 times:

IMPORTANT! The flared end of the mounting pin is on the left side of each seat belt press button buckle

- If the mounting pin cannot be moved out of the anchoring bracket -B-, no further work is required, reposition seat bottoms and close doors
- if the mounting pin does move out of the anchoring bracket -B-, proceed to **Section B**
