RE: 04V-256

In accordance with our campaign to correct a safety defect related to the instrument panel multiplex in certain 2000-2001 model year Honda Accord automobiles, we are submitting a copy of the dealer bulletin, which also includes the text of the customer letter.

Applies To: **See VEHICLES AFFECTED****June 22, 2004****Safety Recall: Accord LX V6 Instrument Panel Lighting****BACKGROUND**

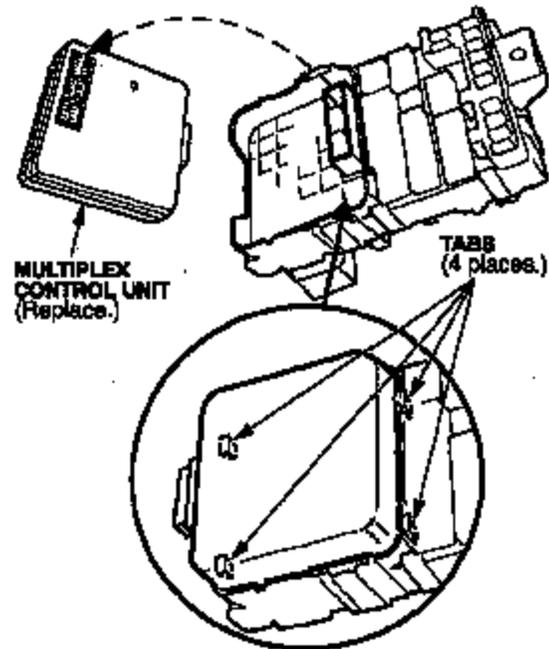
The dimmer control for the instrument panel lights may fail and, at night, the driver may not be able to see the instrument panel gauges and displays.

Honda Motor Co., Ltd., has decided that a defect relating to motor vehicle safety exists in certain 2000-2001 model year Accord LX V6 vehicles. Over time, the dimmer control for the instrument panel could fail due to heat buildup. If this happens, the instrument panel lights may fail and, at night, you may not be able to see the instrument panel gauges, such as the speedometer. This condition can result in driver distraction or the vehicle being driven at an illegal speed. All critical system indicator lights (for example, SRS, seat belt reminder, turn signals, and charging system) are unaffected and would continue to function.

Replace the driver's side multiplex control unit.

- Remove the driver's multiplex control unit.
