Subject: Information Report, NHTSA No.00E-047/00V-246.101

Section 573.5 Defect Information Report

Subject: TRW Ball Stud End and Socket Assemblies

MODELS AFFECTED: Specific Freightliner Century Class, FLD, FLN, and Argosy vehicles; Sterling A Line, L Line, and Acterra vehicles; and Freightliner Custom Chassis Corporation MT-46 and MT-55 vehicles manufactured between July 12, 1999, and October 10, 1999.

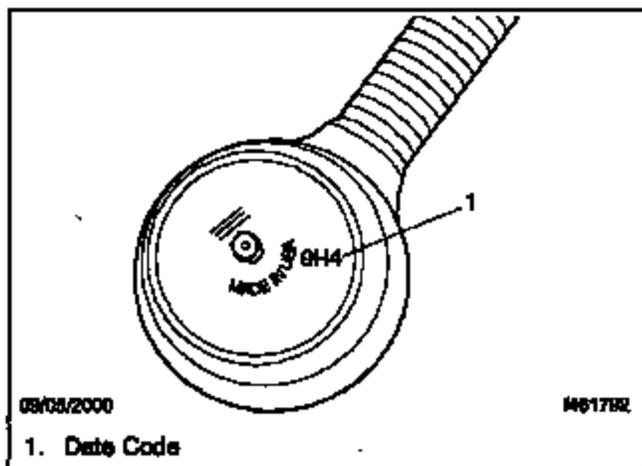
Fig. 1, Location of Date Code

1. Park the vehicle on a level surface. Turn off the engine, apply the parking brakes, and chock the rear tires.
2. Before starting the inspection procedure, check the passenger door jamb for a completion label (form W-147). If the completion label lists Recall Campaign FL268, the inspection procedure is not required.
3. Inspect both tie rod ends for the date code (Table 3). See Fig. 1 for location of date code. Replace both tie rod ends if either tie rod end has one of the following date codes and the sockets are size 20. To identify a size 20 socket, measure the outside swage diameter. See Fig. 2.

4. If the tie rod ends have one of the specified date codes, continue with the replacement procedure below.

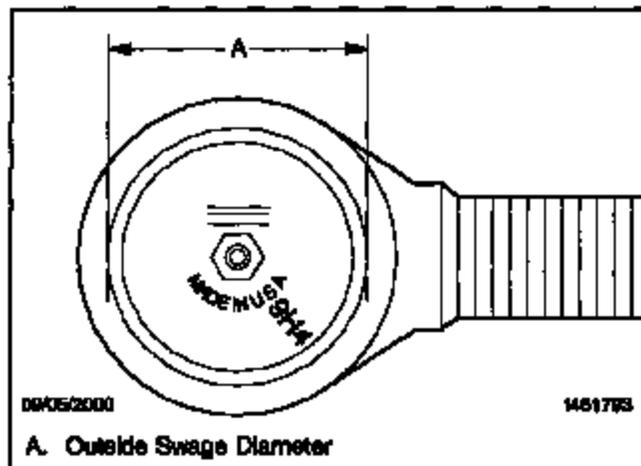
Fig. 2, Measure the Outside Swage Diameter

NOTE: A size 20 socket will measure approximately 1-7/8 inches. Any socket measuring 2-1/8 inches is a size 24 socket and is not part of this campaign.
