Subject: Defect Information Report, in accordance with 49 CFR 575.5
NHTSA File: 00E-047
E-One Service Bulletin: 00-19

1. This report is being submitted by: **Emergency One, Inc.**
1601 SW 37th Ave.
Ocala, Fl 34474
2. This report pertains to TRW tie rods ends installed on 1999 Emergency One, Inc. Model H306 Hush Pumper fire trucks manufactured between October, 1999 and December, 1999.

Service Bulletin #LNK-112

EDL Socket Replacement (Tie Rods)

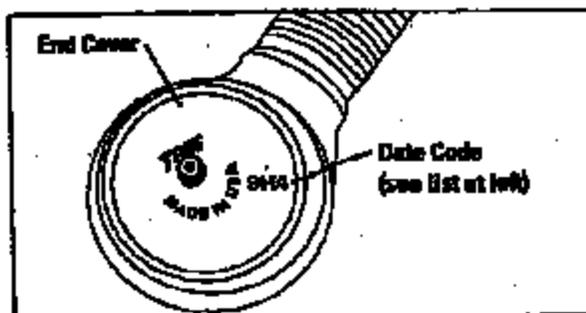
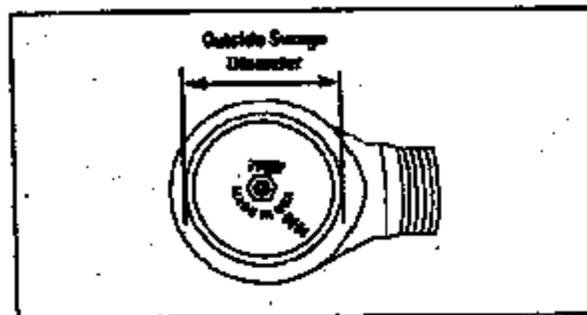
AND _____ The date code on either socket end is any of the following: 9G1, 9G2, 9G3, 9G4, 9H1, 9H2, 9H3, 9H4, 9H5, 9J1, 9J2, 9J3 OR 9J4. If the date code begins with any number other than "9", it is not part of the campaign. If the letter is "A-F" or "K-M", it is not part of the campaign.

AND _____ The sockets are "20 size" sockets. To identify the size: Measure the outside swage diameter. A 20 size socket will measure approx. 1 7/8". Any socket measuring 2 1/8" is a "24 size" socket, and is not part of the campaign.

NOTE: Any socket with "DL" stamped into the end cover is a different design, and IS NOT part of this campaign.

THEN _____ Both socket ends need to be replaced using this kit.
