Re.: NHTSA Safety Recall Campaign Number: ~~00V-007~~ 00V-246.310

PART 573 Defect and Noncompliance Report

Safety Defect and Noncompliance Report Guide for Vehicles

EDL Socket Replacement (Tie Rods)

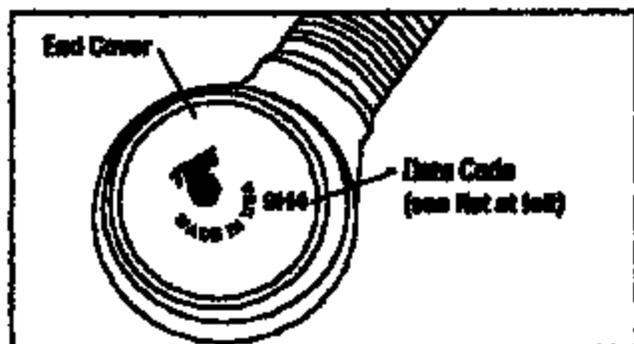
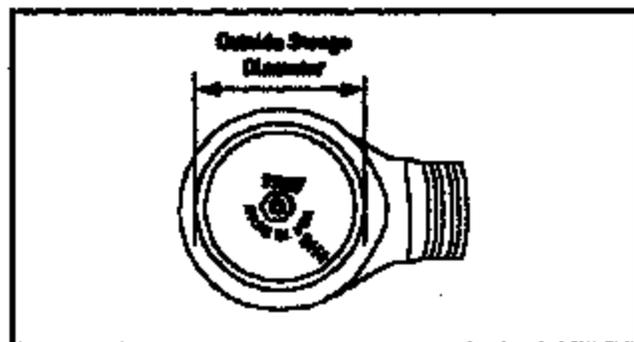
AND The sockets are "20 size" sockets. To identify the size: Measure the outside swage diameter. A 20 size socket will measure approx. 1 7/8". Any socket measuring 2 1/8" is a "24 size" socket, and is not part of the campaign.

NOTE: Only 20 size sockets are subject to this campaign. Make sure you are servicing the correct size socket.

NOTE: Any socket with "DL" stamped into the end cover is a different design, and IS NOT part of this campaign.

THEN Both socket ends need to be replaced using this kit.
