SUBJECT: Vehicle Recall Campaign - SC0262
TRW Tie Rod Ends (00E-047)

SUBJECT: Vehicle Recall Campaign - SC0262
TRW Tie Rod Ends (00E-046.004) *00V-246.103*

SUBJECT: TRW TYPE 20 EDL BALL SOCKETS — FRONT STEER AXLES

EDL Socket Replacement (Tie Rods)

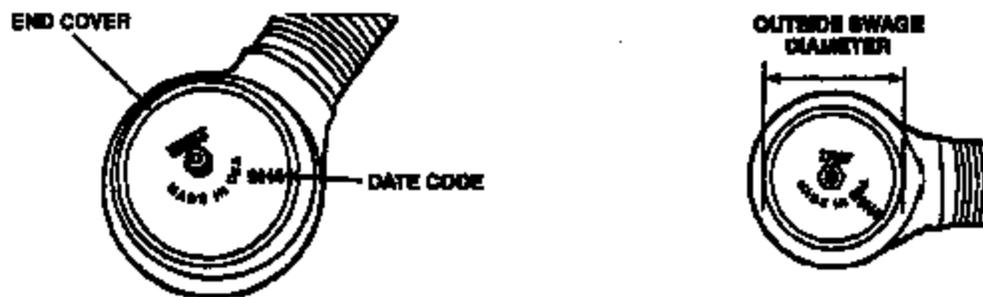
Figure 1 — Ball Socket Identification

The ball sockets on all affected vehicles must be inspected to determine if they are involved in this campaign. To determine if the ball socket is involved, check the date code stamped in the ball socket end cover and measure the outside swage to determine the ball socket size. Any size 20 ball socket (a size 20 ball socket measures 1-7/8" across the outside swage) with the date code 9G1, 9G2, 9G3, 9G4, 9H1, 9H2, 9H3, 9H4, 9H5, 9J1, 9J2, 9J3 or 9J4 is involved in this campaign. If the date code begins with any number other than "9", the date code letter is either "A-F" or "K-M", and the outside swage of the ball socket measures 2-1/8", then the socket is not part of this campaign.

Only size 20 ball sockets are involved in this campaign. Make sure the correct socket is being serviced.

Any socket with the letters "DL" stamped in the end cover are of a different design and NOT part of this campaign.

If the ball socket meets all the conditions as outlined above, both sockets must be replaced with kit part No. 8226-L20KP0006 for ArvinMeritor and MACK front axles, or 8226-L20KP0012 for Dana/Spicer front axles as outlined in the attached TRW Automotive Service Bulletin #LNK-112, *EDL Socket Replacement (Tie-Rods)*, dated September 2000.

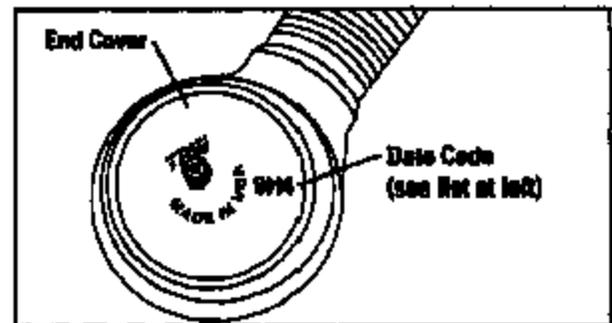
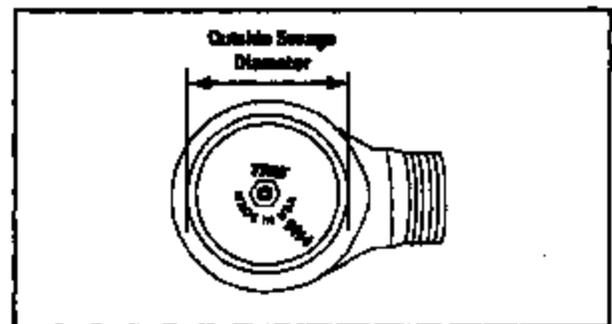
AND The date code on either socket end is any of the following: 9G1, 9G2, 9G3, 9G4, 9H1, 9H2, 9H3, 9H4, 9H5, 9J1, 9J2, 9J3 OR 9J4. If the date code begins with any number other than "9", it is not part of the campaign. If the letter is "A-F" or "K-M", it is not part of the campaign.

AND The sockets are "20 size" sockets. To identify the size: Measure the outside swage diameter. A 20 size socket will measure approx. 1 7/8". Any socket measuring 2 1/8" is a "24 size" socket, and is not part of the campaign.

NOTE: Any socket with "DL" stamped into the end cover is a different design, and IS NOT part of this campaign.

NOTE: Only 20 size sockets are subject to this campaign. Make sure you are servicing the correct size socket.

THEN Both socket ends need to be replaced using this kit.
