RE: NHTSA Recall Campaign Number: *00V-246.306*
Volvo Trucks North America, Inc., Recall Number: RVXX0004

SAFETY RECALL BULLETIN

SUBJECT: TRW Hydraulic Steering Assist Cylinder Ball-Socket Assembly

Service Bulletin #LNK-116

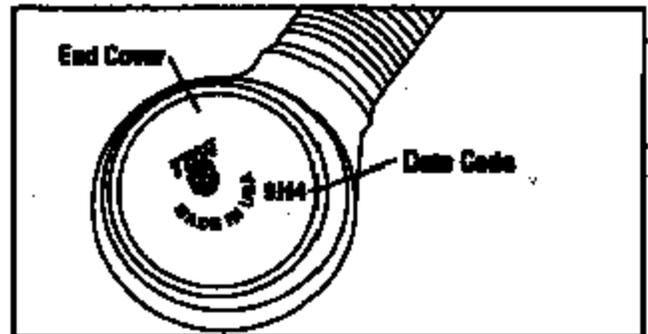
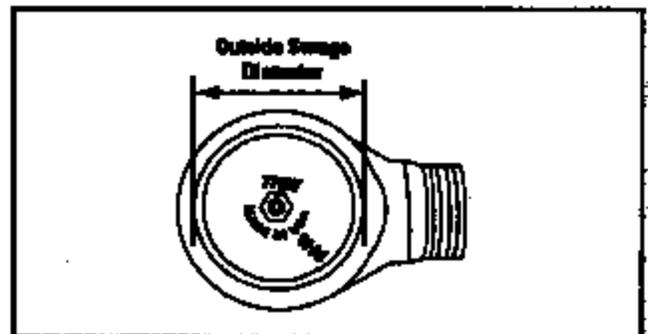
AND The date code on either socket end is any of the following: 9G1, 9G2, 9G3, 9G4, 9H1, 9H2, 9H3, 9H4, 9H5, 9J1, 9J2, 9J3 OR 9J4

AND The socket is a "20 size" socket. To identify the size: measure the outside swage diameter. A 20 size socket will measure approx. 1 7/8". (24 size sockets measure 2 1/8", and are not part of this campaign.)

NOTE: Only 20 size sockets are subject to this campaign. Make sure you are servicing the correct size socket.

NOTE: Any socket with "DL" stamped into the end cover is a different design, and IS NOT part of this campaign.

THEN Replace the identified socket end using this bulletin.
