SUBJECT: Vehicle Recall Campaign - SC0282  
TRW Tie Rod Ends (00E-048.004) *00V-246.103*

SUBJECT: TRW TYPE 20 EDL BALL SOCKETS — FRONT STEER AXLES

## Service Bulletin #LNK-112

### EDL Socket Replacement (Tie Rods)

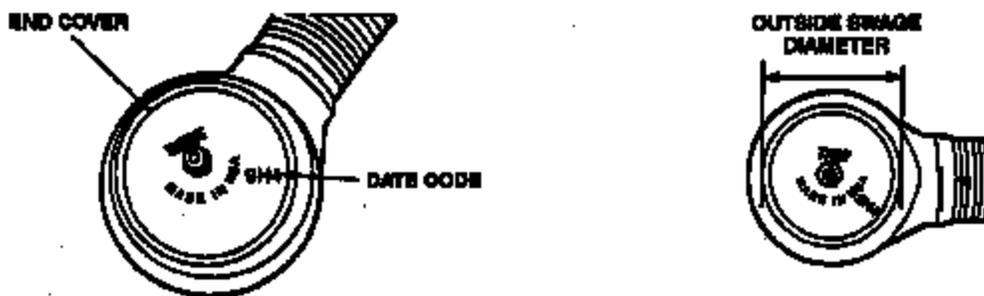
Figure 1 — Ball Socket Identification

The ball sockets on all affected vehicles must be inspected to determine if they are involved in this campaign. To determine if the ball socket is involved, check the date code stamped in the ball socket end cover and measure the outside swage to determine the ball socket size. Any size 20 ball socket (a size 20 ball socket measures 1-7/8" across the outside swage) with the date code 9G1, 9G2, 9G3, 9G4, 9H1, 9H2, 9H3, 9H4, 9H5, 9J1, 9J2, 9J3 or 9J4 is involved in this campaign. If the date code begins with any number other than "9", the date code letter is either "A-F" or "K-M", and the outside swage of the ball socket measures 2-1/8", then the socket is not part of this campaign.

Only size 20 ball sockets are involved in this campaign. Make sure the correct socket is being serviced.

Any socket with the letters "DL" stamped in the end cover are of a different design and NOT part of this campaign.

If the ball socket meets all the conditions as outlined above, both sockets must be replaced with kit part No. 8228-L20KP0008 for ArvinMeritor and MACK front axles, or 8228-L20KP0012 for Dana/Spicer front axles as outlined in the attached TRW Automotive Service Bulletin #LNK-112, *EDL Socket Replacement (Tie-Rods)*, dated September 2000.

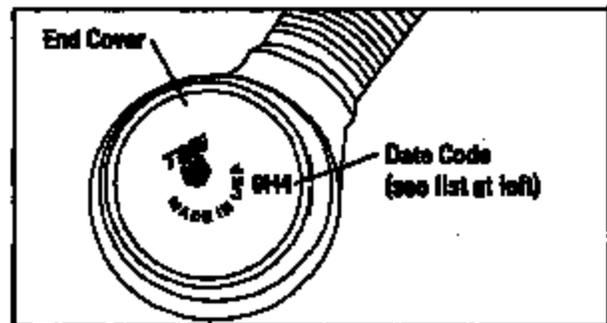
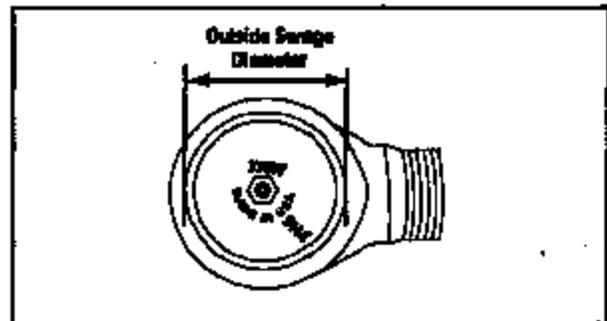
**AND** ..... The date code on either socket end is any of the following: 9G1, 9G2, 9G3, 9G4, 9H1, 9H2, 9H3, 9H4, 9H5, 9J1, 9J2, 9J3 OR 9J4. If the date code begins with any number other than "9", it is not part of the campaign. If the letter is "A-F" or "K-M", it is not part of the campaign.

**AND** ..... The sockets are "20 size" sockets. To identify the size: Measure the outside swage diameter. A 20 size socket will measure approx. 1 7/8". Any socket measuring 2 1/8" is a "24 size" socket, and is not part of the campaign.

**NOTE:** Only 20 size sockets are subject to this campaign. Make sure you are servicing the correct size socket.

**NOTE:** Any socket with "DL" stamped into the end cover is a different design, and IS NOT part of this campaign.

**THEN** ..... Both socket ends need to be replaced using this kit.

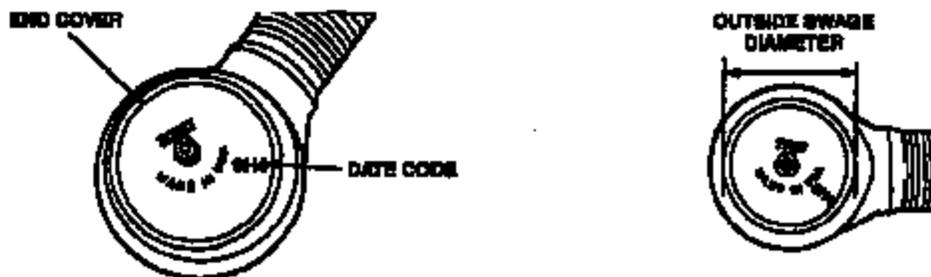
Figure 1 — Ball Socket Identification

The ball sockets on all affected vehicles must be inspected to determine if they are involved in this campaign. To determine if the ball socket is involved, check the date code stamped in the ball socket end cover and measure the outside swage to determine the ball socket size. Any size 20 ball socket (a size 20 ball socket measures 1-7/8" across the outside swage) with the date code 9G1, 9G2, 9G3, 9G4, 9H1, 9H2, 9H3, 9H4, 9H5, 9J1, 9J2, 9J3 or 9J4 is involved in this campaign. If the date code begins with any number other than "9", the date code letter is either "A-F" or "K-M", and the outside swage of the ball socket measures 2-1/8", then the socket is not part of this campaign.

If the ball socket meets all the conditions as outlined above, both sockets must be replaced with kit part No. 8228-L20KP0008 for ArvinMeritor and MACK front axles, or 8228-L20KP0012 for Dana/Spicer front axles as outlined in the attached TRW Automotive Service Bulletin #LNK-112, *EDL Socket Replacement (Tie-Rods)*, dated September 2000.

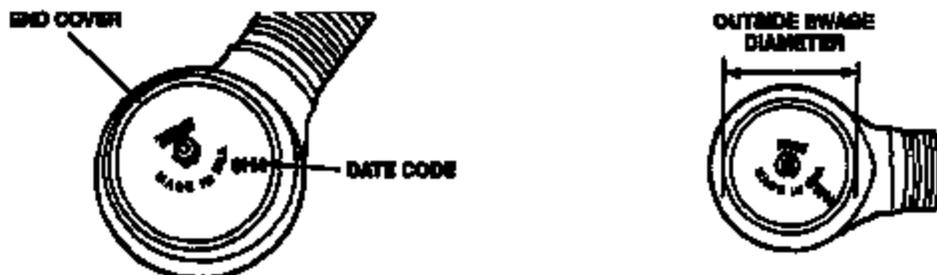
Figure 1 — Ball Socket Identification

The ball sockets on all affected vehicles must be inspected to determine if they are involved in this campaign. To determine if the ball socket is involved, check the date code stamped in the ball socket end cover and measure the outside swage to determine the ball socket size. Any size 20 ball socket (a size 20 ball socket measures 1-7/8" across the outside swage) with the date code 9G1, 9G2, 9G3, 9G4, 9H1, 9H2, 9H3, 9H4, 9H5, 9J1, 9J2, 9J3 or 9J4 is involved in this campaign.

- ▶ If the date code begins with any number other than "9", then the socket is not part of the campaign.
- ▶ If the date code letter is either "A-F" or "K-M", then the socket is not part of the campaign.
- ▶ If the outside swage of the ball socket measures 2-1/8", then the socket is not part of the campaign.

If the ball socket meets all the conditions as outlined above, both sockets must be replaced with kit part No. 8226-L20KP0008 for ArvinMeritor and MACK front axles, or 8226-L20KP0012 for Dana/Spicer front axles as outlined in the attached TRW Automotive Service Bulletin #LNK-112, *EDL Socket Replacement (Tie-Rods)*, dated September 2000.

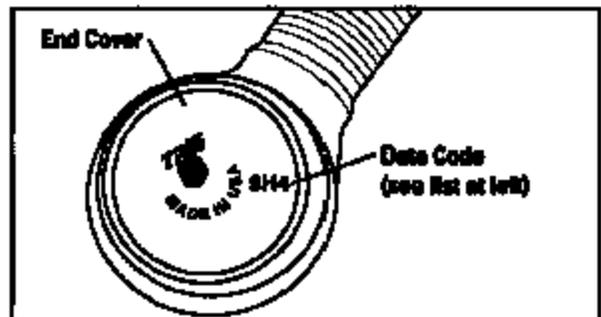
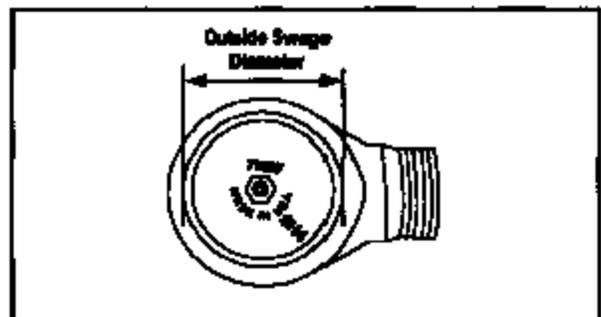
**AND** ..... The date code on either socket end is any of the following: 9G1, 9G2, 9G3, 9G4, 9H1, 9H2, 9H3, 9H4, 9H5, 9J1, 9J2, 9J3 OR 9J4. If the date code begins with any number other than "9", it is not part of the campaign. If the letter is "A-F" or "K-M", it is not part of the campaign.

**AND** ..... The sockets are "20 size" sockets. To identify the size: Measure the outside swage diameter. A 20 size socket will measure approx. 1 7/8". Any socket measuring 2 1/8" is a "24 size" socket, and is not part of the campaign.

**NOTE:** Only 20 size sockets are subject to this campaign. Make sure you are servicing the correct size socket.

**NOTE:** Any socket with "DL" stamped into the end cover is a different design, and IS NOT part of this campaign.

**THEN** ..... Both socket ends need to be replaced using this kit.
