VEHICLE RECALL

G-00512
October, 2000

**SUBJECT: SAFETY RECALL (U.S., EXPORT)
TRW Tie Rod Ends On Certain 2000, 4000, 8000 and
9000 model series built from 7/5/1999 through
11/31/1999.**

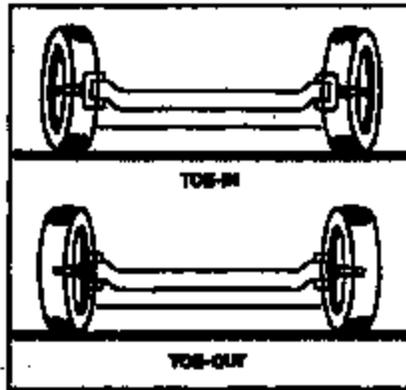
Figure 1: Viewed From The Front Of The Vehicle

TOE-IN PROCEDURE: The following procedure may be used to set toe-in when electronic alignment equipment is not available. To obtain an accurate reading, two trained technicians are required to insure that the pointers are always placed or adjusted to be exactly in front of the line scribed on both tires. Toe-in is the amount in fractions of an inch that the front wheels are closer together at the front than at the back (Figure 1, on the next page).
