Subject: Safety Recall 00V-349 NSA-11paw
(Ford Number 00S37)

SUBJECT: DEMONSTRATION / DELIVERY HOLD – Advance Announcement of Safety Recall 00S37: Certain 1994 - 2001 Model Year Mustang Vehicles Equipped With Manual Transmission – Park Brake Control Assembly Modification

SUBJECT: **DEMONSTRATION / DELIVERY HOLD - Safety Recall 00S37: Certain 1994 - 2001 Model Year Mustang Vehicles Equipped With Manual Transmission - Park Brake Control Assembly Modification**

PARKING BRAKE CONTROL ASSEMBLY MODIFICATION

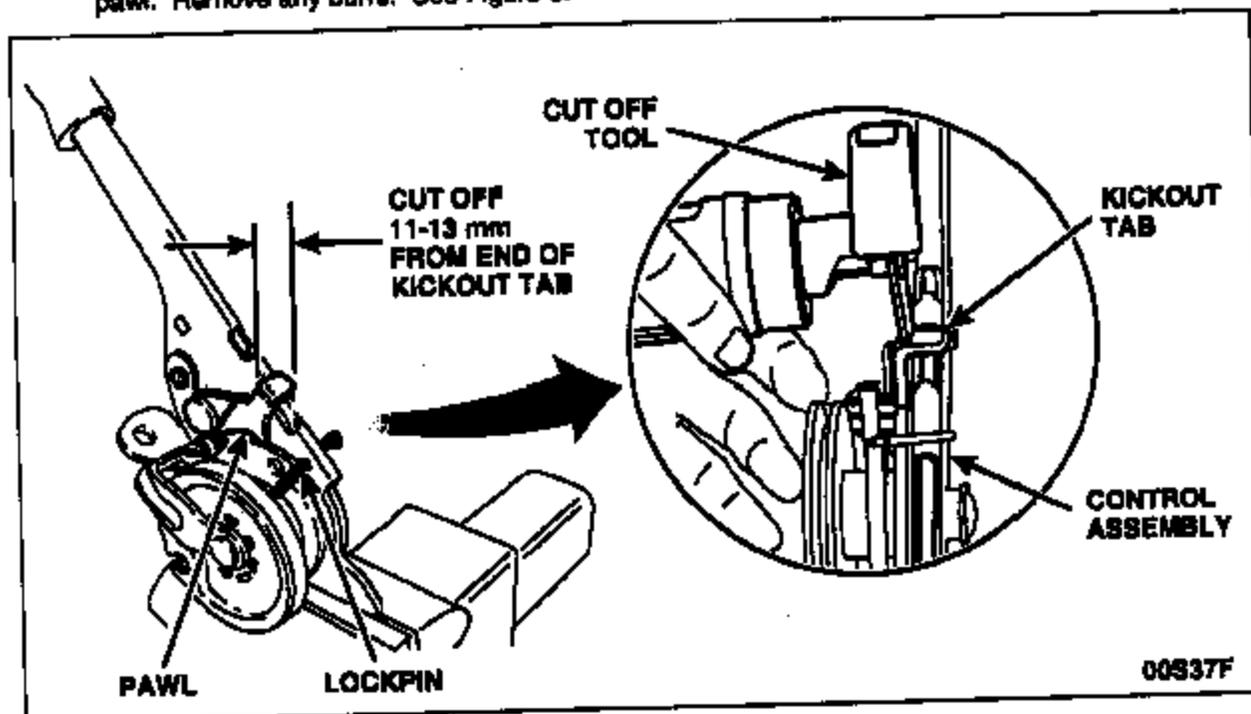
FIGURE 6

Affected vehicles have the potential for a mis-alignment condition within the park brake control assembly. Mis-alignment of the pawl to the sector gear teeth of the park brake self-adjust mechanism can allow for less than 100% sector tooth engagement (identified as "perching") when the parking brake is applied.

If this condition occurs, there is a potential for the pawl to fall into the next sector tooth or skip to a different sector tooth. If one or more sector teeth are skipped, a reduction in the park brake cable load will result, which may lead to unintended vehicle movement.

1. Position the control assembly in a vise.
2. **CAUTION:** The plastic handle cover must be removed or it will be damaged during the cutting procedure. Covers are not serviced separately.
On 1994-2000 model year vehicle control assemblies, remove the plastic handle cover by disengaging the locking tabs (one on each side) from the underside of the handle using a small screwdriver or other suitable tool.
3. **CAUTION:** Be sure to cut only the kickout tab. Do not cut the handle or any other part of the control assembly.
Using a suitable cutoff tool, remove 11-13 mm from the end of the kickout tab on the self-adjust pawl. Remove any burrs. See Figure 6.
