Subject: Information Report, NHTSA No. 00V-357

Subject: Business Class Brake Pedal Piston Rod

MODELS AFFECTED: All Freightliner FLN Business Class vehicles manufactured between May 1, 1997 and November 10, 2000, equipped with air brakes.

**SUBJECT: RECALL FL276 - BUSINESS CLASS BRAKE PEDAL PISTON RODS
REVISED WORK INSTRUCTIONS**

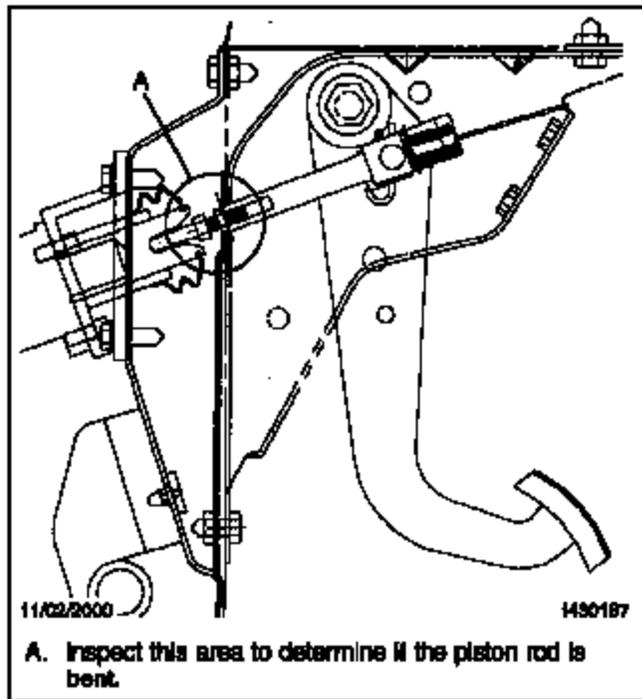
Fig. 1, Piston Rod Installation

Customers should immediately inspect their vehicle to determine if the brake piston rod is bent.

Do not drive a vehicle with a damaged brake piston rod. To do so could result in brake failure, which could cause personal injury or death, and property damage.

1. Locate the brake piston rod and clevis under the dash, behind the brake pedal assembly. See Fig. 1. The threaded end of the piston rod is installed on the clevis and the other end is inserted in the brake valve plunger (the plunger is enclosed in a rubber boot).
2. Inspect the threaded section of the piston rod where it threads into the jam nut and clevis. See Fig. 2.
 - If the piston rod is bent, take the vehicle out of service and contact your Freightliner dealer for immediate repairs.
 - If the piston rod is not bent, your vehicle is safe to operate but it should be campaigned by a Freightliner dealer as soon as parts are available.
