| SUBJECT: LOWER BALL JOINT — SAFETY RECALL CAMPAIGN | | | No: SR-01-007 |
| | | | DATE: March, 2001 |

Mitsubishi Motor Sales of America, Inc. (MMSA) is voluntarily recalling affected vehicles for possible premature wear to the lower lateral arm ball joint assembly as a result of moisture intrusion. MMSA identified that the lower lateral arm ball joint may have other areas of leakage beyond the cut or torn boot that was the subject of safety recall bulletin SR-99-002. Such moisture intrusion could result in excessive ball joint clearances that could eventually result in ball joint separation.

1994-1998 Galant, 1995-1999 Eclipse, and 1996-1999 Eclipse Spyder models

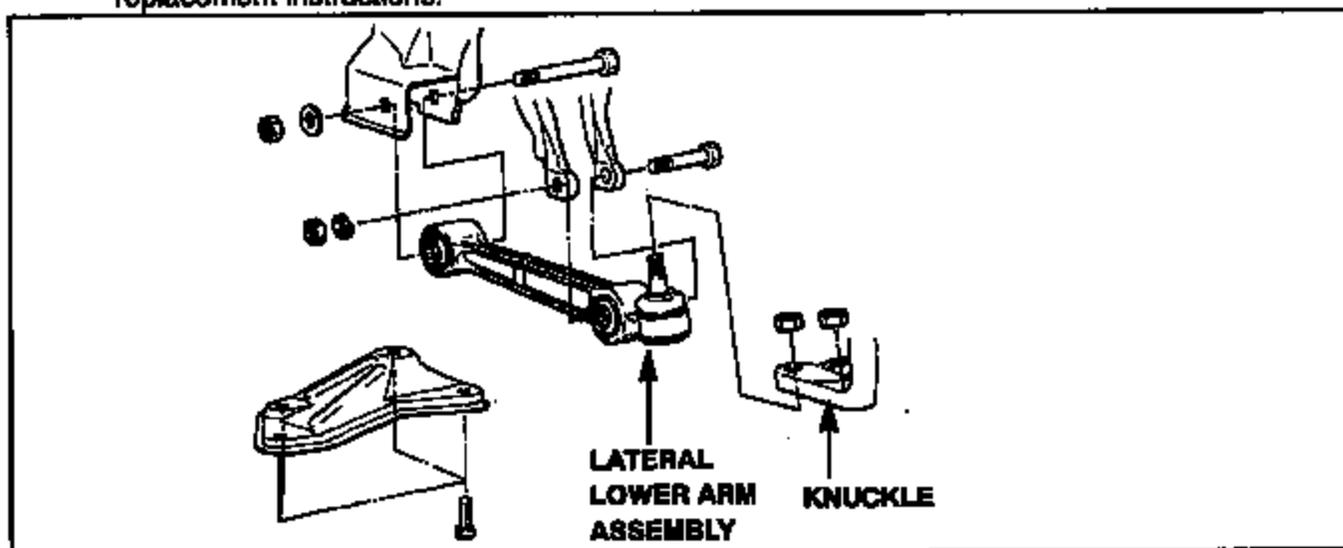
2. Inspect the lateral lower arm ball joint rubber boot on both sides for cracks and damage. Gently push the boot in with your fingers. Do not remove any parts for the inspection. Damage to the boot is evident if any cuts or tearing are observed, if grease comes out when it is pushed in, or if there are any other signs of leakage.
 - a. If the rubber boot is **not** damaged on either side of the vehicle, go to Steps 3 and 4 for ball joint inspection.
 - b. If the rubber boot is damaged, replace the lateral lower arm assembly, using the parts listed in the PARTS INFORMATION section of this bulletin. Go to Step 5 for lateral lower arm replacement instructions.

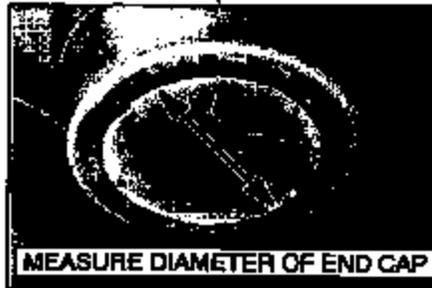
3. Measure the lower ball joint end cap diameter as shown. Note this measurement. (The free play specification is different for end caps 28 - 30 mm diameter, than for end caps 32 - 35 mm diameter.)

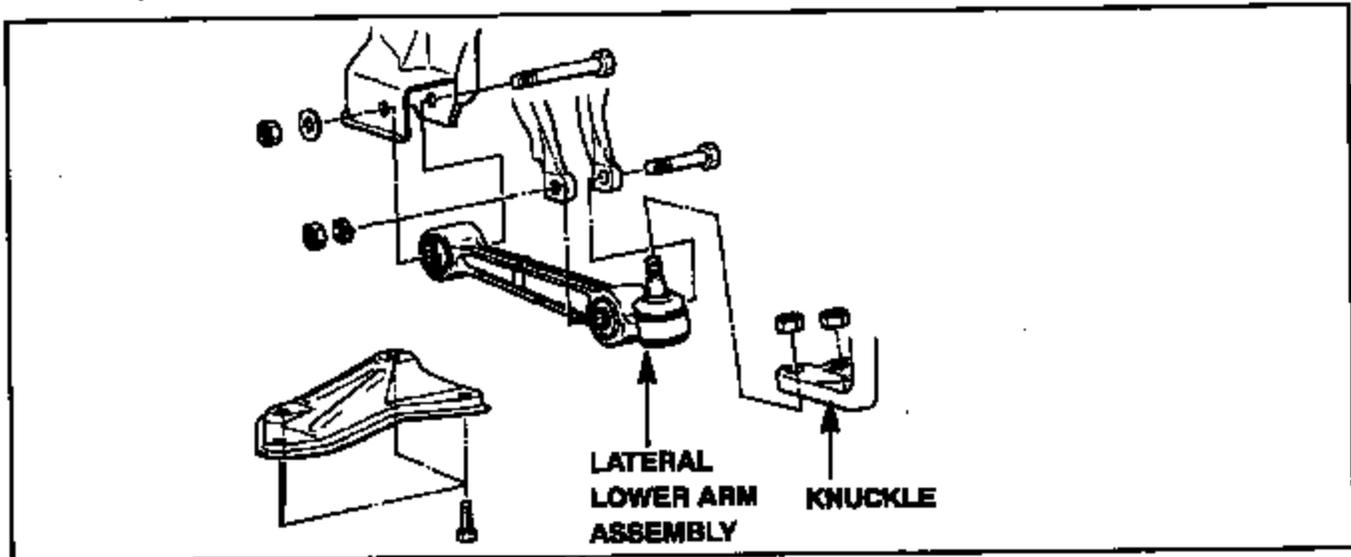
2. Inspect the lateral lower arm ball joint rubber boot on both sides for cracks and damage. Gently push the boot in with your fingers. Do not remove any parts for the inspection. Damage to the boot is evident if any cuts or tearing are observed, if grease comes out when it is pushed in, or if there are any other signs of leakage.
 - a. If the rubber boot is **not** damaged on either side of the vehicle, go to Step 4 for ball joint free play inspection.
 - b. If the rubber boot is damaged, replace the lateral lower arm assembly, using the parts listed in the PARTS INFORMATION section of this bulletin. Go to Step 5 for lateral lower arm replacement instructions.

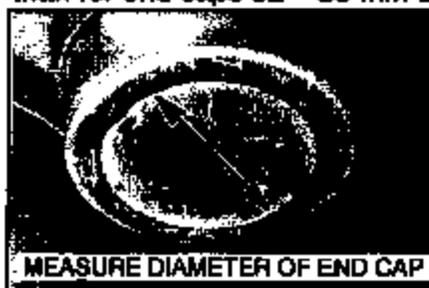
3. Measure the lower ball joint end cap diameter as shown. Note this measurement. (The free play specification is different for end caps 28 - 30 mm diameter, than for end caps 32 - 35 mm diameter.)
