## **Safety Recall No. 967**

### **Lower Lateral Arm Ball Joint Boots**

1995-2000 (FJ) Dodge Avenger and Chrysler Sebring Coupe

1995-1998 (FJ) Eagle Talon

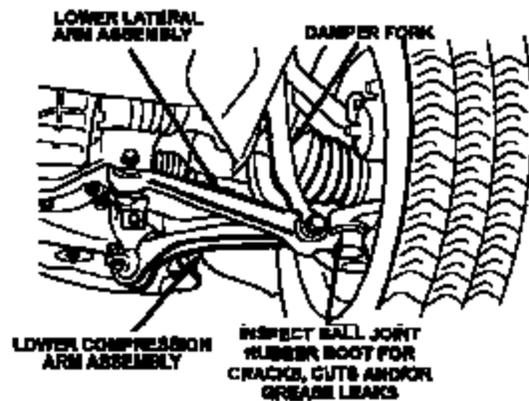
Figure 1 – Left Side Shown

3. Inspect the LEFT ball joint rubber boot on the lower lateral arm. Using a light, look for cracks, cuts and/or other damage by pushing the boot with your fingers (Figure 1). The boot is damaged if there is evidence of grease leakage. If necessary, use a clean cloth or cotton swab as an aid to determine if grease is present.
4. If the rubber boot is damaged or leaking grease, proceed to Section “C” – Lower Lateral Arm Replacement. If the rubber boot is not damaged, continue with Step 5 of this inspection procedure.

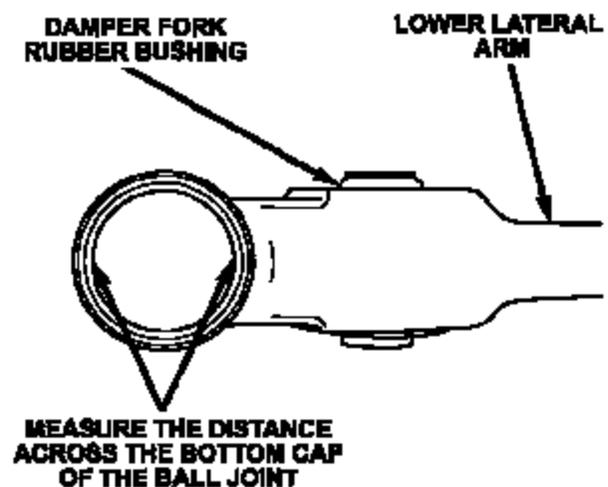
Figure 2 – Bottom View Shown

5. Remove the front wheel and tire assembly from the vehicle.
6. Measure the bottom of the lower lateral arm ball joint as shown in Figure 2. If the ball joint measurement is 1-1/8” to 1-5/32” (28mm to 30mm), the ball joint is considered a 1-1/8” (28mm) ball joint. If the ball joint measurement is 1-1/4” to 1-3/8” (32mm to 35mm), the ball joint is considered a 1-1/4” (32mm) ball joint.

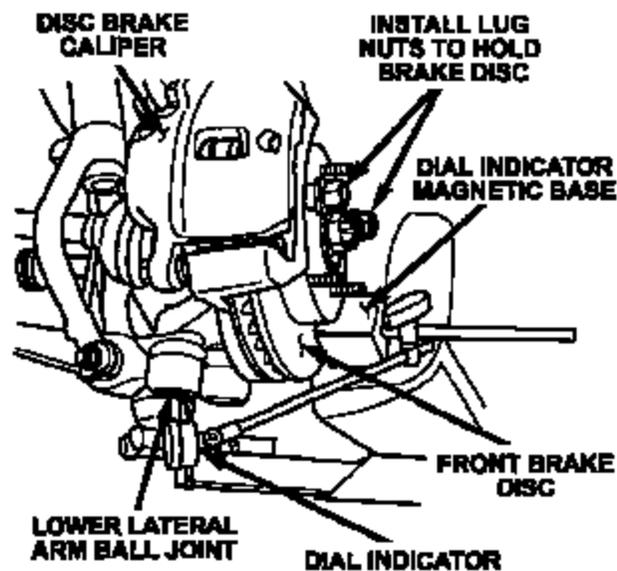
Figure 3 – Left Side Shown

10. To measure the vertical motion of the ball joint, set up a dial indicator with a magnetic base onto the left brake rotor and place the dial indicator measuring plunger on the center of the bottom cap of the lower lateral arm ball joint (Figure 3).

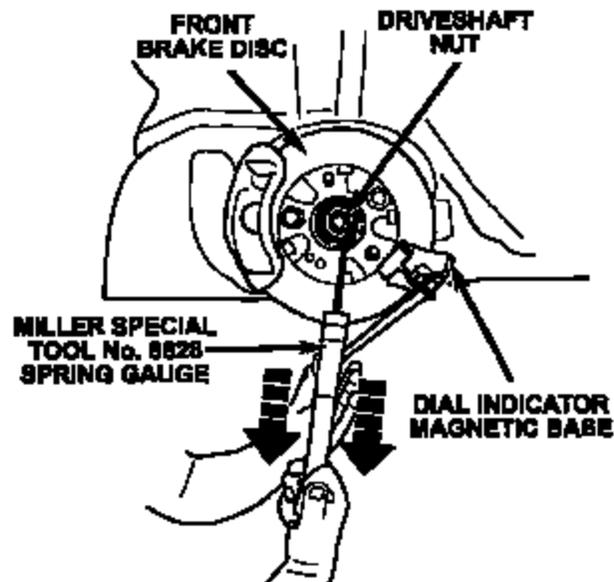
Figure 4

11. Place the hook of the spring gauge (Miller Tool #8828) on the drive shaft nut (Figure 4).
12. Pull down on the spring gauge until the needle on the spring gauge reads 33 lbs. (15 kg) and zero the dial indicator (Figure 4). Then slowly release the spring gauge.

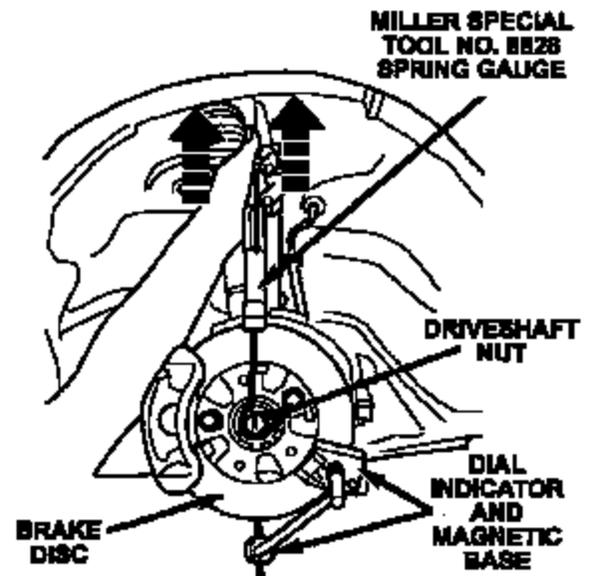
Figure 5

13. With the dial indicator still attached and set to zero, use the spring gauge to apply 33 lbs. (15 kg) of upward force to the driveshaft nut and read the dial indicator (Figure 5). Record the amount of total movement of the ball joint.

➤ For 1-1/8 inch (28mm) ball joints, if the total movement recorded is less than 0.020" (0.5mm), continue with Section "B" – Apply Sealant to the Ball Joint Cap. If the movement recorded is 0.020" (0.5mm) or more, the lower lateral arm must be replaced. Continue with Section "C" – Lower Lateral Arm Replacement.

➤ For 1-1/4 inch (32mm) ball joints, if the total movement recorded is less than 0.004" (0.1mm), continue with Section "B" – Apply Sealant to the Ball Joint Cap. If the movement recorded is 0.004" (0.1mm) or more, the lower lateral arm must be replaced. Continue with Section "C" – Lower Lateral Arm Replacement.
