SUBJECT: SAFETY RECALL NOTIFICATION

00V-389(0)

SAFETY RECALL

DATE : November 2000	SECTION : 11
SUBJECT : TAG AXLE INSPECTION AND INSTALLATION OF REINFORCEMENT PARTS

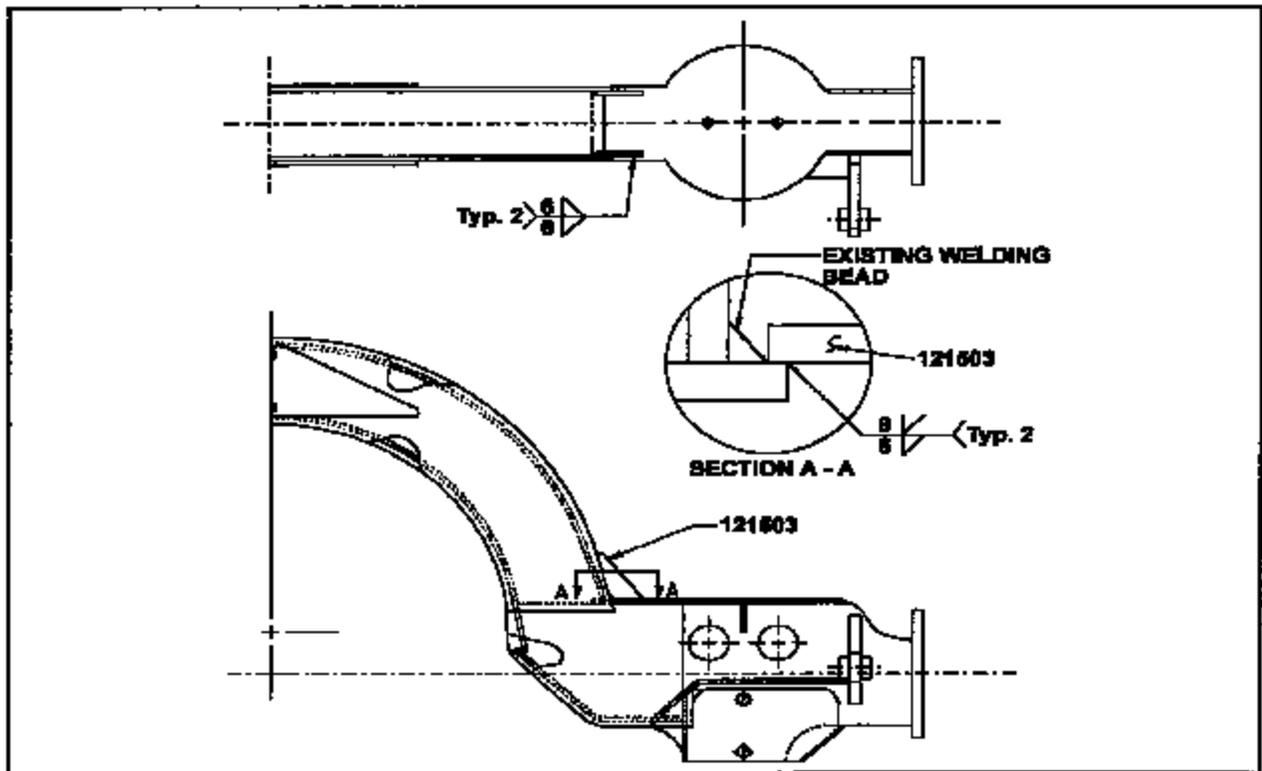
FIGURE 1

2. Remove asphalt base undercoating (Gravel Guard 3M) and any rust present near the risk or affected area, the risk areas are the joints between axle arch and sub-assemblies (refer to figure 1).
3. Check if tag axle is cracked, check if cracks are superficial by grinding the affected area to make the cracks disappear. If cracks are only superficial, chip off or grind to bare metal then reweld crack referring to paragraph: Steel - Steel Welding. Weld reinforcement parts referring to figure 1 welding specifications

4. If no cracks are present on tag axle, weld reinforcement parts referring to figure 1 welding specifications.

- Do not connect welding cables to electronic control components.
5. Weld reinforcement parts as per figure 1 and refer to welding specifications indicated in paragraph: **Steel – Steel Welding:**

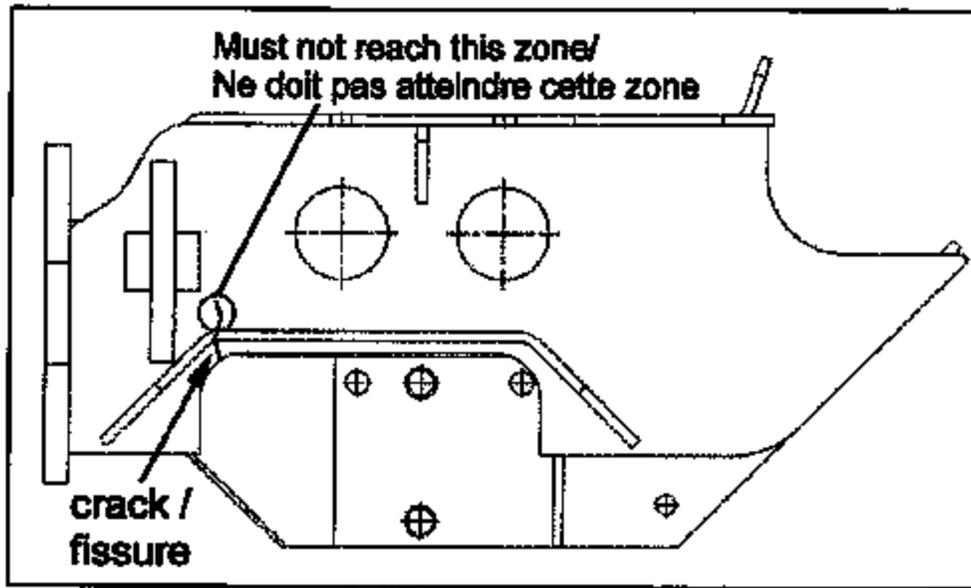
FIGURE 2

2. Remove asphalt base undercoating (Gravel Guard 3M) and any rust present near the risk or affected area, the risk areas are located on sub-assemblies and indicated in figure 2.
