Campaign Bulletin

Bulletin No: 00024

SUBJECT: 00024 - FRONT BRAKE HOSE ABRASION

MODELS: 1999-2000 CHEVROLET SILVERADO AND GMC SIERRA 1/2 TON PICKUP TRUCKS

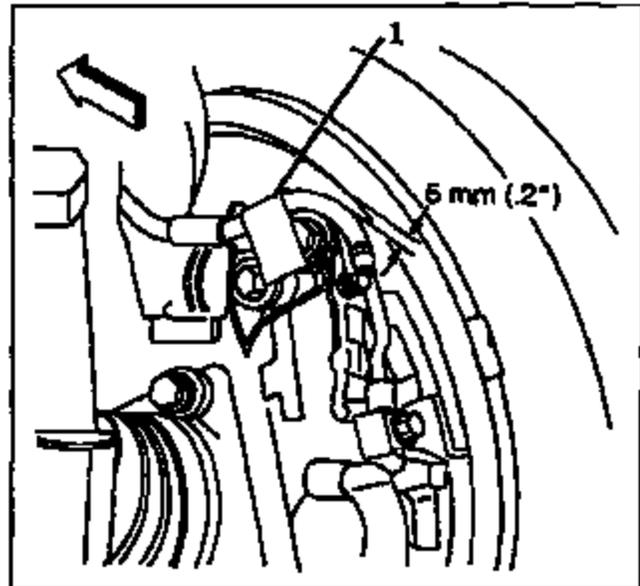
On certain 1999-2000 Chevrolet Silverado and GMC Sierra 1/2 ton pickup trucks, failure to follow the service procedure set forth in the Service Manual for removal of the front brake caliper can result in movement of the front brake hose relative to its knuckle mounting bracket. If this movement results in increased length between the bracket and the banjo fitting that attaches to the brake caliper, it is possible for the brake hose to come in contact with the wheel rim. This contact with the wheel rim could, in time, cause the brake hose to become worn to the point that brake fluid leakage could occur. If this occurred, loss of front brakes is possible.

1. Raise the vehicle.
2. On the driver's side, clean the area of the brake hose between the banjo block and the knuckle bracket.

3. Install the notice label (1), ensuring that there is a minimum clearance between the brake hoses and the wheels of 5 mm (.2 in).
4. Repeat on the passenger's side.
5. Lower the vehicle.
6. Install the GM Campaign Identification Label.
