A.R. O'Neill
 Director
 Vehicle Service and Programs
 Ford Customer Service Division

SUBJECT: DEMONSTRATION / DELIVERY HOLD: Safety Recall 01S21:
 Certain 2001 Model Year Crown Victoria, Excursion, Expedition, F-150, F-250
 through F550, Grand Marquis, Navigator, Ranger, Town Car, and Windstar vehicles -
 Seat Belt Buckle Retention

SEAT BELT BUCKLE INSPECTION AND/OR REPLACEMENT PROCEDURE

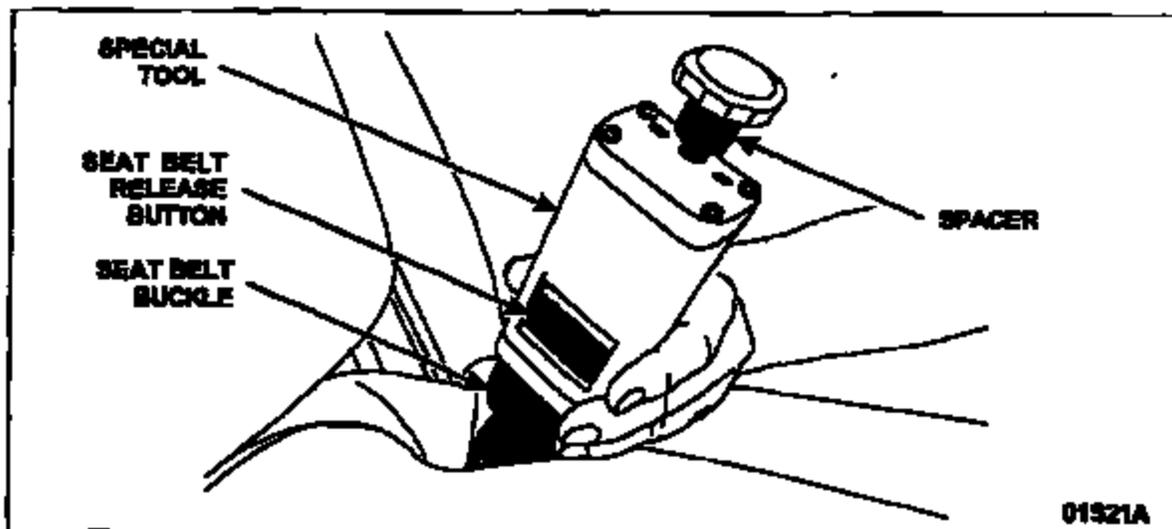
FIGURE 1

⚠ Slowly press and release the red seat belt release button located on the driver side seat belt buckle. Then, install the special tool onto the driver side seat belt buckle and hold it in place. See Figure 1.

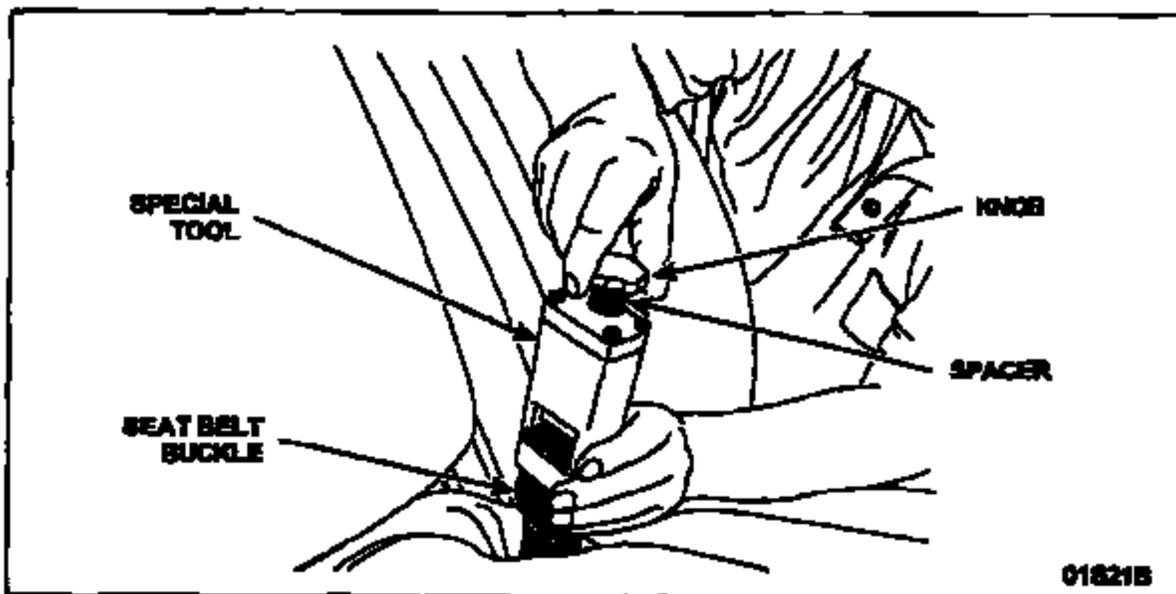
FIGURE 2

While holding the special tool in place, turn the knob on the special tool until it bottoms out. If resistance is felt while turning the knob on the special tool, it may require lubrication. Lubricate the threads on the knob shaft with Lubriplate® (130-AA) white grease or similar white lithium grease. See Figure 2.

- If the special tool does not stay locked into place in the belt buckle, but instead disengages from the belt buckle, the belt buckle must be replaced. Refer to the Service Procedure section of this document for instruction.

- If the special tool does stay locked into place in the belt buckle and cannot be disengaged without depressing the red seat belt release button, the belt buckle does not need to be replaced.

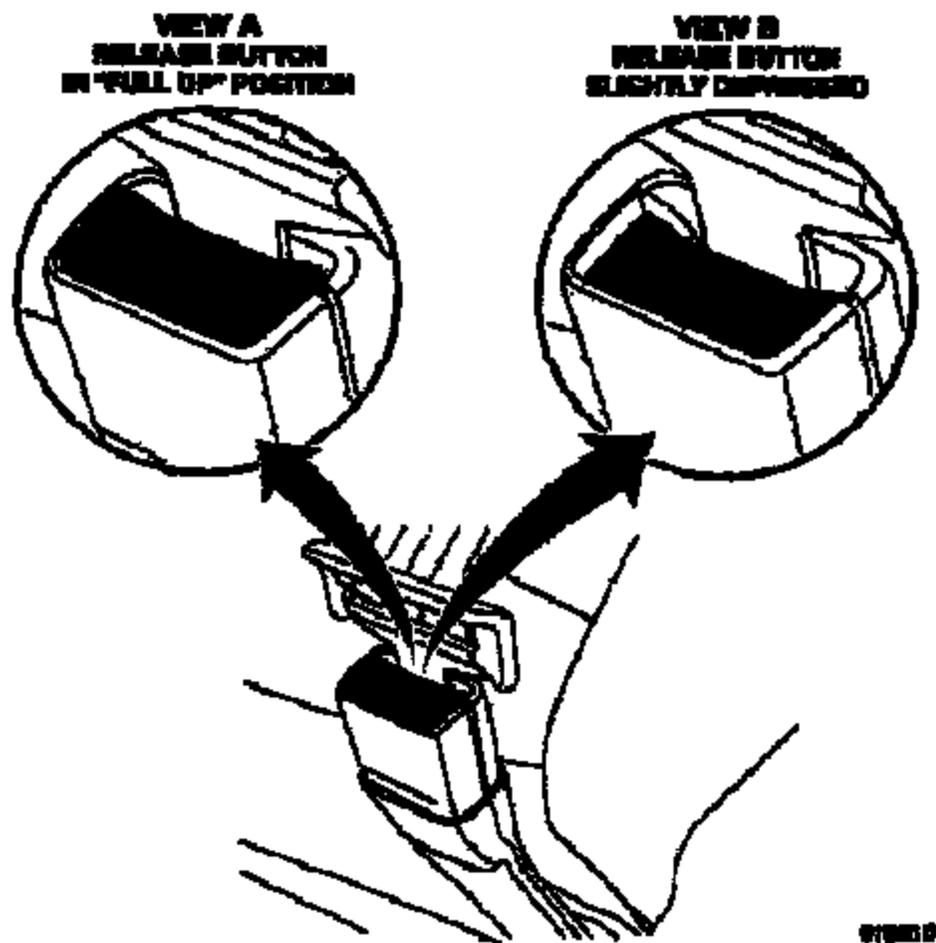
The illustration below shows the red seat belt buckle release button in both the "full up", or properly latched position (View A) and in a "slightly depressed" position (View B). Notice: When properly latched, the red release button will return to the position it was in before the tongue was inserted into the seat belt buckle.

If your buckle release button looks like that shown in View B, the buckle is only partially latched. Remove the tongue from the buckle by pressing the red release button. After removal, reinsert the tongue quickly and firmly into the buckle. Be sure that the red release button is in the position shown in View A ("full up" position) after insertion.
