Service Recall Bulletin - 96S48 Supplement #1

Attachment IV - Technical Instructions (Rail Inspection/Replacement)

1990-92 PROBE PASSIVE RESTRAINT (MOTORIZED) SEAT BELT SYSTEM
 REPLACEMENT OF LEFT SIDE RAIL (96S48) –
 INSPECTION/REPLACEMENT OF RIGHT SIDE (96S99)

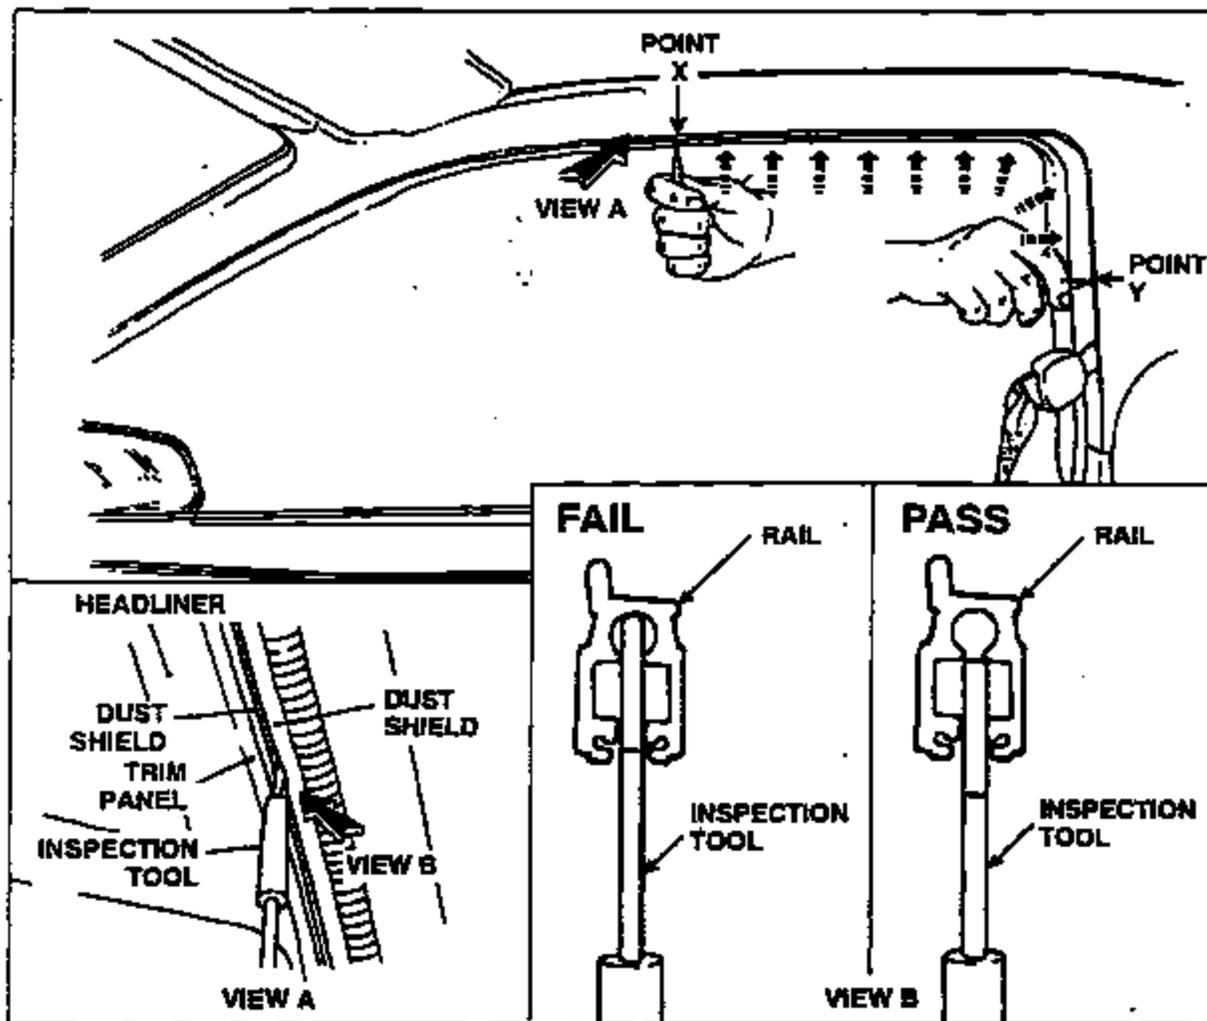
FIGURE 1

Insert the inspection tool between dust shields of the rail assembly at point X. Tool must be installed until it bottoms out in the rail assembly. Note the distance between the dust shields and the scribed line on the tool. Insert the inspection tool every 1/2" from point X to point Y of the rail assembly. See Figure 1. **DO NOT SLIDE THE INSPECTION TOOL ALONG THE RAIL ASSEMBLY. REMOVE AND REINSERT EVERY 1/2" BETWEEN POINT X AND POINT Y.**

- If installed inspection tools' depth *does not increase* (scribe line *does not* move closer to the dust shield) anywhere between points X and Y, no service action is required.
- If installed inspection tools' depth *increases* (scribe line *moves closer* to the dust shield) anywhere between point X and Y, the rail assembly must be replaced. Go to Page 4 for Rail Replacement.
