Note Log: 96548
Period: 07/23/97 12:32:35 thru 09/25/97 14:33:31

Subject: PART NUMBERS F72Z 61610D44 B AND F72Z 61610D45 B

1990-92 PROBE PASSIVE RESTRAINT (MOTORIZED) SEAT BELT SYSTEM REPLACEMENT OF LEFT SIDE RAIL (96S48) - INSPECTION/REPLACEMENT OF RIGHT SIDE (96S99)

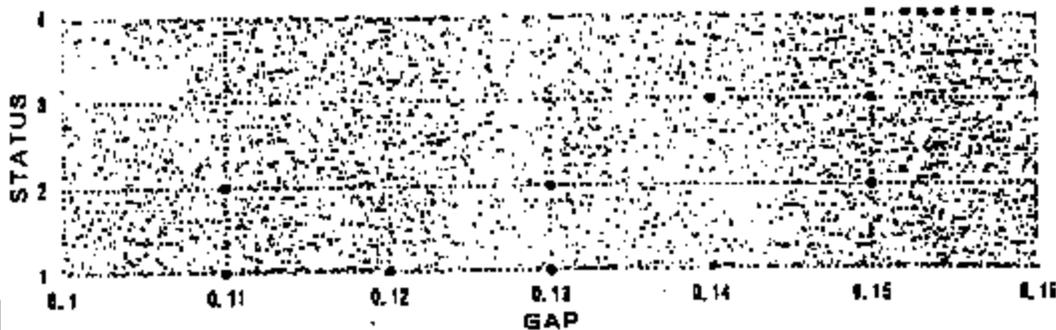
chart 1

- Cable comes out of position when the gap becomes more than 0.15".
- As the rail gap becomes larger due to the wear progress, buckle starts showing roughness and becomes further rough. Finally, cable comes out of rail and the buckle stops. Therefore, future failure can be predicted based on the buckle roughness.

Sandy dust contamination initiated the aluminum rail wear and the both aluminum wear shaving and sandy dust progressed the wear further. The rail gap becomes larger and the cable came out of rail as a result.
(See chart 1)

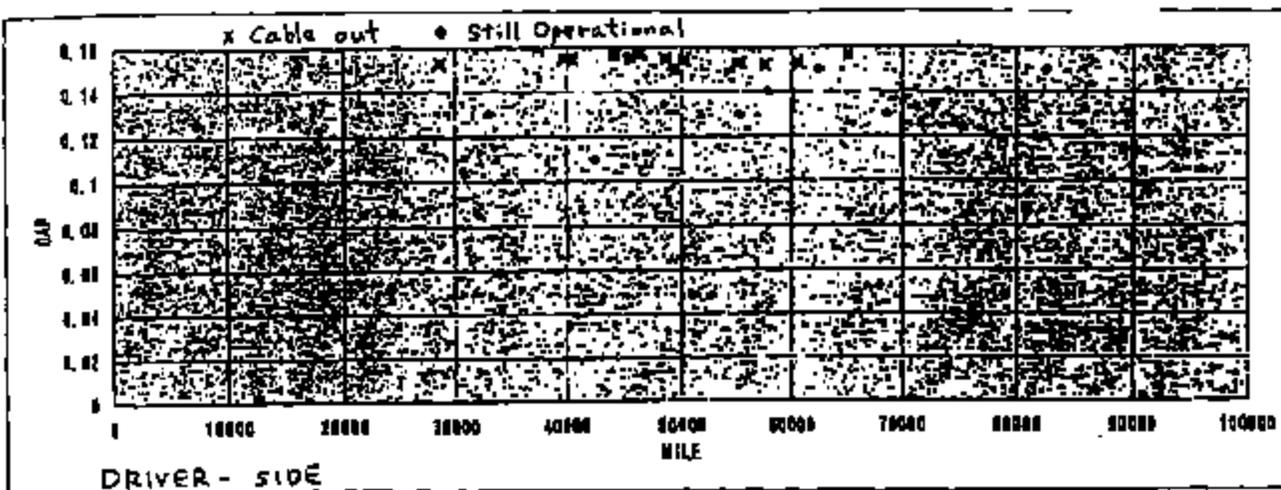
(3) Correlation of mileage and gap (Data : Group B and C)

- Passenger side : The wear is hardly seen on the passenger side rail. This is because of less usage frequency and less window opening comparing to the drivers side.
- Drivers side: The wear progress differs from car to car. The specific correlation can not be seen. This must be because of the different usage environment and the type of usage.

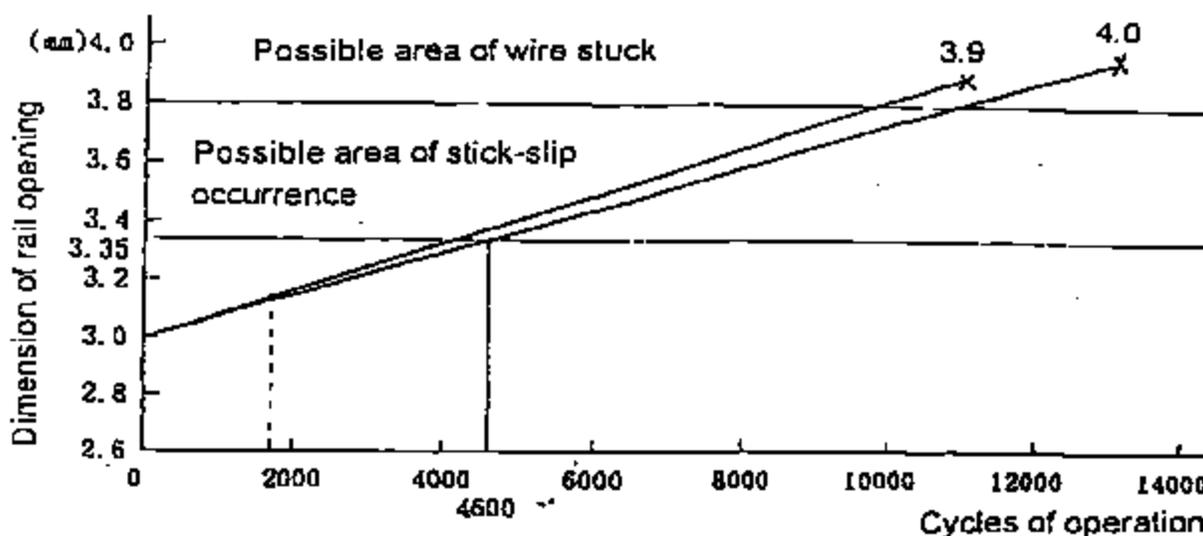
Figure 1

- The subject system satisfied the 100,000 cycles durability standard if no sand is sprinkled.
- Although test number 2 and 3 are considered very severe, stick-slip occurred before the wire got stuck.

While beginning timing of stick-slip varies in each test, it started to occur at latest one third of the total tested cycles. (Relations between rail wear and occurrence of stick-slip/wire stuck observed at test number 2 and 3 are roughly illustrated in figure 1)

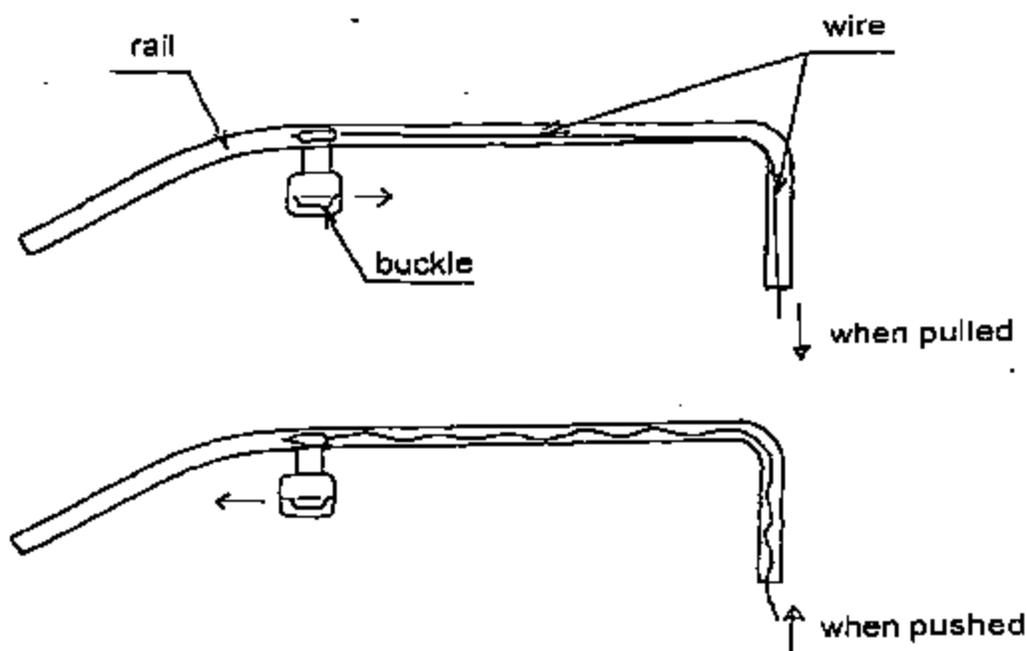
Figure 2

The buckle is driven through the wire by pushing (forward) and pulling (rearward). Since a tensile load is applied on the wire when the wire is pulled, wire can move smoothly against the rail. On the other hand, a compressive load is applied on the wire when the wire is pushed, causing an unstable movement of the wire due to waving wire. (See figure 2)

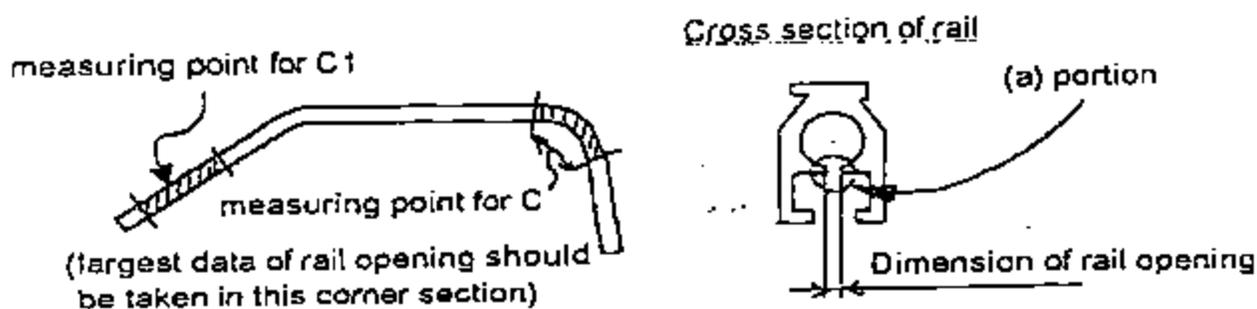
Figure 3

Dimensions of the rail opening (shown as (a) portion on the picture below) at two different points in the rail (points of corner and straight) are to be measured.

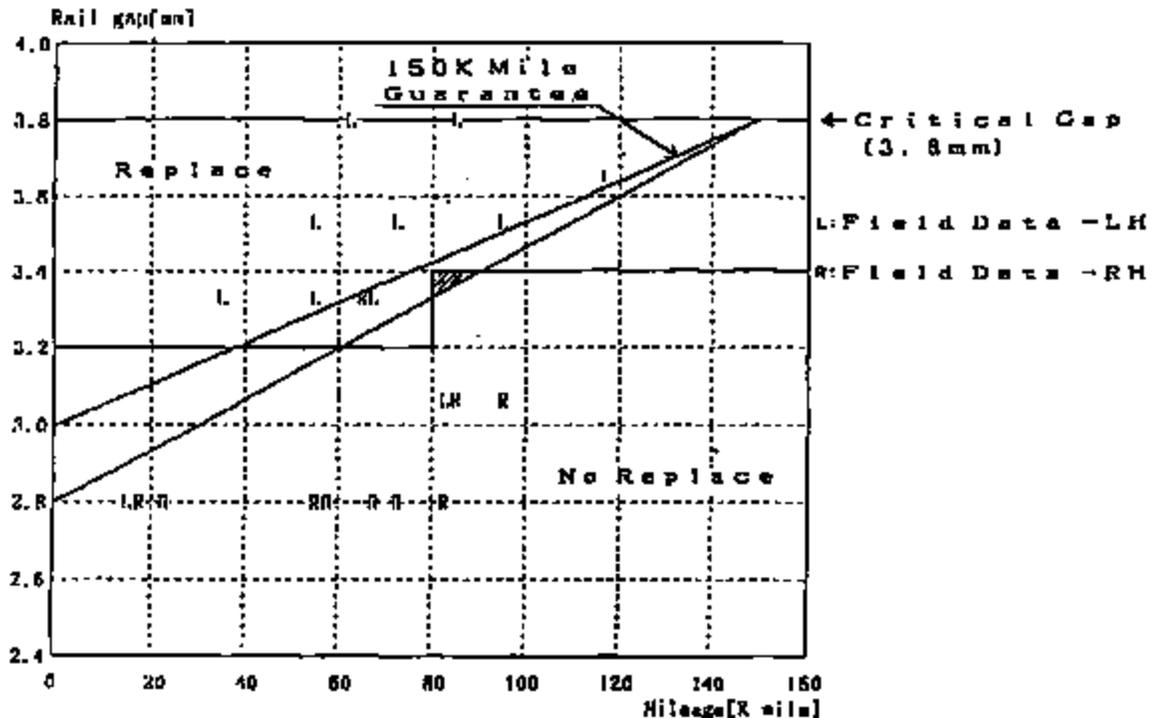
1. Study on the possibility of area
 - A : Estimated percentage of vehicles driven between 80K to 90K when the inspection is performed. -- 10 %
 - B : Estimated percentage of vehicles having initial gap of 2.9 mm or less. -- 16 %
 - C : Estimated percentage of vehicles having 3.3 to 3.4 mm rail gap when the inspection is performed. -- 30 % at the maximum

Estimated percentage of subject area is:
 $A * B * C = 0.48 \%$ at the maximum

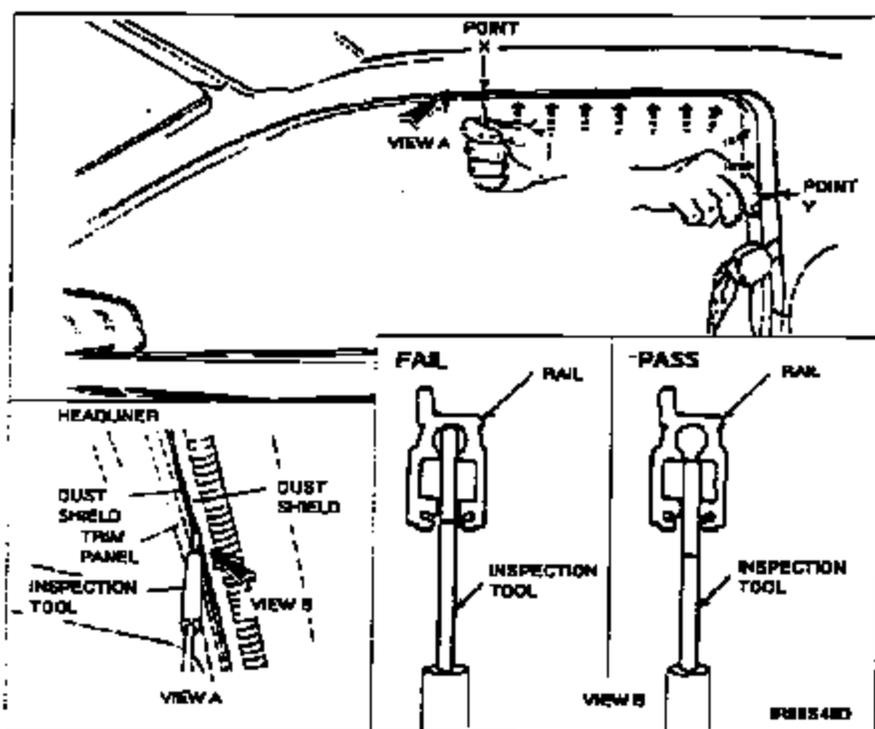
Figure 1

Dust shield wear may cause the position of the scribe line to vary. Insert the inspection tool between dust shields of the rail assembly at point X. Tool must be installed until it bottoms out in the rail assembly. Note the distance between the dust shields and the scribed line on the tool. Insert the inspection tool every 1/2" from point X to point Y of the rail assembly. See Figure 1. **DO NOT SLIDE THE INSPECTION TOOL ALONG THE RAIL ASSEMBLY. REMOVE AND REINSERT EVERY 1/2" BETWEEN POINT X AND POINT Y.**

3.
 - a. If installed inspection tools' depth does not increase (scribe line does not move closer to the dust shield) anywhere between points X and Y, no service action is required.
 - b. If installed inspection tools' depth increases (scribe line moves closer to the dust shield) anywhere between points X and Y, the rail assembly must be replaced. Go to Page 4 for Rail Replacement.

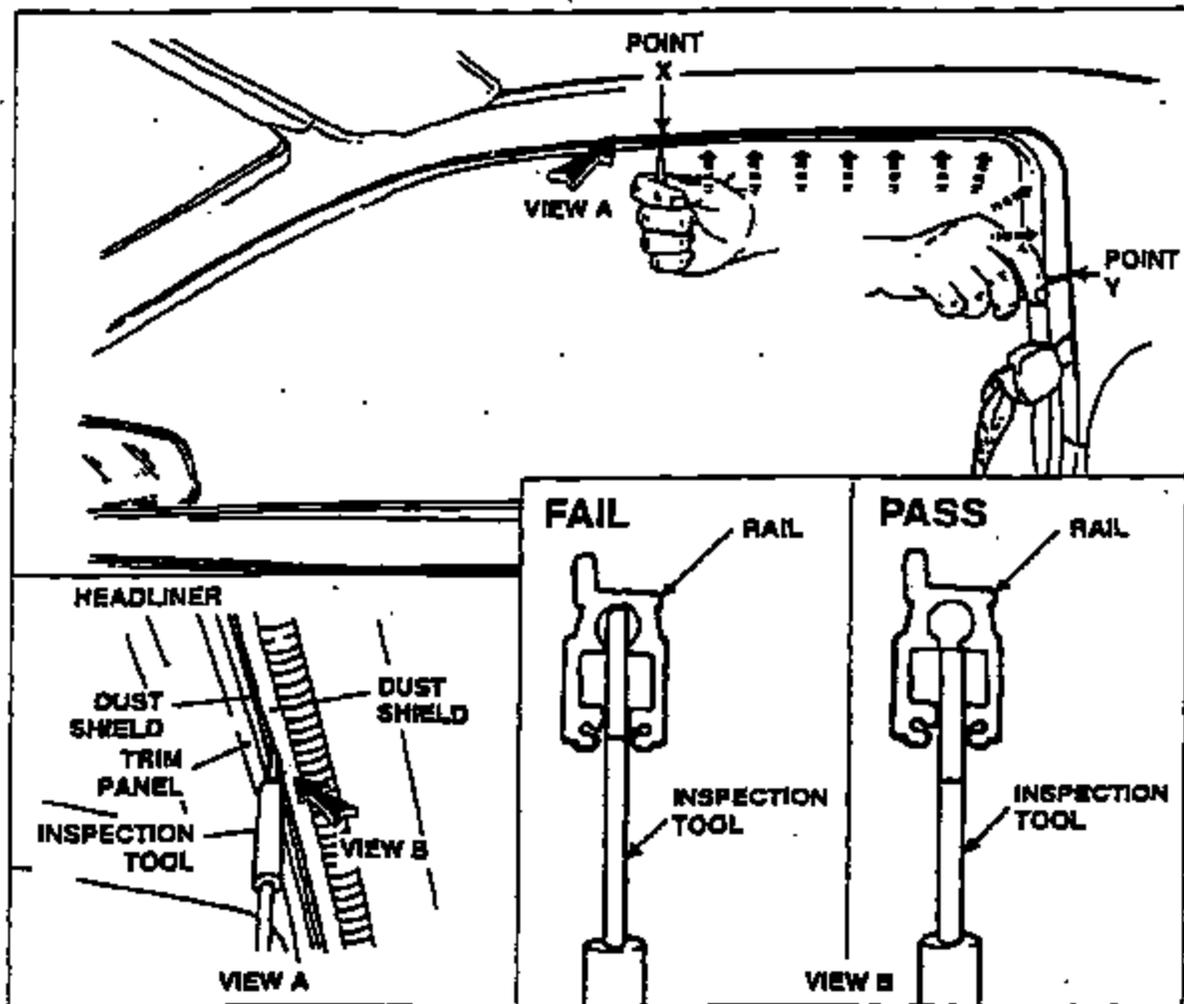
FIGURE 1

Insert the inspection tool between dust shields of the rail assembly at point X. Tool must be installed until it bottoms out in the rail assembly. Note the distance between the dust shields and the scribed line on the tool. Insert the inspection tool every 1/2" from point X to point Y of the rail assembly. See Figure 1. **DO NOT SLIDE THE INSPECTION TOOL ALONG THE RAIL ASSEMBLY. REMOVE AND REINSERT EVERY 1/2" BETWEEN POINT X AND POINT Y.**

- If installed inspection tools' depth *does not increase* (scribe line *does not* move closer to the dust shield) anywhere between points X and Y, no service action is required.
- If installed inspection tools' depth *increases* (scribe line *moves* closer to the dust shield) anywhere between point X and Y, the rail assembly must be replaced. Go to Page 4 for Rail Replacement.
