# **EA04-019 Closing Report**

## **Wheel Separations in Model Year 2002 -2004 Jayco Travel Trailer and Fifth Wheel Recreational Vehicles (RVs)**

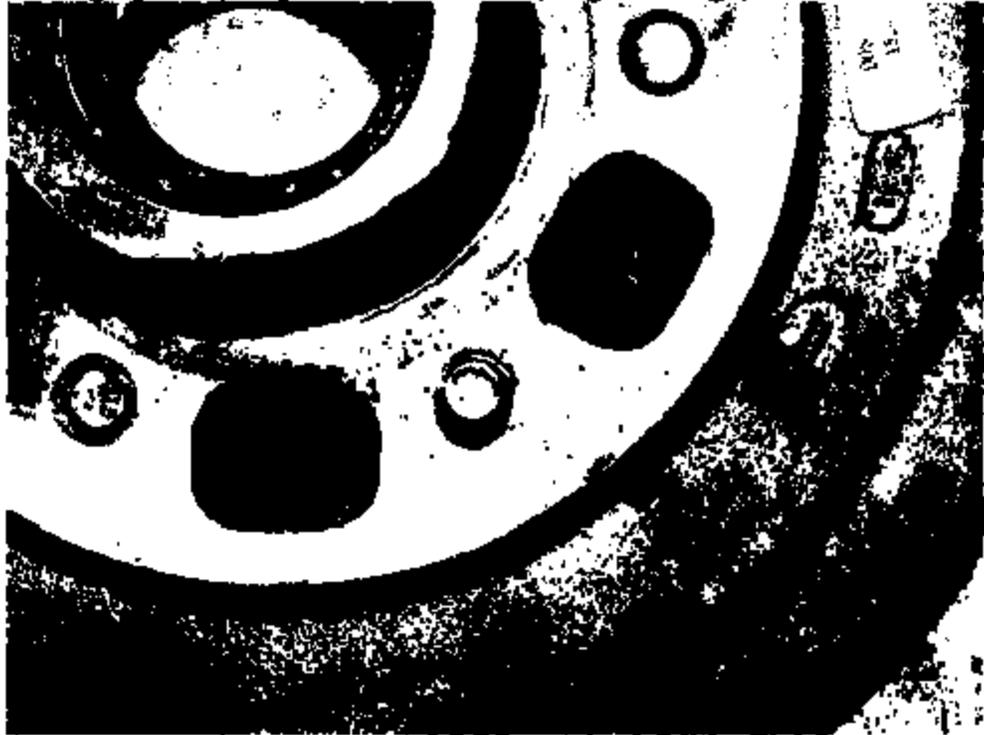
**Photograph # 3, Inspected Vehicle # 2, Pigeon Forge, Tennessee**

**View of driver's side rear hub mounting face. The wheel had separated from this hub. Note one broken stud (at left of photograph) and one intact stud (in center of photograph). Two unbroken studs installed in this hub indicate that the nuts backed off these studs whereas the other four studs had fractured. Bearing grease is evident (center of photograph) in the recess of the hub mounting face proximate to the wheel-mounting studs.**
