Engineering Analysis Closing Report
Park Brake Ineffectiveness on MY 1999-2003 Silverado/Sierra ½ ton Pickup Trucks
Equipped with Manual Transmissions
EA04-011

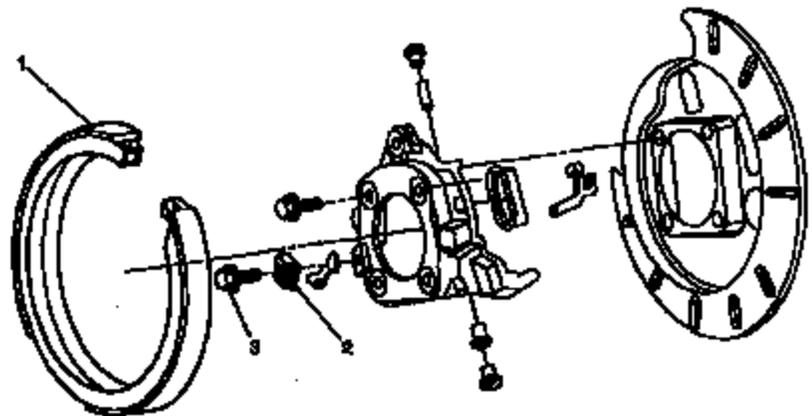
features (park pawl in automatics, Reverse or First gear in manuals). This parking brake system is distinguished from other DIH designs in that it contains a single brake shoe bearing two friction linings (Item 1 in Figure 1) and is referred to as a “Banksia”-style brake. The brake shoe is expanded by a cable-actuated piston and is confined against the backing plate by a spring-loaded hold-down clip (Item 2 in Figure 1). The Banksia parking brake system contains fewer
