Reference: NVS-213cla; PE05-027

This document updates input received by DaimlerChrysler Corporation ("DCC") between June 8 and October 5, 2005 regarding alleged 5.7L V8 engine stalling while driving on 2004-2005 model year Dodge Durango sport utility vehicles and Dodge Ram pickup trucks manufactured for sale or lease in the United States. June 8, 2005 was the cut off date utilized for data provided with the July 28, 2005 response to PE05-027. DCC has conducted a reasonable and diligent search of records kept in the ordinary course of business for such information. By providing the information contained herein, DCC is not waiving its claim to attorney work product and attorney-client privileged communications.

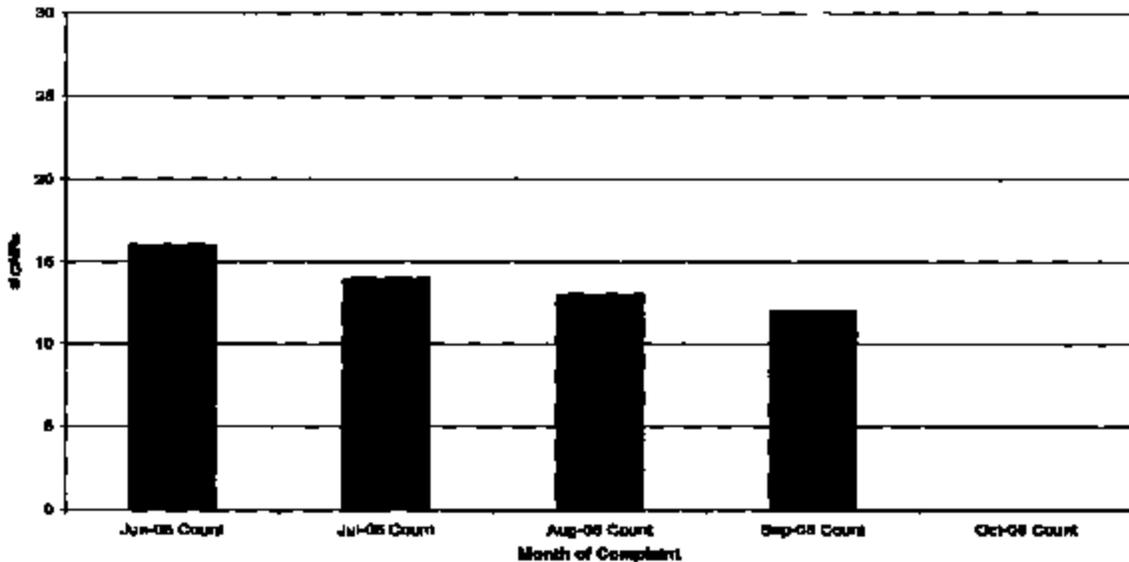
CAIRs by Month of Complaint

The chart below reflects CAIR input for steady state and low speed stall allegations received between June 1 and October 5, 2005. Through the data cut off date utilized for this update, there have been no inputs received during the month of October. This data shows an overall complaint rate that is low and clearly decreasing.

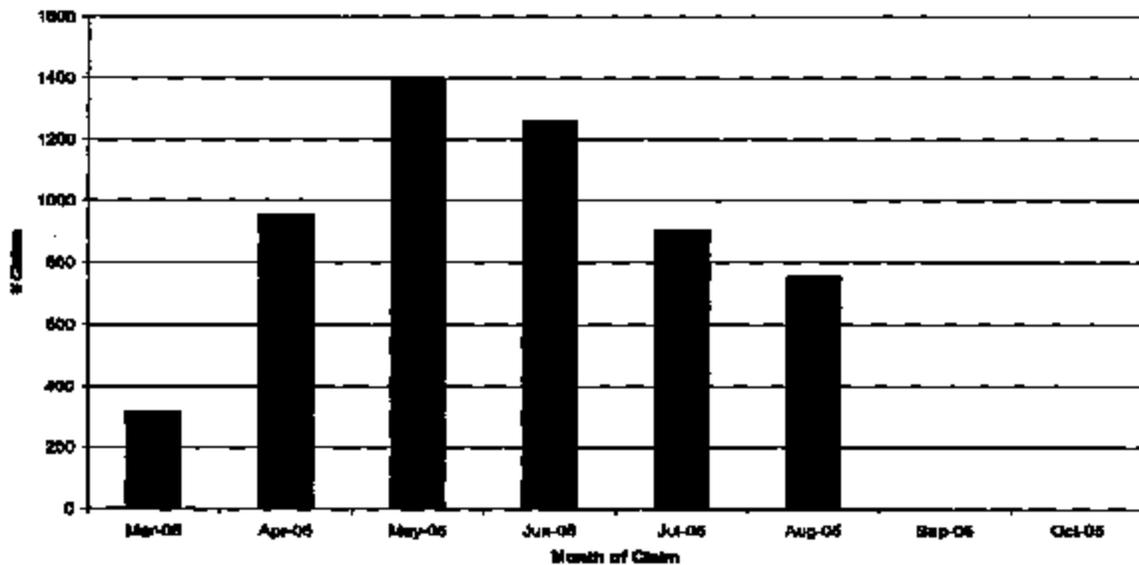
Warranty Claims by Claim Date  
LOP 08194391  
Latest Calibration, TSB 18-013-05

The chart below reflects the total number of warranty claims against the most recent calibration flash for the 5.7L V8 engine Powertrain Control Module (PCM), which was released into production on February 1, 2005 for the Durango and March 15, 2005 for the Ram pickup truck, and via Technical Service Bulletin (TSB) # 18-013-05 on March 16, 2005.

DCC's customer concerns are being addressed as indicated by the previous chart summarizing TSB completions. Complaint data shows that the number of customer concerns is decreasing over time as the TSB becomes more widely applied in the field on vehicles experiencing the condition.

This TSB was released to address potential engine calibration concerns and involved reprogramming the PCM if the vehicle experienced rough idle, idle fluctuation, Malfunction Indicator Lamp illumination, or in isolated cases stalling.

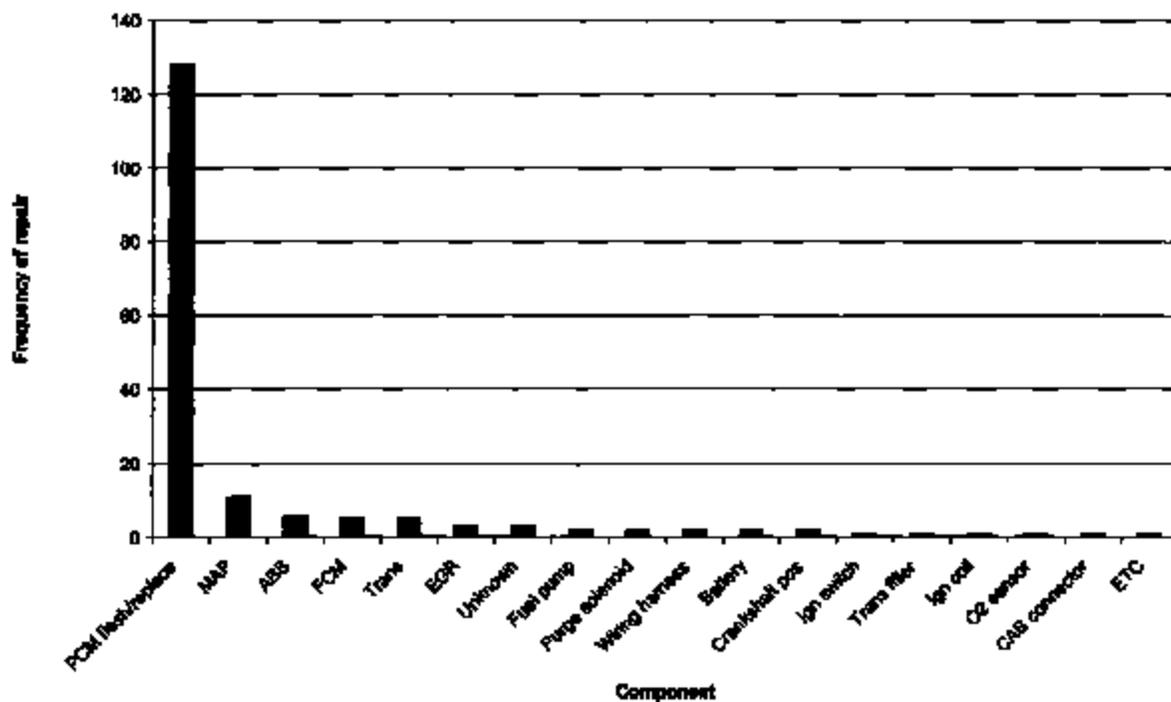
Component Repaired/Replaced Under Warranty  
Vehicle Data through June 8, 2005

As detailed in the July 28, 2005 PE05-027 response, there were 355 vehicles identified with customer complaints, field reports, or claims/lawsuits that may relate to the subject condition. Additional analysis was completed on the repair history for those vehicles. The following chart depicts by frequency the repaired/replaced component for those vehicles with no further complaints after the repair was completed. As can be seen in this data, a PCM flash/replace was the final repair for the large majority of subject vehicles with the alleged condition.

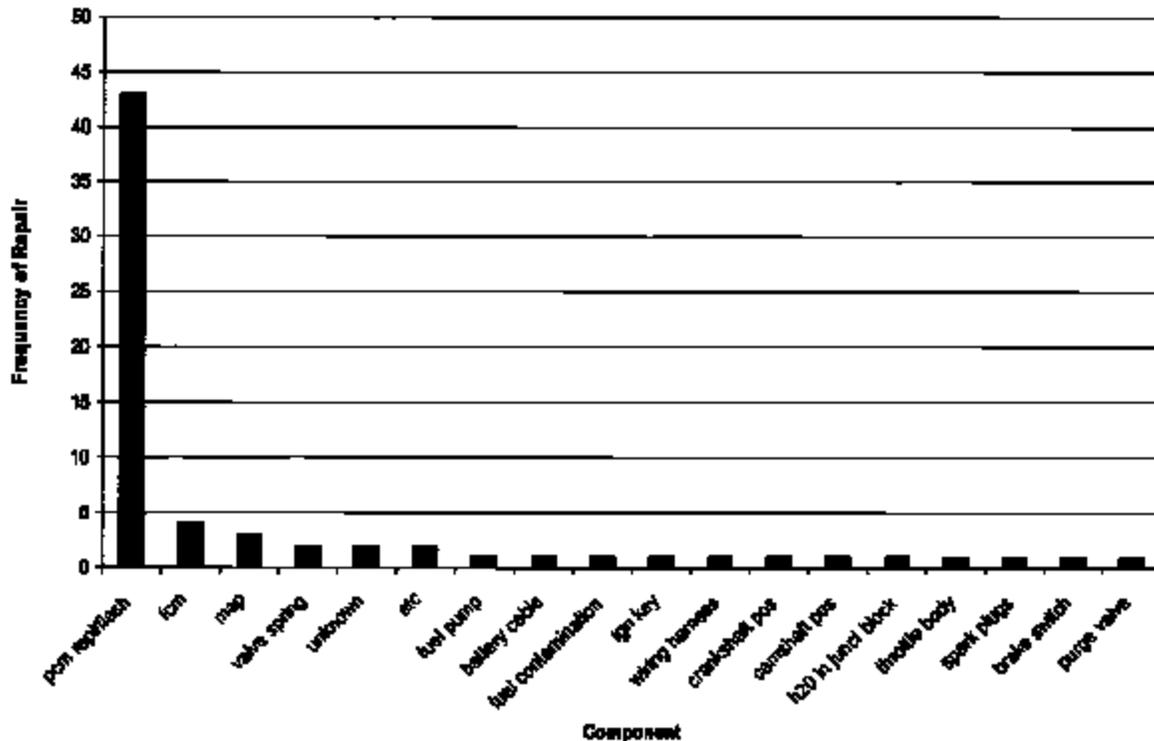
Component Repaired/Replaced Under Warranty  
Vehicle Data from June 8 through October 5, 2005

Identical analysis was conducted on the 178 vehicles for which DCC received input between June 8, 2005 and October 5, 2005. The chart that follows represents the findings of this analysis. PCM flash/replace was again the final repair for the vast majority of subject vehicles with the alleged issue.

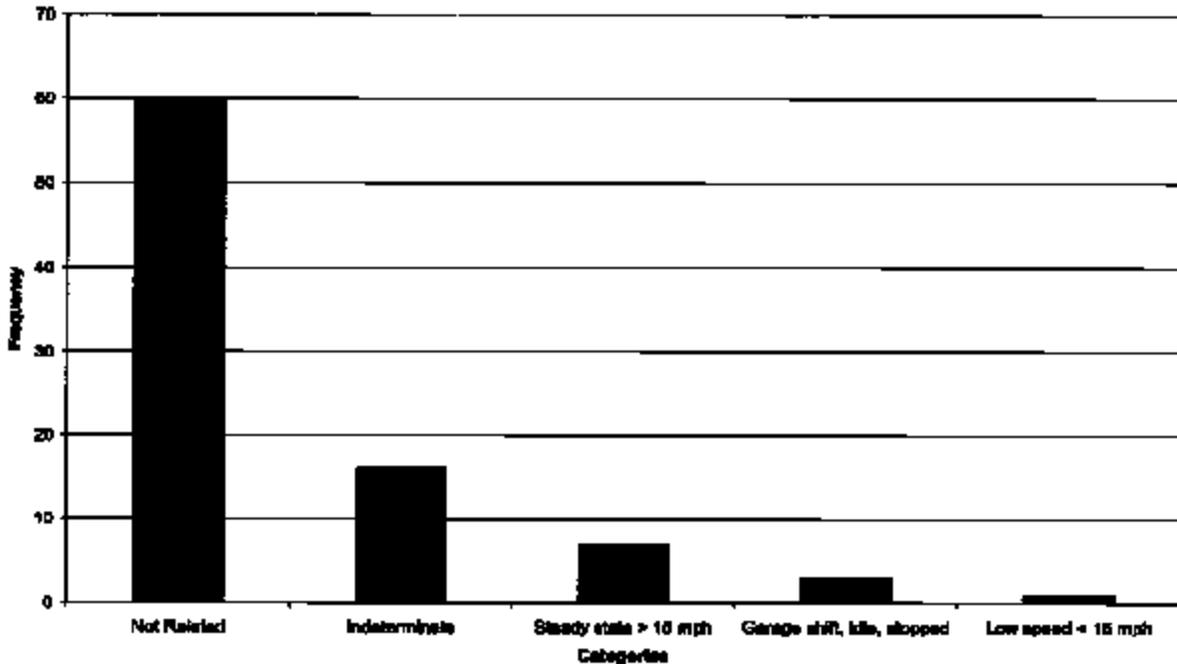
### Warranty Narratives by Categorization

Most warranty claims do not have associated narrative data. A small number of the warranty claims included with the PE response did have narrative data available. An analysis of those narratives showed that the vast majority or 69% (60 of 87) were clearly not related to the alleged condition. For another 18% (16 of 87) the narrative did not provide sufficient information to determine if the claim was related. Based on the available narrative data, only a small number were found that may relate to the alleged condition, and are shown on the following chart.
