**INVESTIGATION OF FUEL TANK CRACKS  
1998-2005 SUZUKI VL1500 MOTORCYCLES**

**NHTSA Defect Investigation PE05-031  
Suzuki / NHTSA Meeting  
November 3, 2005**

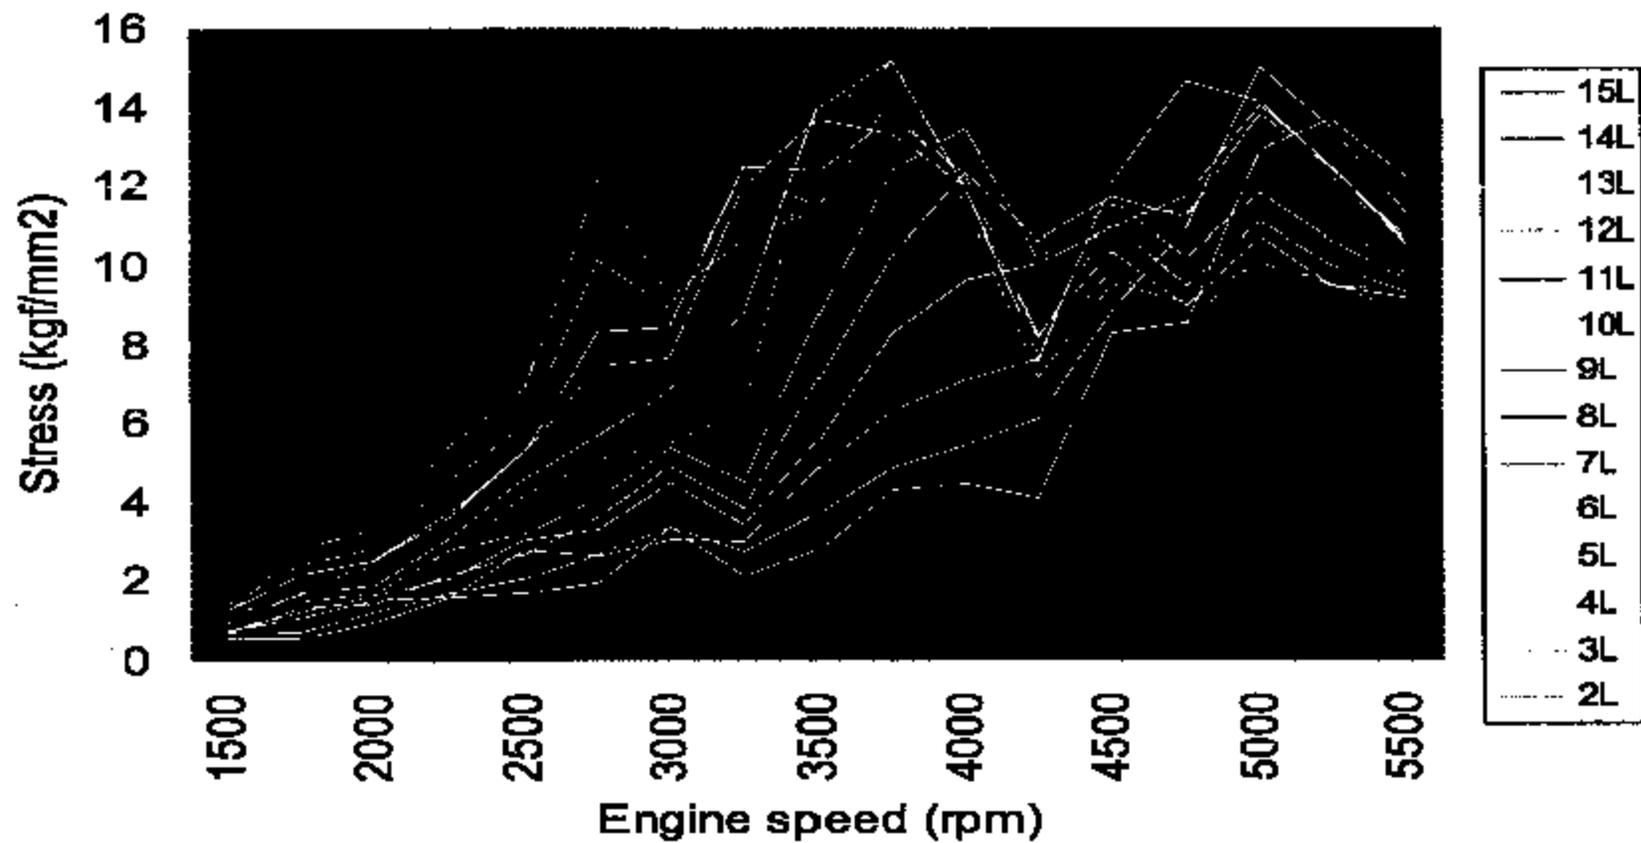
Test #2 Right Front Point

- HIGHEST STRESS MEASURED AT RIGHT FRONT MOUNTING LOCATION
- NO-LOAD ENGINE SPEED INCREASE
- 52 CONDITIONS EVALUATED

- **STRESS LEVEL DEPENDS ON ENGINE SPEED AND FUEL LEVEL**
  - Peak observed at 2750 rpm with full tank
  - Peak observed at 3500 rpm with 11 liters of fuel
- **MOST STRESS PEAKS ARE LESS THAN 15 kgf/mm<sup>2</sup>**
- **IN RARE CASES, STRESS LEVEL OF 16 kgf/mm<sup>2</sup> OBSERVED**
  - 2 out of 52 conditions

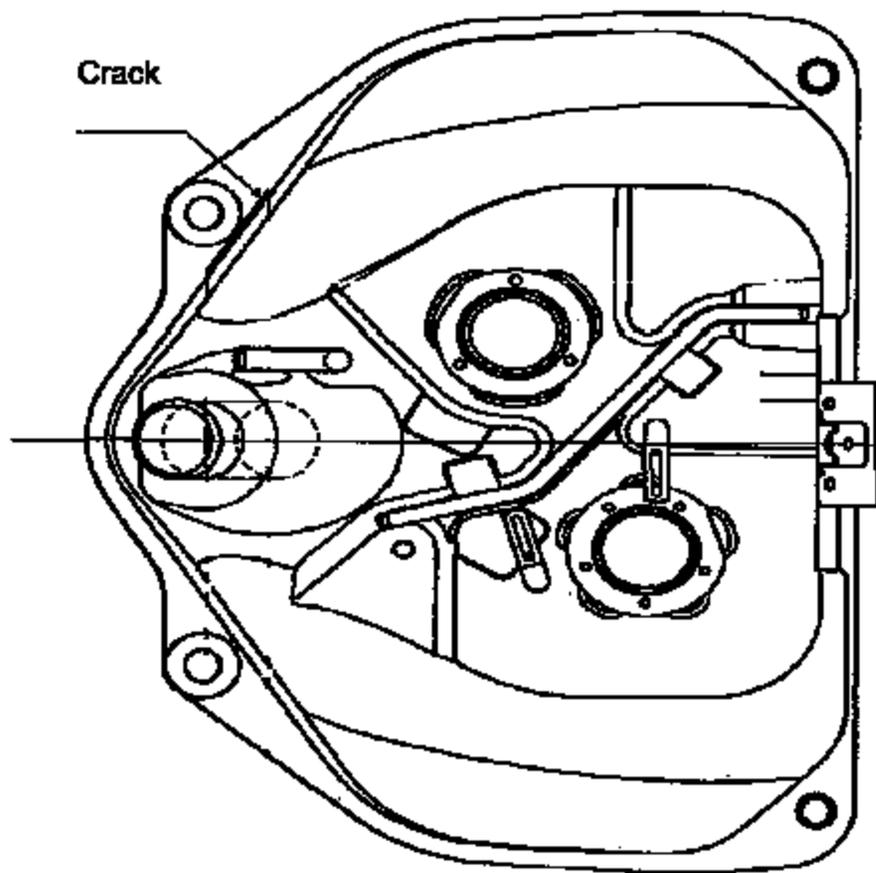
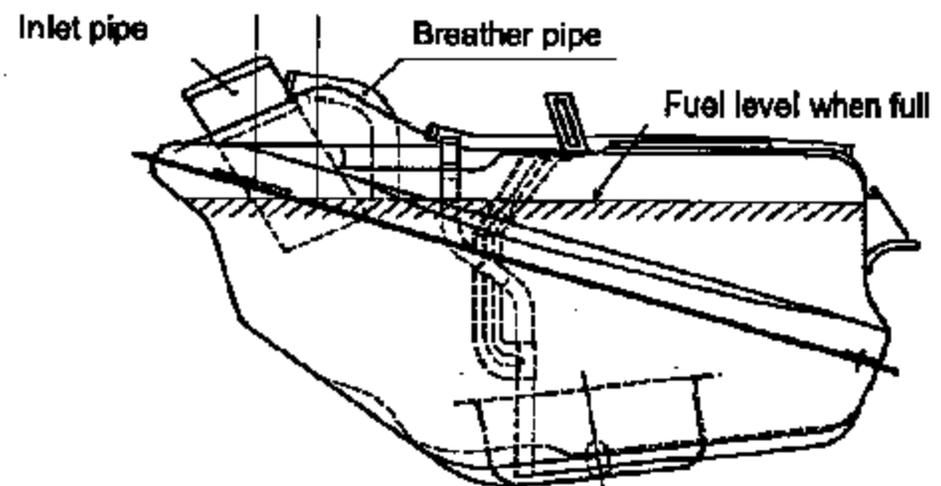
# FUEL TANK DESIGN

- **FREQUENTLY REPEATED STRESS OF 16 kgf/mm<sup>2</sup> CAN CAUSE CRACK DUE TO METAL FATIGUE**
- **NO DEFECT TREND EXISTS**
  - ASMC has received 1 customer complaint, 18 field reports, and 29 warranty claims which may relate to alleged defect for population of 33,000 vehicles
  - SMC confirmed cracks in only 5 tanks for population of 60,000 vehicles
  - For very small number of vehicles, very unique conditions may produce stress of 16 kgf/mm<sup>2</sup> (stress peaks at 2750 rpm with full tank, 3500 rpm with 11 liters of fuel). Prolonged exposure to these unique conditions would be rare
  - 1,000,000 repetitions of 16 kgf/mm<sup>2</sup> stress needed for crack to start to form

- **NO SIGNIFICANT RISK TO SAFETY EXISTS**
  - No reports of fire, accidents, or injuries
  - No liquid fuel drop was observed when testing with cracked tank
  - Crack is at right front installation point, so fuel drop when parked will not occur, even with full tank
  - Vibration testing shows that if crack occurs, it does not expand beyond 75 mm
  - If a crack occurs, the rider should notice the smell of gasoline from any fuel seepage and seek repair
