V. ATTACHMENTS

PHOTOGRAPHS

DETERMINATION OF ORIGIN AND CAUSE

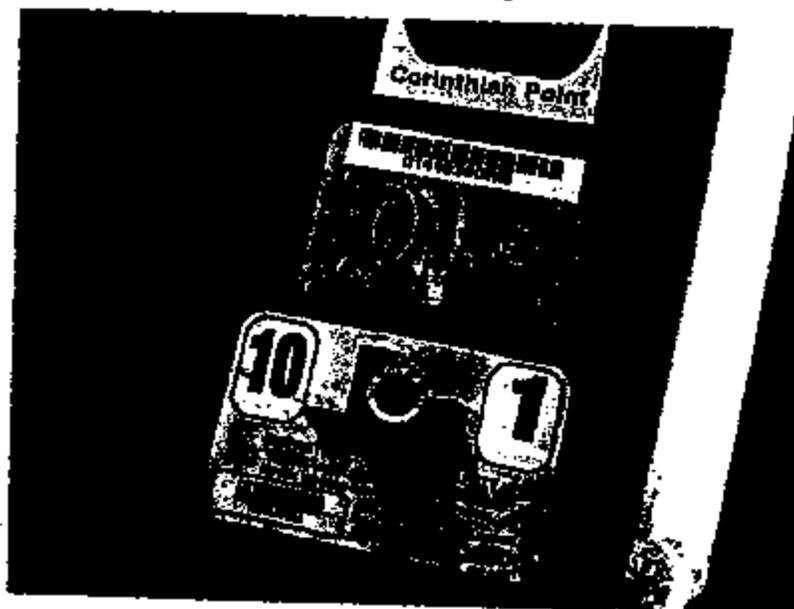
6. View of the state inspection and vehicle registration stickers.

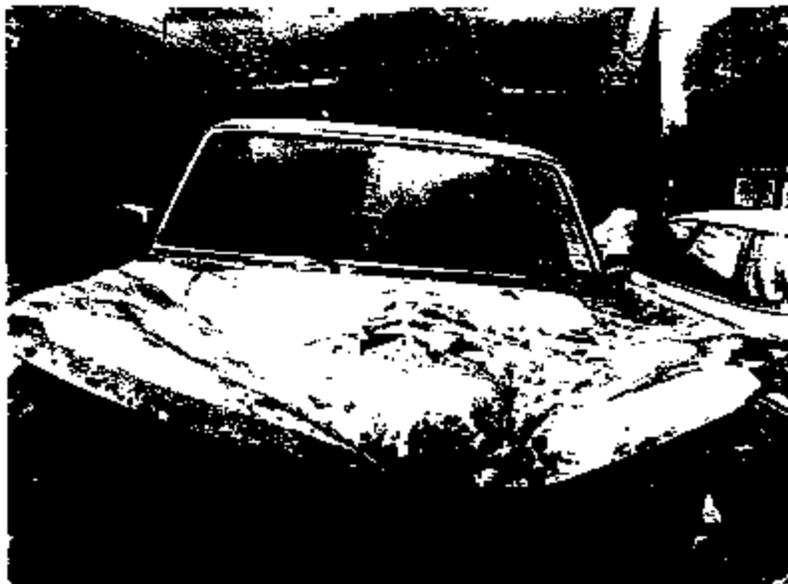
7. Closer view of the burned experienced by the vehicle hood.

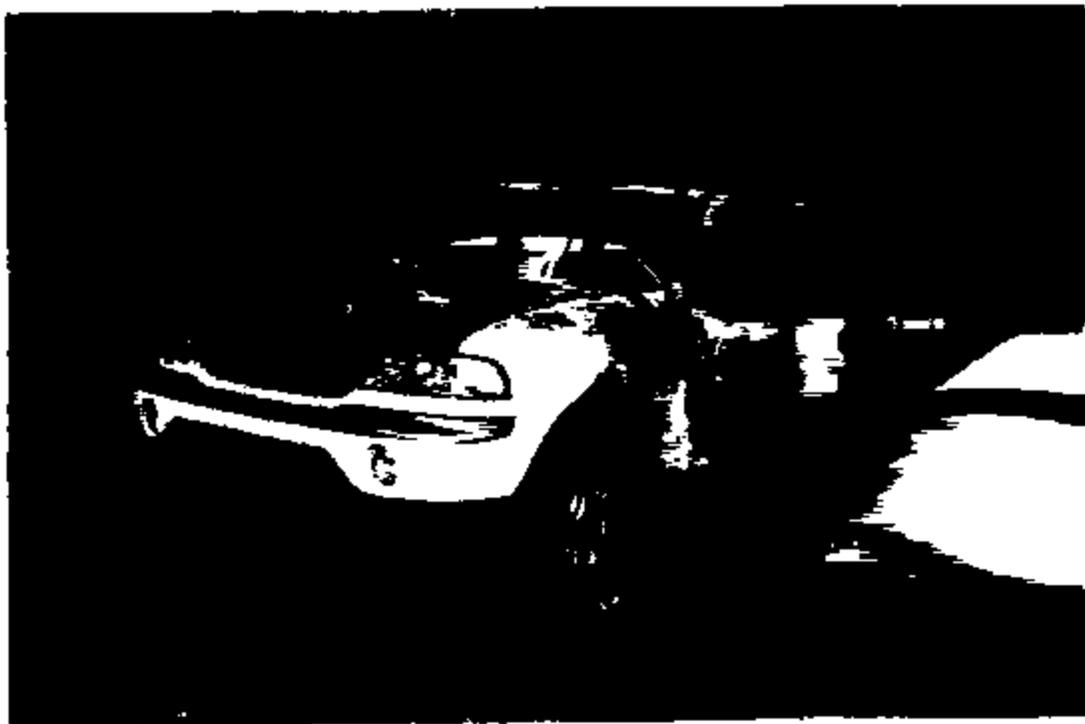
1. & 2. Damage to the vehicle.

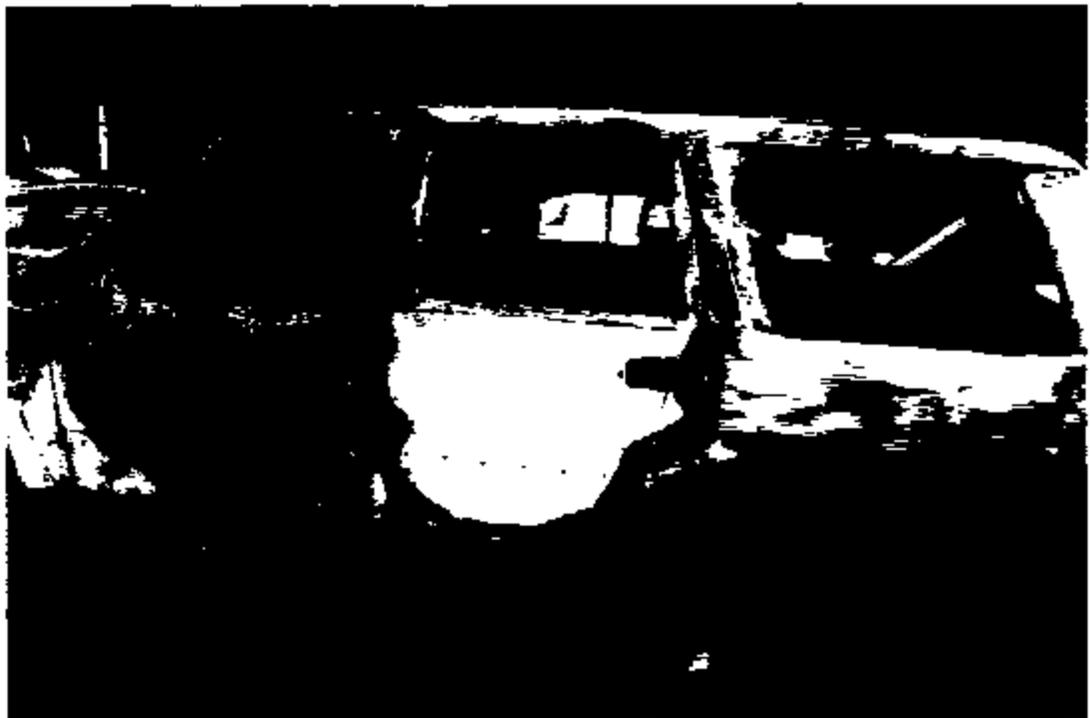
4. Damage to the left side of the vehicle.
