ODI RESUME

INVESTIGATION: SQ01-014
 DATE OPENED: Nov. 27, 2001 DATE CLOSED: Oct. 3, 2002
 SUBJECT: Post Rear End Collision Fires
 PROMPTED BY: Ford TSB No. 01-21-14
 Consumer Complaints
 PRINCIPAL ENGINEER: F. Borris

MANUFACTURER: Ford Motor Company
 MODEL(S): Ford Crown Victoria (including Police Interceptor), Mercury Grand Marquis,
 Lincoln Town Car
 MODEL YEAR(S): 1992-2001
 VEHICLE POPULATION: 3,128,603

Investigation No.: SQ01-014
 Subject: Fuel Tank Integrity in Rear Collisions
 Manufacturer: Ford Motor Company
 Model Years: 1992-2001
 Models: Crown Victoria, Town Car, Grand Marquis
 Date Opened: November 27, 2001 Date Closed: October 3, 2002

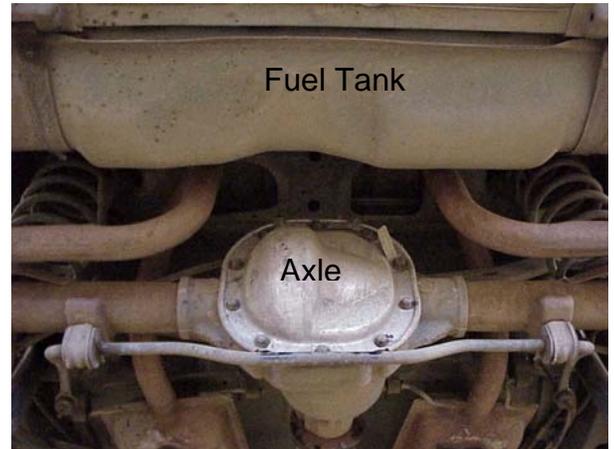
The picture to the right was taken at a local police department and shows the relationship of the fuel tank to the rear axle. The distance from the tank leading edge to the differential cover ring gear bulge is approximately four inches. Also visible are the sway bar brackets and dual exhaust pipes. This vehicle is a MY 2000 CVPI.

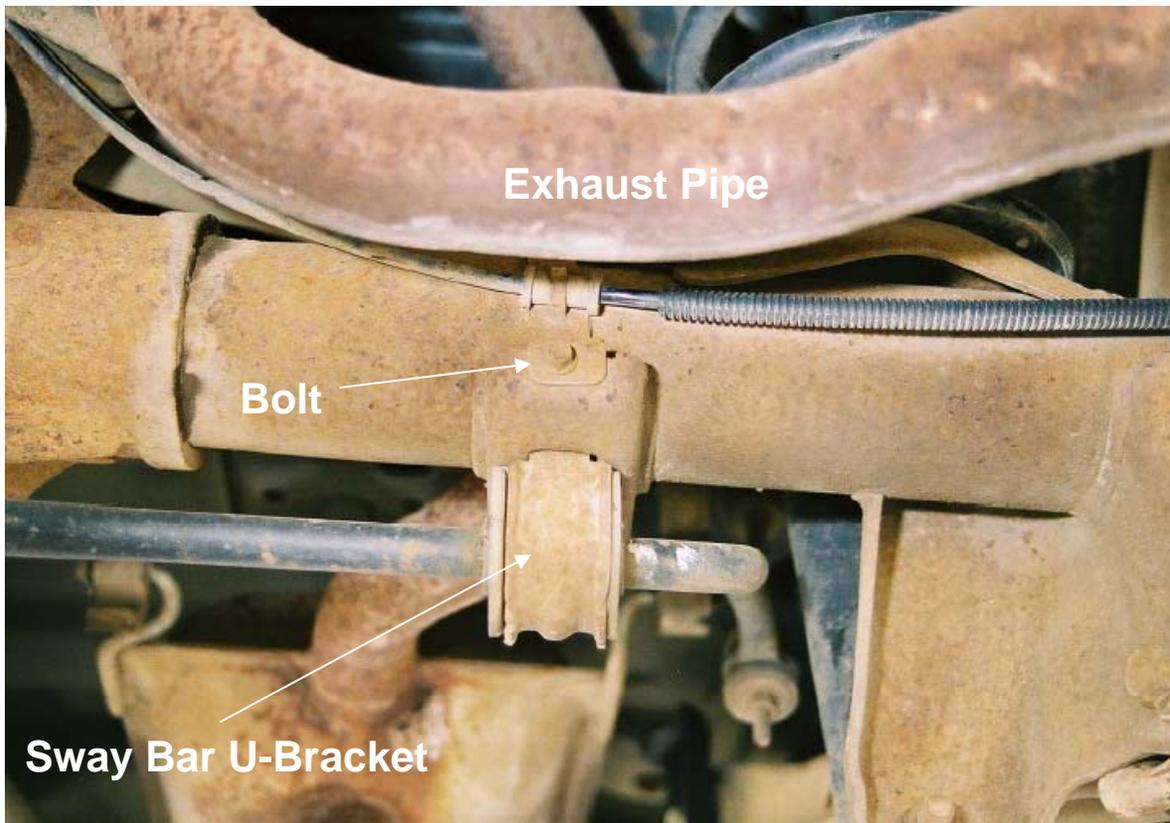
- 1) On 1992-1997 models, the hex-headed bolt that secures the parking brake cable to the axle protrudes beyond the cable bracket by 18 mm. Ford determined that this bolt could puncture the fuel tank in high-energy rear crashes. (In 1998 the Panther rear suspension was redesigned and does not use this parking brake attaching bracket or bolt.)
- 2) On 1992-2001 models, the sway bar U-brackets include a tab (4mm high by 6 mm wide) that can cut the tank. In high-energy rear crashes, the axle tends to rotate upward, exposing the fuel tank to these tabs.

To address these two potential sources of fuel tank puncture, Ford's TSB recommended replacing the hex-headed parking brake cable bolt with a different fastener having a rounded head and grinding the U-bracket tabs flush, leaving no sharp edges.

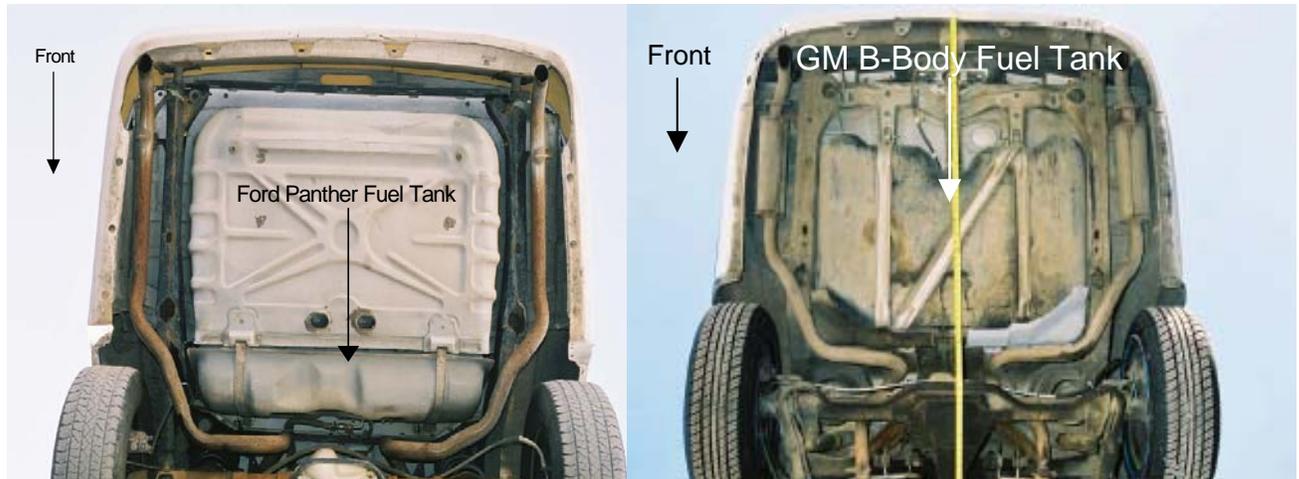
Like the Ford Panther vehicles, the GM B-Body stores its fuel in a tank mounted aft of the rear axle. But unlike the Panther's vertically mounted steel tank, the B-Body tank is made of plastic (HDPE) and is horizontally mounted below the trunk floor. As illustrated in the photographs below, the GM fuel layout strategy presents less of the tanks leading edge toward the rear suspension components at the expense of being further within the vehicle's crush zone.

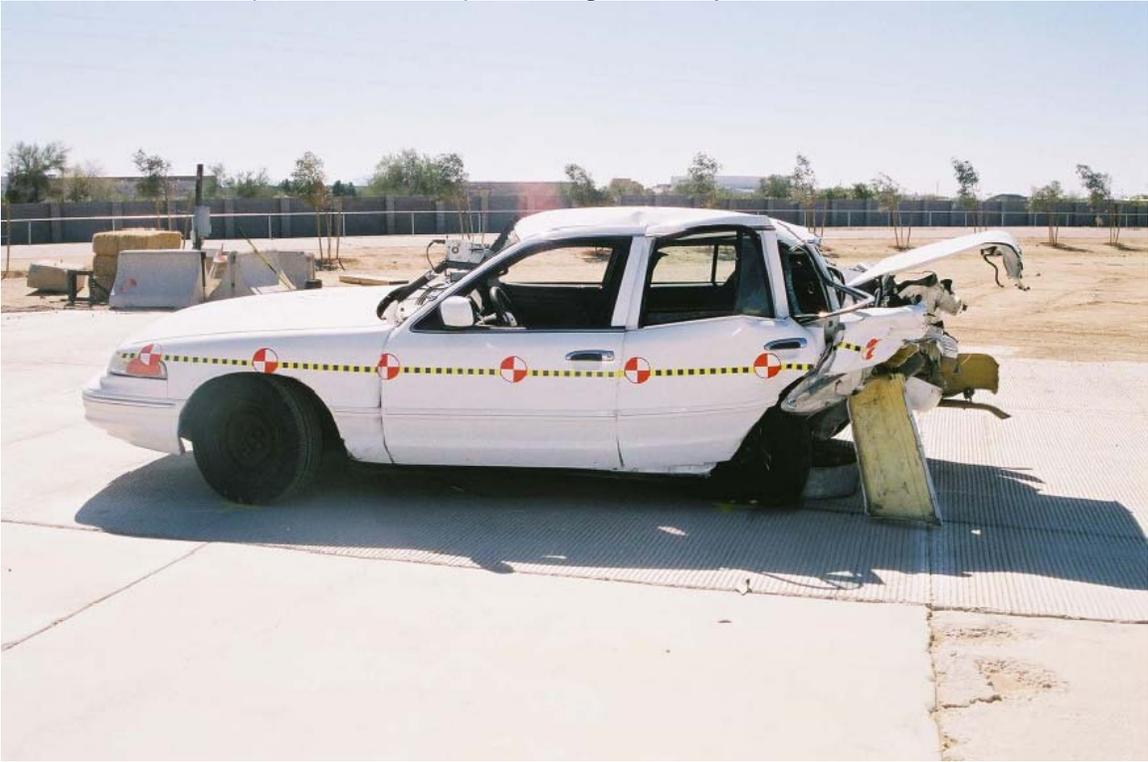
Crash Test 7156 (Crown Victoria) showing severe penetration.

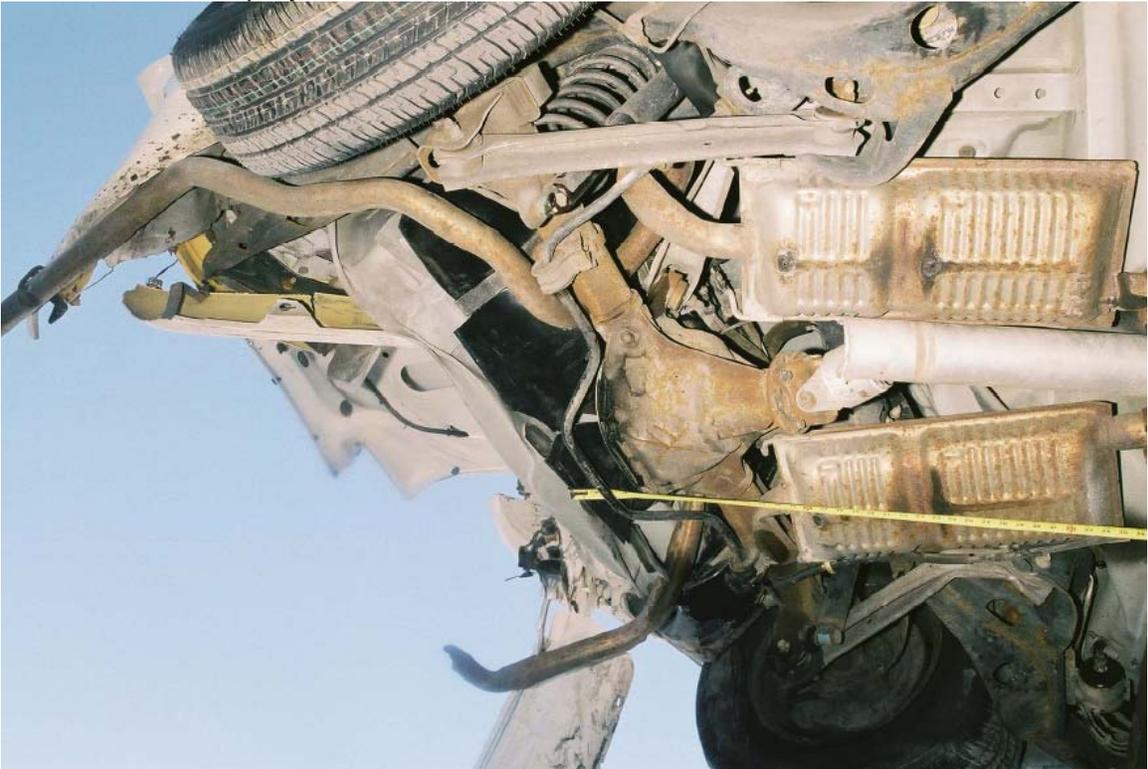
Crash Test 7156 (Crown Victoria with TSB modifications) showing crushed fuel tank with a black polymer shield installed.

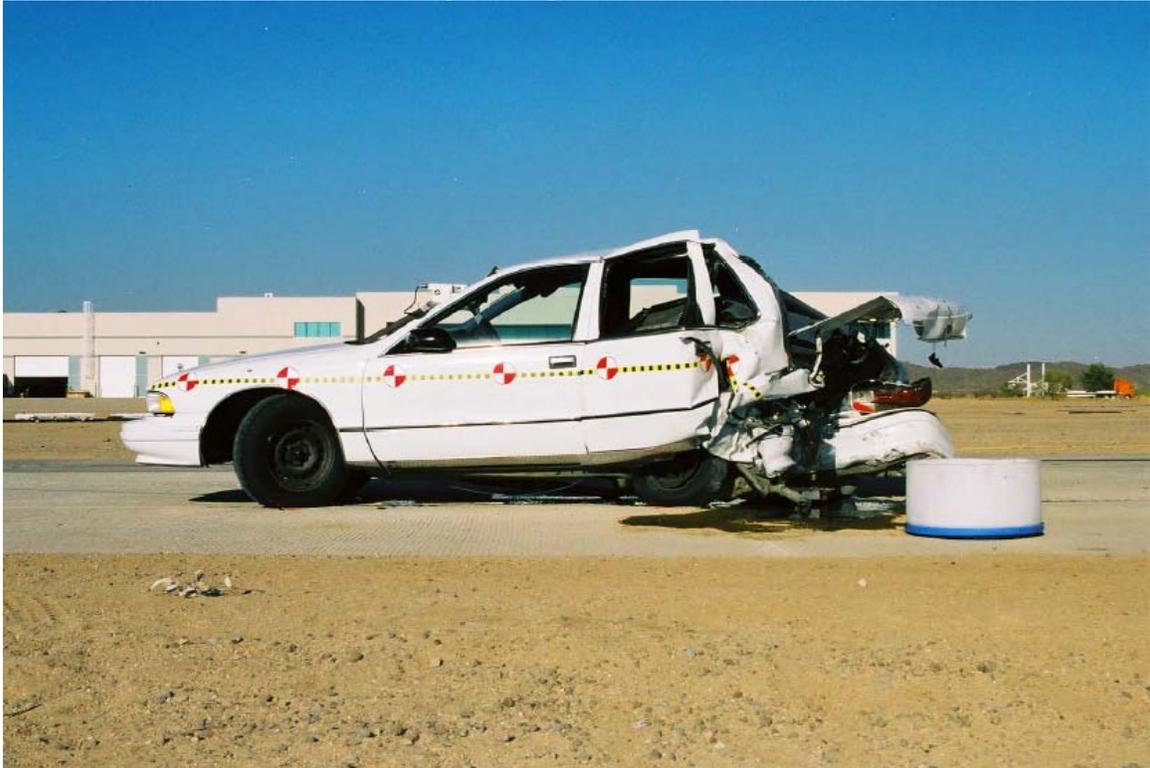
The photograph below was taken during Crash Test 7153 (Caprice) and shows severe penetration and resulting leakage.

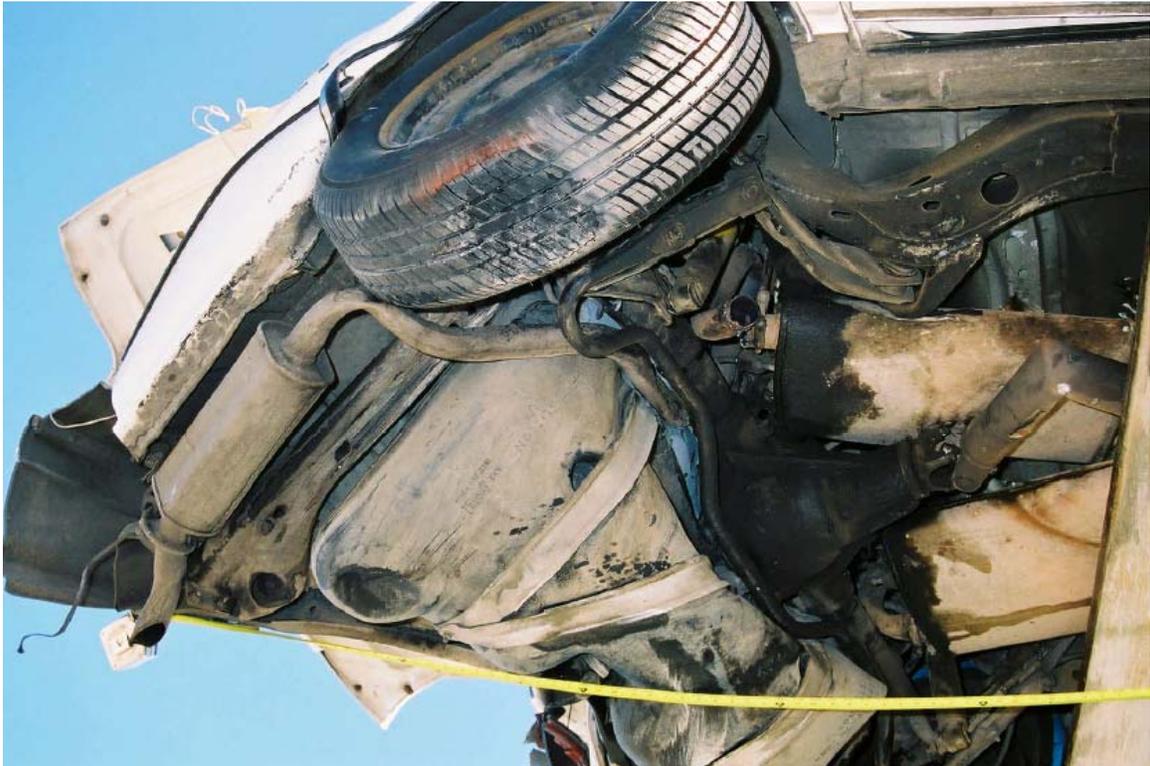
Crash Test 7153 (Caprice) showing severe deformation of fuel tank.
