TO: US and Canada Dealer Principals, Service Managers, Parts Managers and Sales Managers
RE: Recall R158 Volvo S40, V50 with T5 engine (MY2004.5 – 6) Fuel Line in Engine Bay

VOLVO				TITLE:		GROUP:	NO:	
				Recall 158 Replacing Fuel Line in Engine Bay		23	158	
Service Manager Bulletin				MODEL YEAR 2004.5 - 2006 S40 & V50 with T5 Engine		ISSUING DEPARTMENT: Warranty		
				REFERENCE BULLETINS: TNN# 23-158 PB 23-158 Supersedes SMB 23-158 dated 2006-05-02		CARMARKET: United States, Canada		
Service Person- nel: read and initial.	SERVICE MANAGER	SERVICE WRITER	WARRANTY ADMINISTRATOR	DATE:		YEAR	MONTH	DAY
				2006	06	02	Page 1 of 3

NO: 23-158
DATE: 5-2-2006
MODEL/YEAR: S40 2004.5-2006 (Turbocharged engines) Engine code 68.
V50 2005-2006 (Turbocharged engines) Engine code 68.
CHASSIS: 544 0000001-0157396
545 0000001-0158012

SUBJECT: Recall 158 Replacing Fuel Line in Engine Bay.
REFERENCE: VIDA, SMB 23-158, PB 23-158

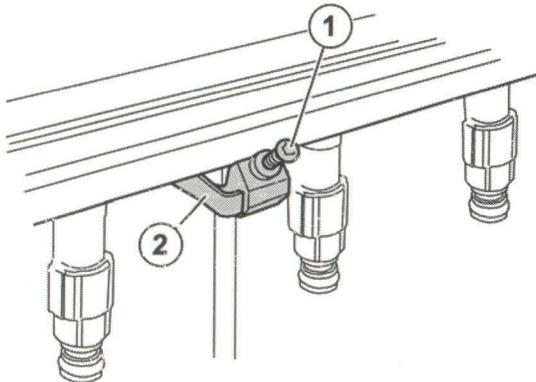
i-240955

Note! During running production a new coupling (catch) has been introduced between the fuel line and fuel rail.

Unscrew the screw (1).
Bend out the secondary lock (2). Pull out the catch.
Remove the fuel rail.

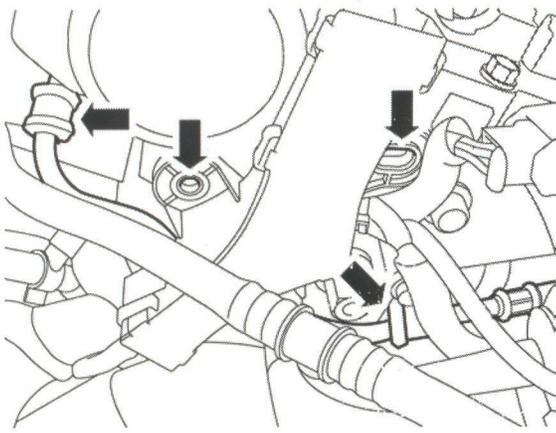
i-239295

Note! It is important that there is space behind the cable duct when installing the new fuel line.

- the screws for the clamps on the fuel line
- the two screws for the cable duct. Pull out the cable duct as far as possible from the cylinder head and secure it.

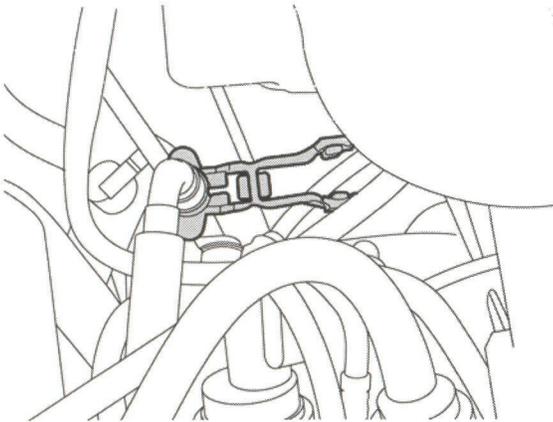
i-239293

Caution! Note how the fuel line is routed.

Cut off the plastic section of the fuel line exactly behind the junction between the plastic pipe and the metal pipe and remove the fuel line.

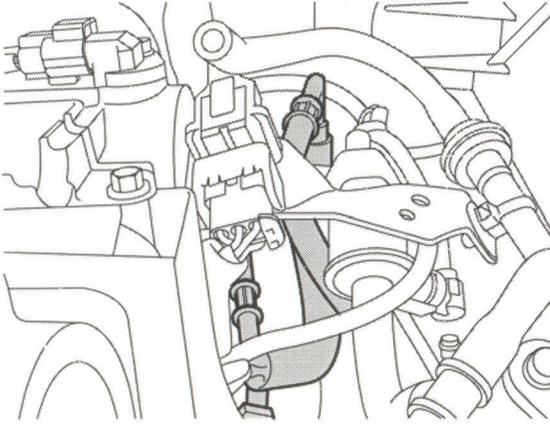
i-239294

The plastic section of the new fuel line is preformed but is softer than the old one. At installation it can be straightened and carefully threaded behind the cable duct.

Note! The hose must not be bent or kinked, i.e. there cannot be any sharp bends in the hose. If the hose is bent this can affect the shape of the hose restricting the flow of fuel.

Install the new fuel line.

Thread the fuel line behind the cable duct further along under the electrical cable and up on the other side of the electrical cable, so that it is located between the electrical cable and the EVAP valve.

Install the fuel line's quick release connector to the fuel line from the tank. A click should be heard once it is locked.

Check that it is locked by pulling the coupling.

Check that the bend in the fuel line can be moved freely and is not pinched by surrounding components.
