AUTOCAR SAFETY RECALL A-0603 NHTSA RECALL 06V-167 May 2006

ATTENTION:	SERVICE MANAGERS / PARTS MANAGERS
SUBJECT:	Axilok Spindle Nut Tabs
VEHICLES AFFECTED:	Certain WX, WXR and WXLL 2006 model-year, heavy-duty Class 8 vehicles equipped with Hendrickson Lift Axles, shipped between November 9, 2004 and April 25, 2006 with serial numbers in the range 201463 through 203515.

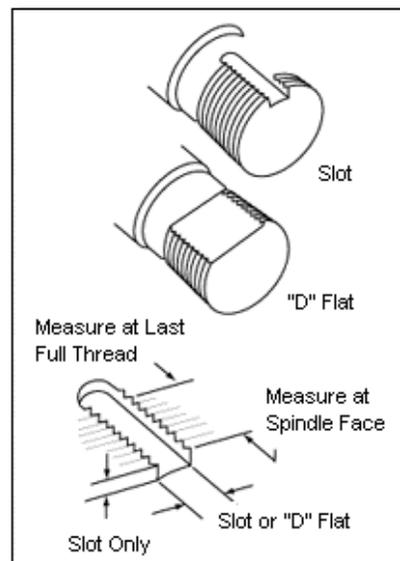
Figure 3

Remove hub to fully expose spindle and its slot or "D" flat. Carefully measure the width and depth of the spindle slot or "D" flat at the outboard end of the spindle and at the last full thread of the slot or "D" flat. If the measurements are identical, Axilok may be used. If not, DO NOT use Axilok on this spindle. Use a conventional wheel nut retaining system. Refer to Figure 3.

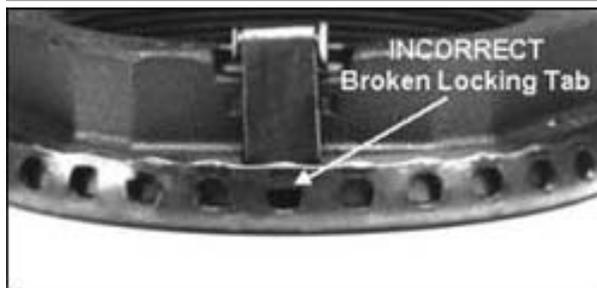
- Each locking clip should be securely fastened to the nut body and have a rivet that passes through the top of the locking clip body.
- Each locking clip should have a locking clip tab protruding completely through the retainer cage adjustment slot (when properly aligned and not compressed by a socket). Refer to Figures 2, 4 and 5.
- Locking clips should not be bent, cracked or broken.

Locking clip tabs broken
Figure 4

If locking clip tabs do not protrude through the adjustment slots, rotate Axilok slightly clockwise. Refer to Figures 2, 4 and 5. If locking clip(s) are broken, replace Axilok and repeat installation procedures.

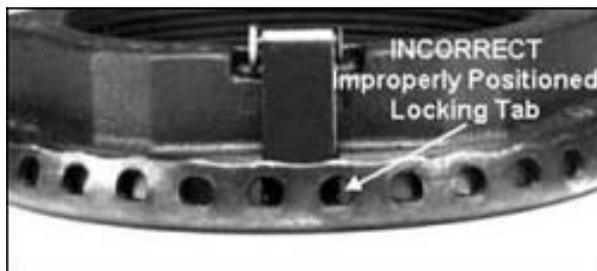
Improperly positioned locking clip tabs
Figure 5

7. After end play adjustment, make sure that both locking clip tabs are protruding through the slots in the retainer cage. Refer to Figures 2, 4 and 5.
