TECHNICAL SERVICE BULLETIN

Bulletin Number: V-06-02
Model Years: 2006

SUBJECT: Rear axle failure on 2006 Vegas[®], Vegas Eight Ball[™] and Kingpin[™]

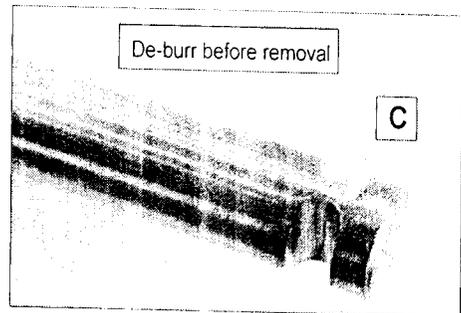
6. Before removing the axle, inspect it closely in area (C) for any burrs or raised edges that may have formed by contact with the retainer plate. Be sure to check both top and bottom side of the axle. Remove any burrs or raised areas carefully using a file or a small hand grinder.
7. Clean any metal shavings from the axle.
8. Draw axle out LEFT side.
