# TECHNICAL SERVICE BULLETIN

Bulletin Number: V-06-02  
Model Years: 2006

### SUBJECT: Rear Axle Failure on 2006 Vegas<sup>®</sup>, Vegas Eight Ball<sup>™</sup> and Kingpin<sup>™</sup>

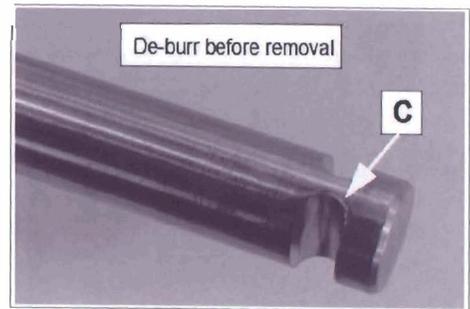
7. Before removing the axle, inspect it closely in area (C) for any burrs or raised edges that may have formed by contact with the retainer plate. Be sure to check both top and bottom side of the axle. Remove any burrs or raised areas carefully using a file or a small hand grinder.
8. Clean any metal shavings from the axle.
9. Draw axle out LEFT side.
